TUNITAS CREEK BEACH IMPROVEMENT PROJECT

DESIGN ALTERNATIVES

July 2020

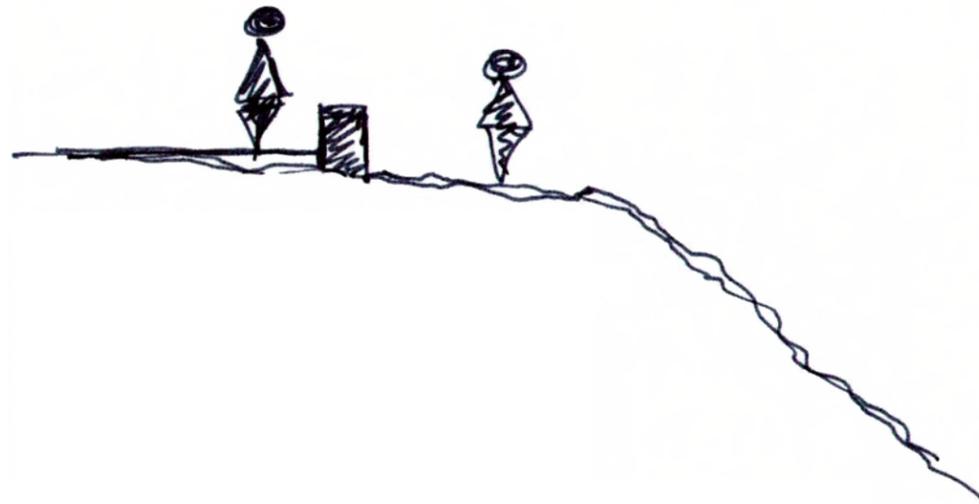
ALTERNATIVE 1

Minimum improvements to get the park open and stabilize sensitive landscapes

- Improvements to the entry configuration, vehicular circulation, and parking layout
- Replace unregulated dirt shoulder parking with new driveways, parking bays, and accessible parking
- Existing residence removed and native planting restored
- Public restroom at the mid-bluff* area
- Clear and safe access to beach designated by wayfinding markers and signage
- Removal of some invasive vegetation and restoration of natives

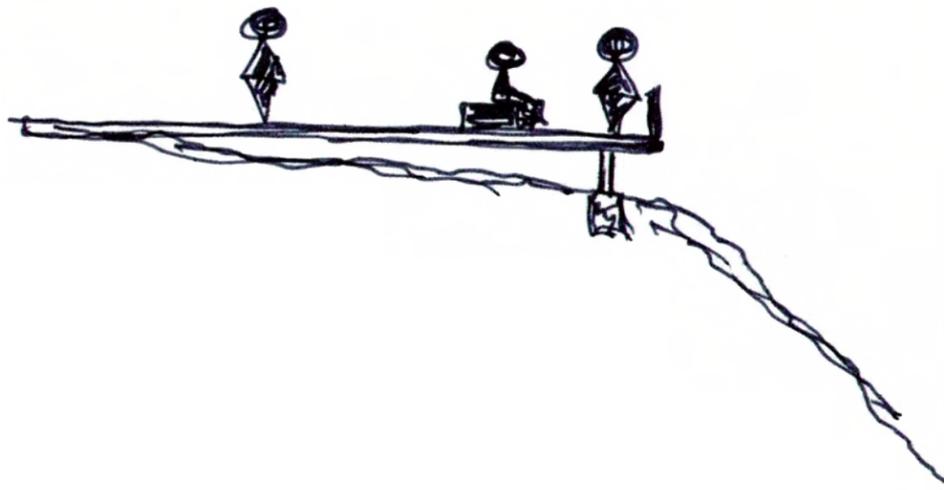
ALTERNATIVE 2

Additional improvements to enhance operations, user experience and site restoration

- Additional improvements to the entry configuration, vehicular circulation, and parking
- Larger number of parking spaces
- Larger paved promenade at the top of bluff next to parking area
- Addition of ranger station and residence at the mid-bluff area
- Creation of habitat protection zones for threatened species such as the snowy plover
- Accessible pathway to the mid-bluff
- Additional seating structures at overlook points
- Creation of a loop trail

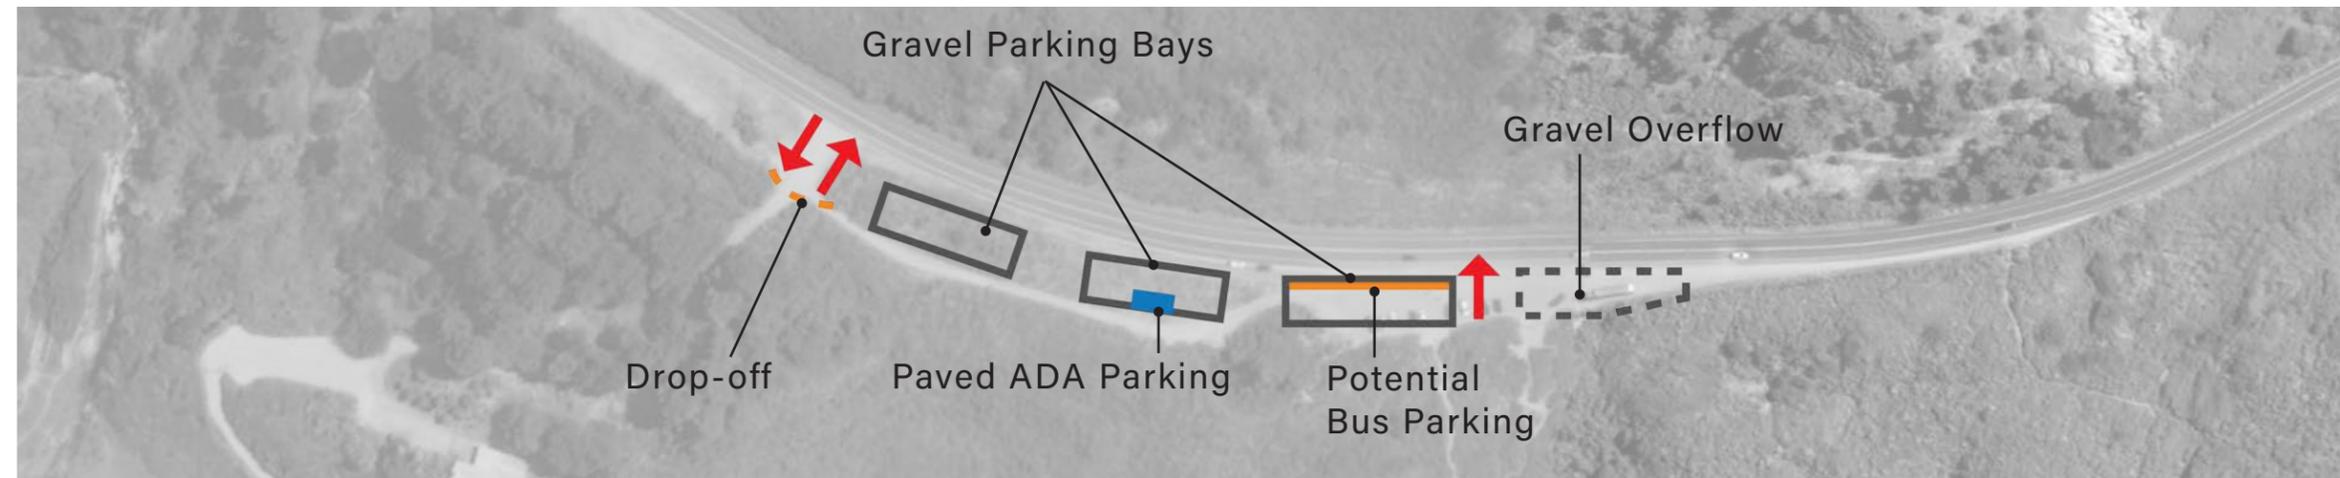
Alternative 1:

- ~60 public parking spaces
- ~20 overflow parking spaces
- ~4 ADA parking spaces
- Drop-off

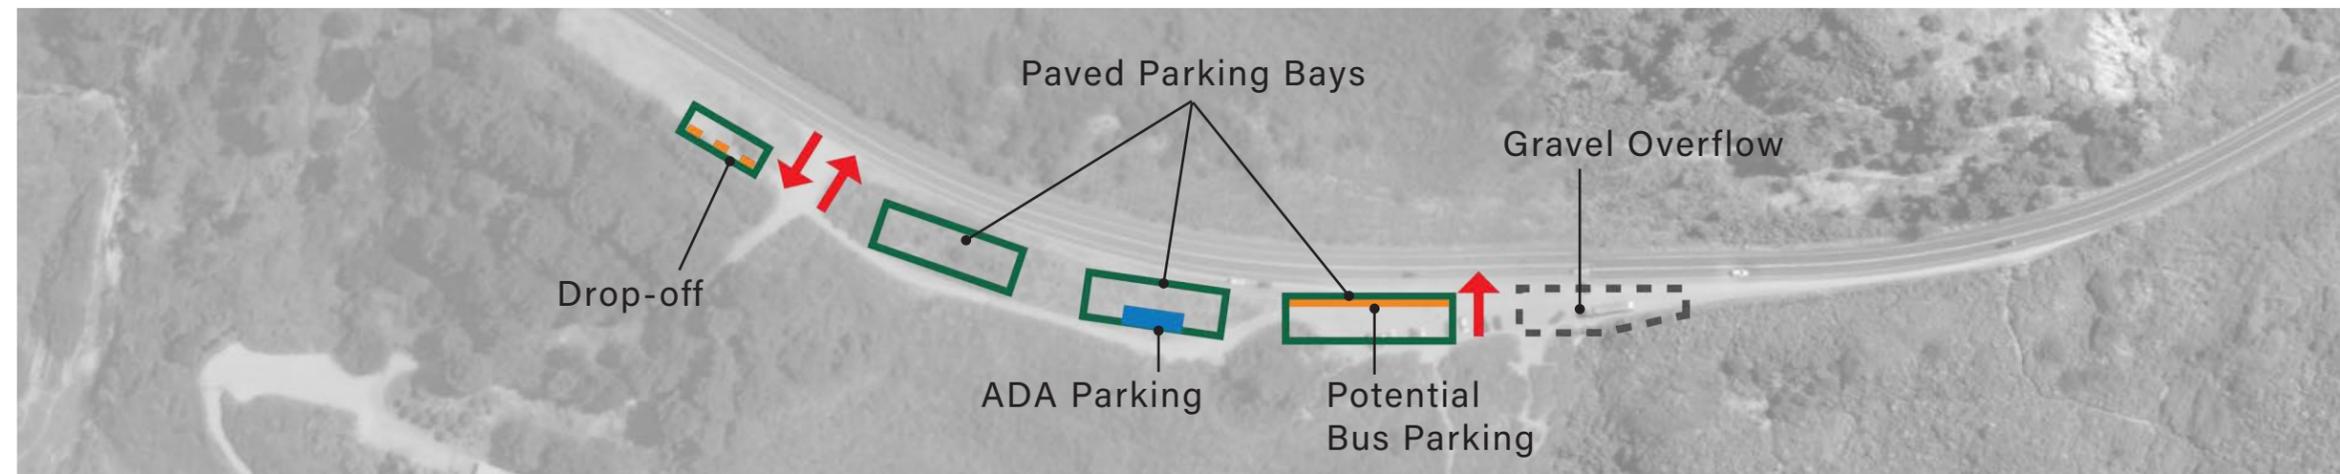
Alternative 2:

- ~60 public parking spaces
- ~20 overflow parking spaces
- ~5 ADA parking spaces
- Drop-off

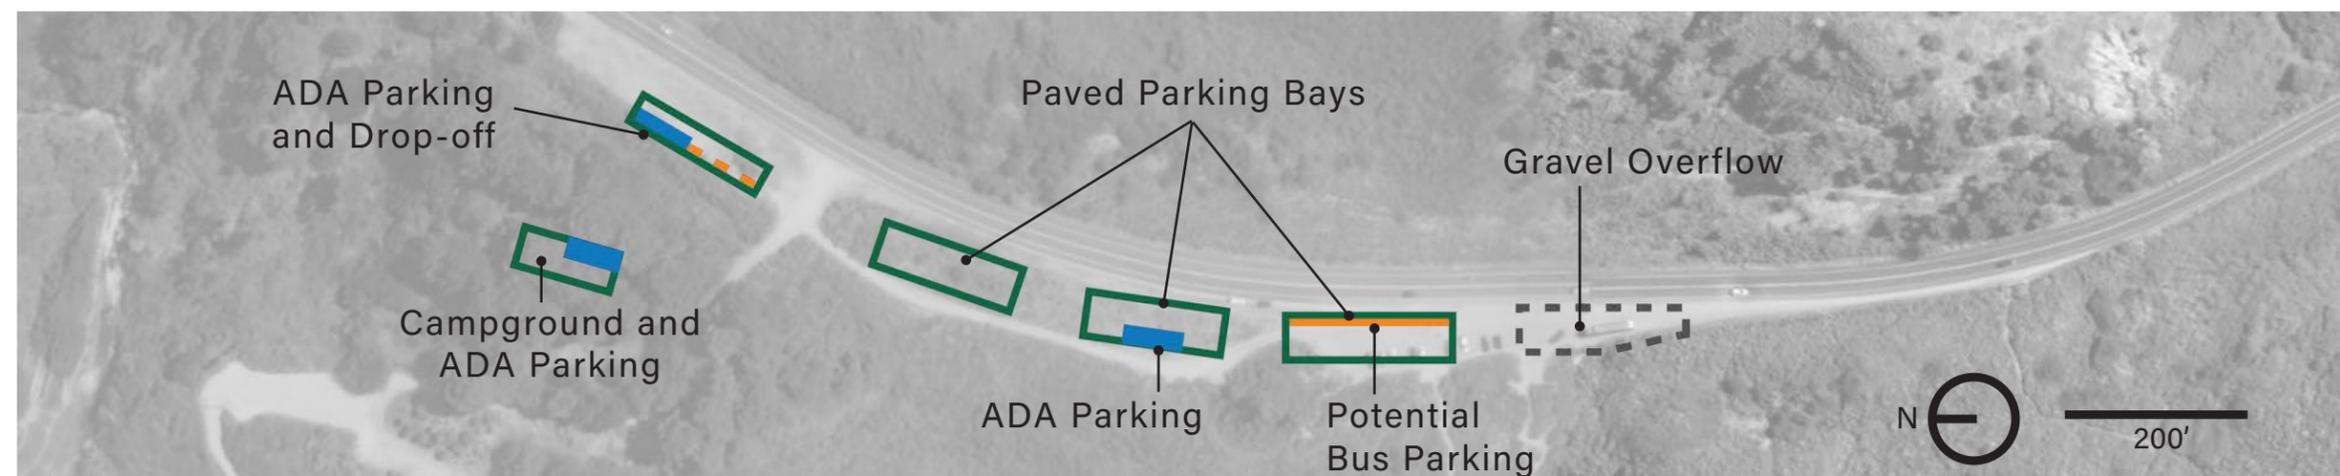
Alternative 3:

- ~90 public parking spaces
- ~20 overflow parking spaces
- ~6 ADA parking spaces
- Campground parking spaces
- Drop-off and bus parking

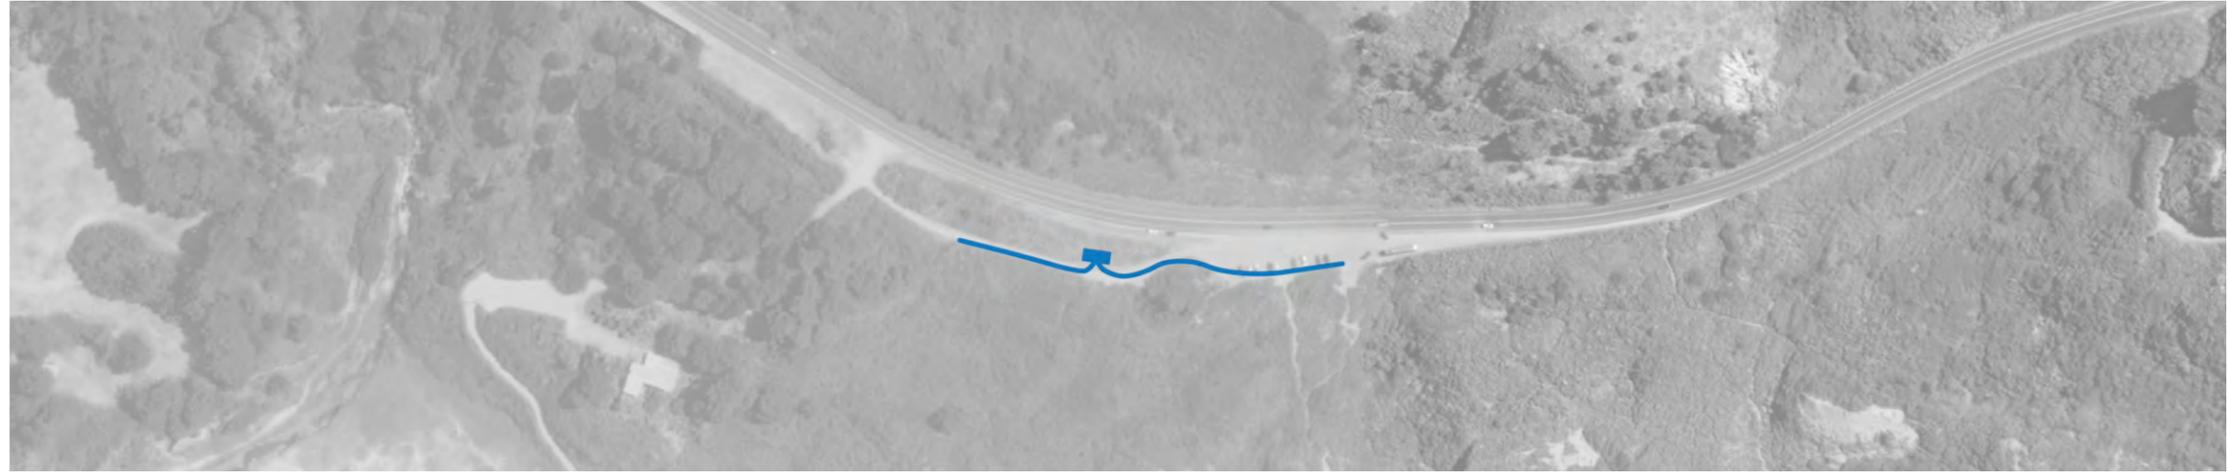
Alternative 1:

- ADA-Accessible Overlook and Promenade

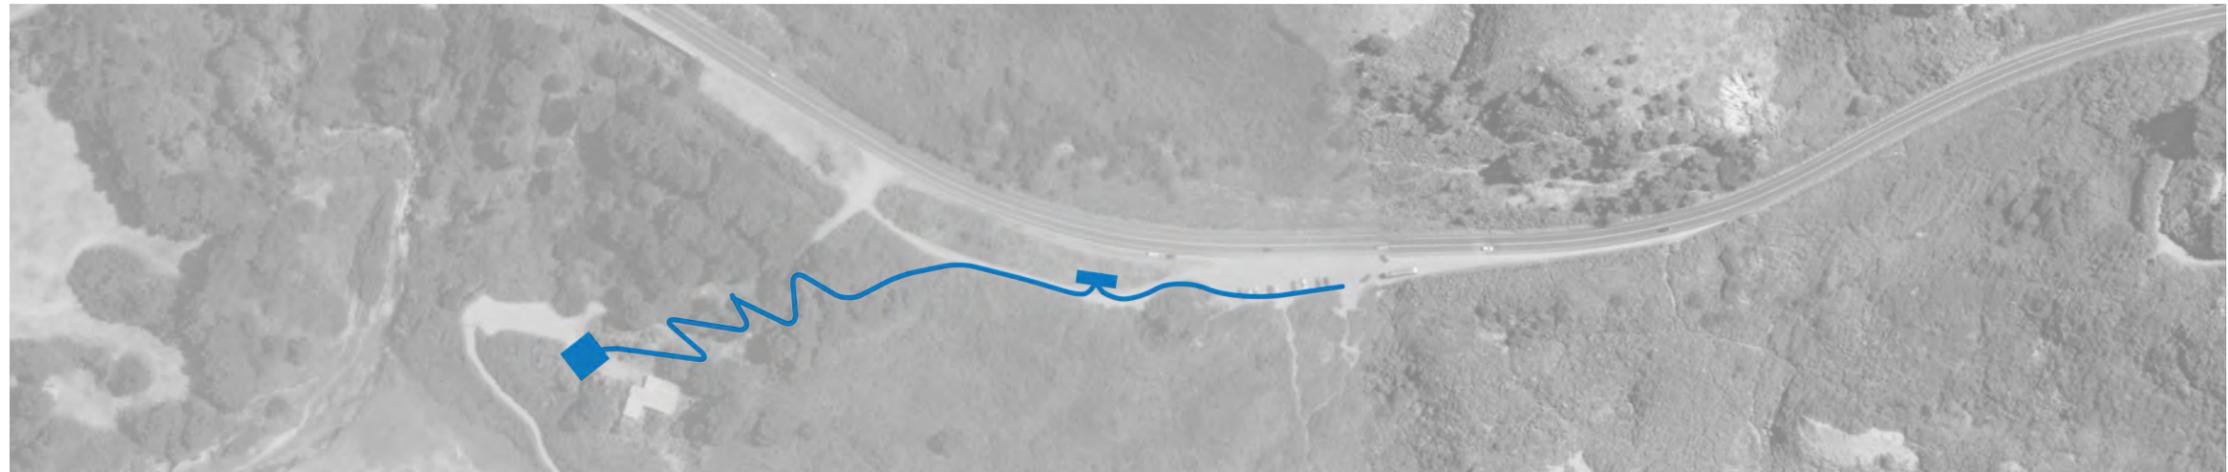
Alternative 2:

- ADA-Accessible Overlooks and Promenade
- ADA Path to Mid-Bluff

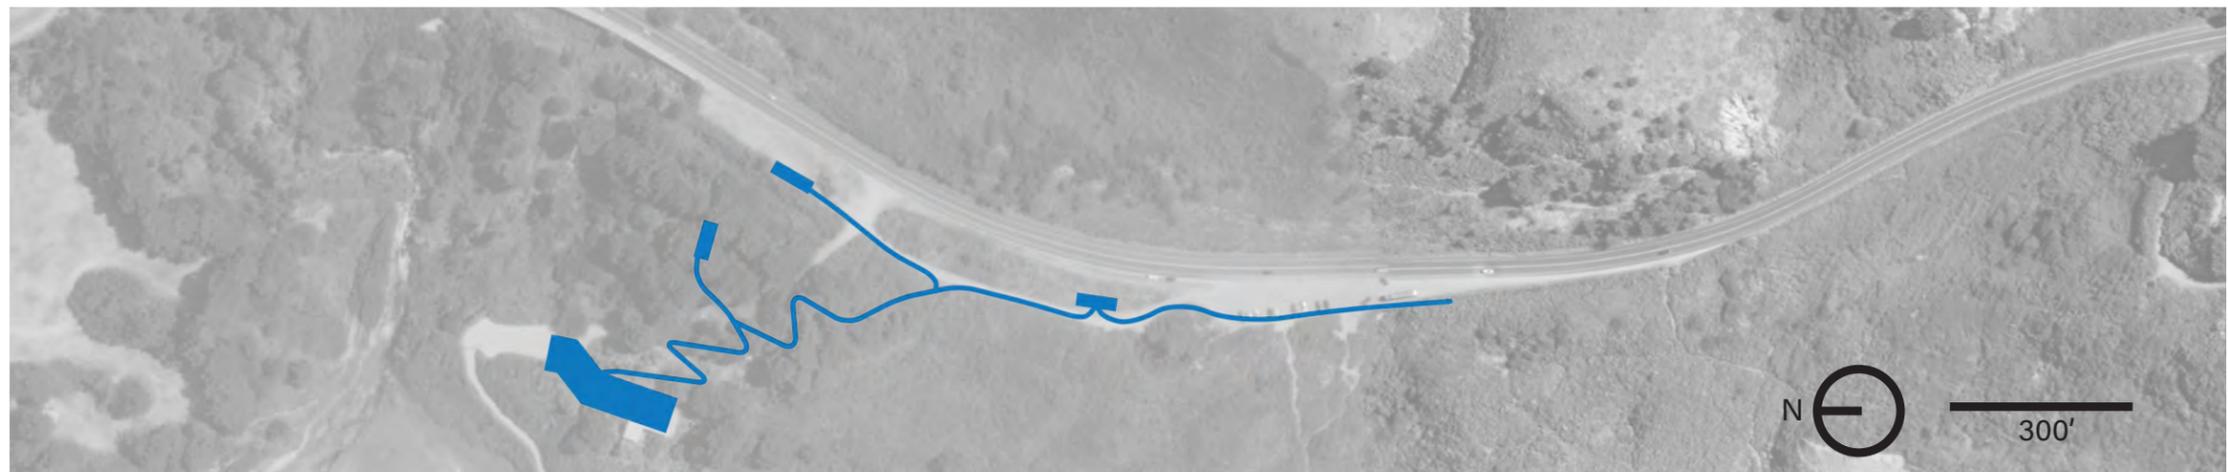
Alternative 3:

- ADA-Accessible Overlooks and Promenade
- ADA Path to Mid-Bluff
- ADA-Accessible Mid-Bluff Experience
- ADA Path to Visitor Center

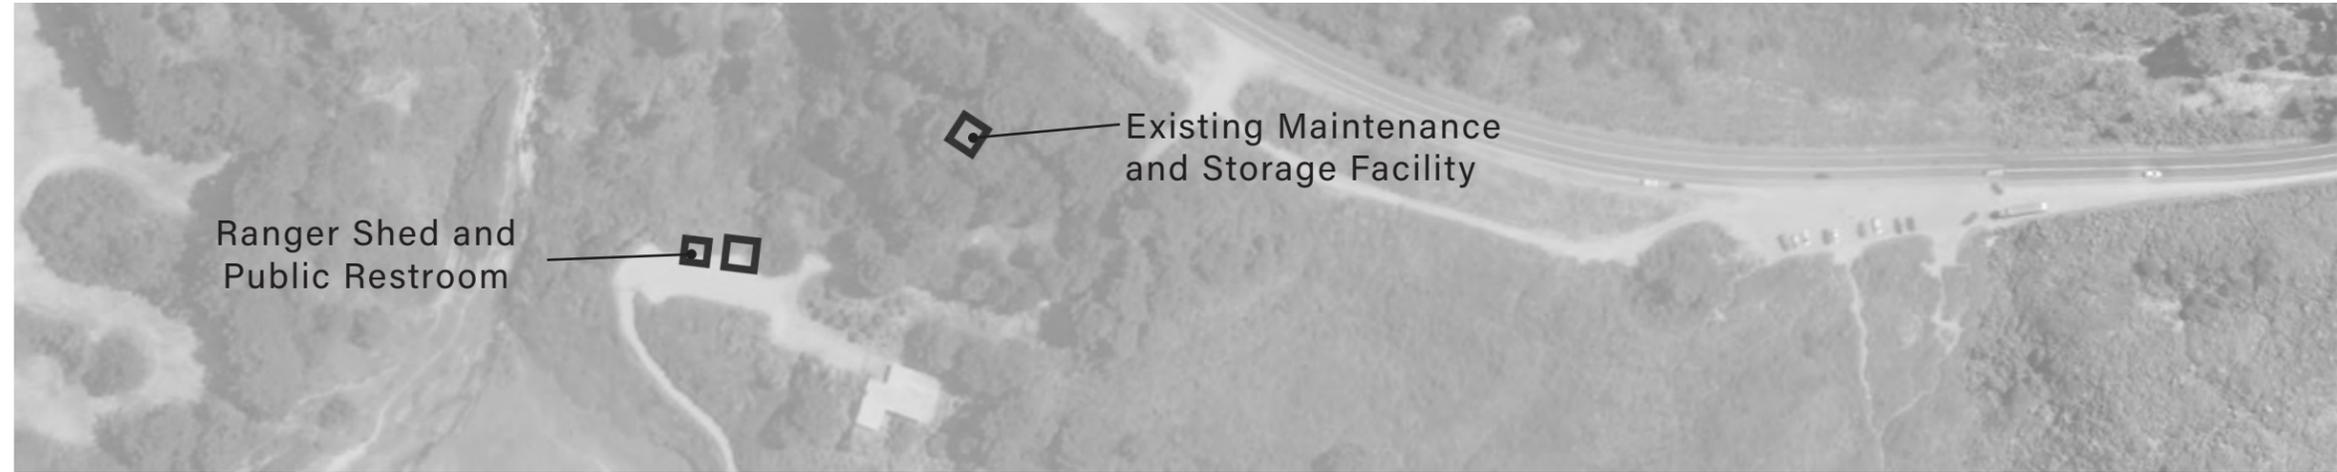
Alternative 1:

- Ranger Shed: 100-150 sqft
- Public Restroom: 400-500 sqft
- Existing Maintenance/Storage: 1,000 sqft

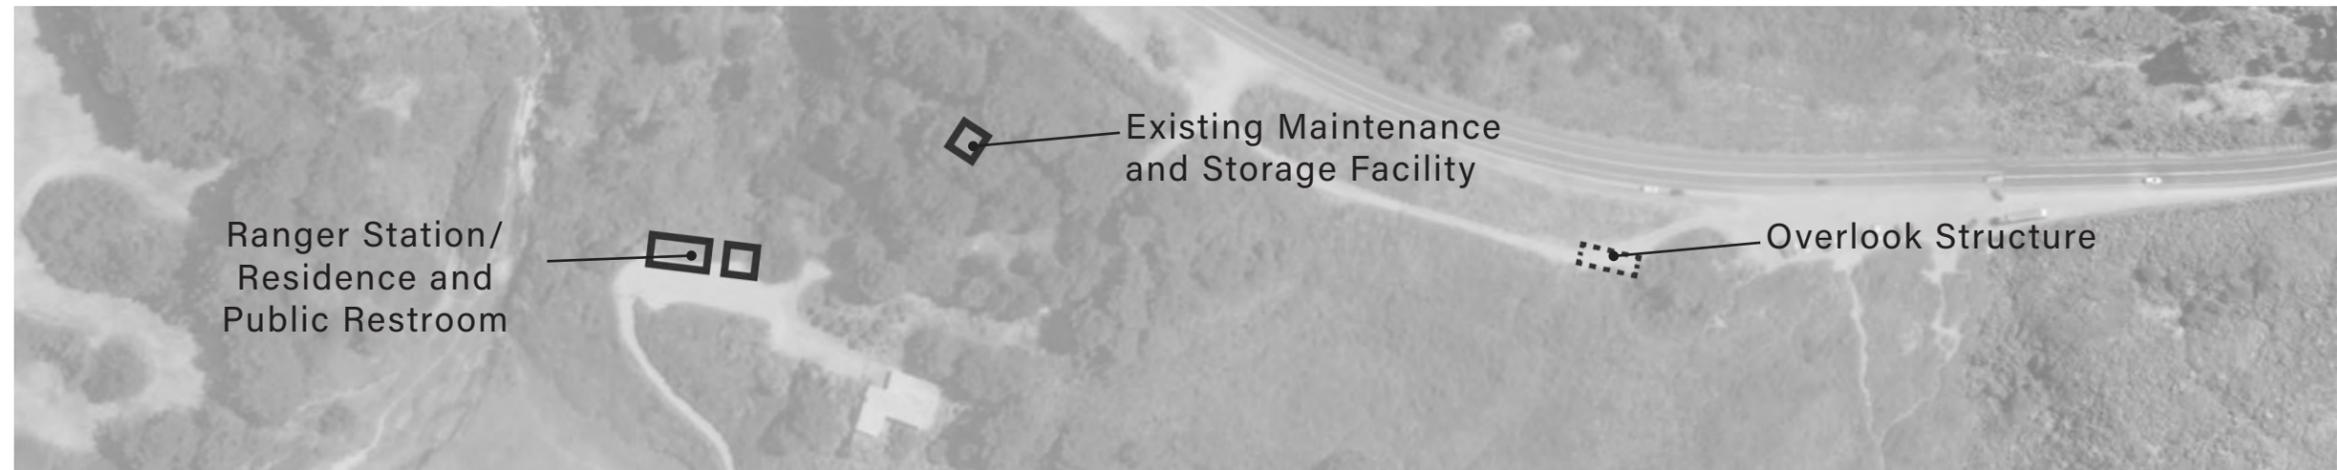
Alternative 2:

- Ranger Station and Residence: 1,000-1,500 sqft
- Public Restroom: 400-500 sqft
- Existing Maintenance/Storage: 1,000 sqft

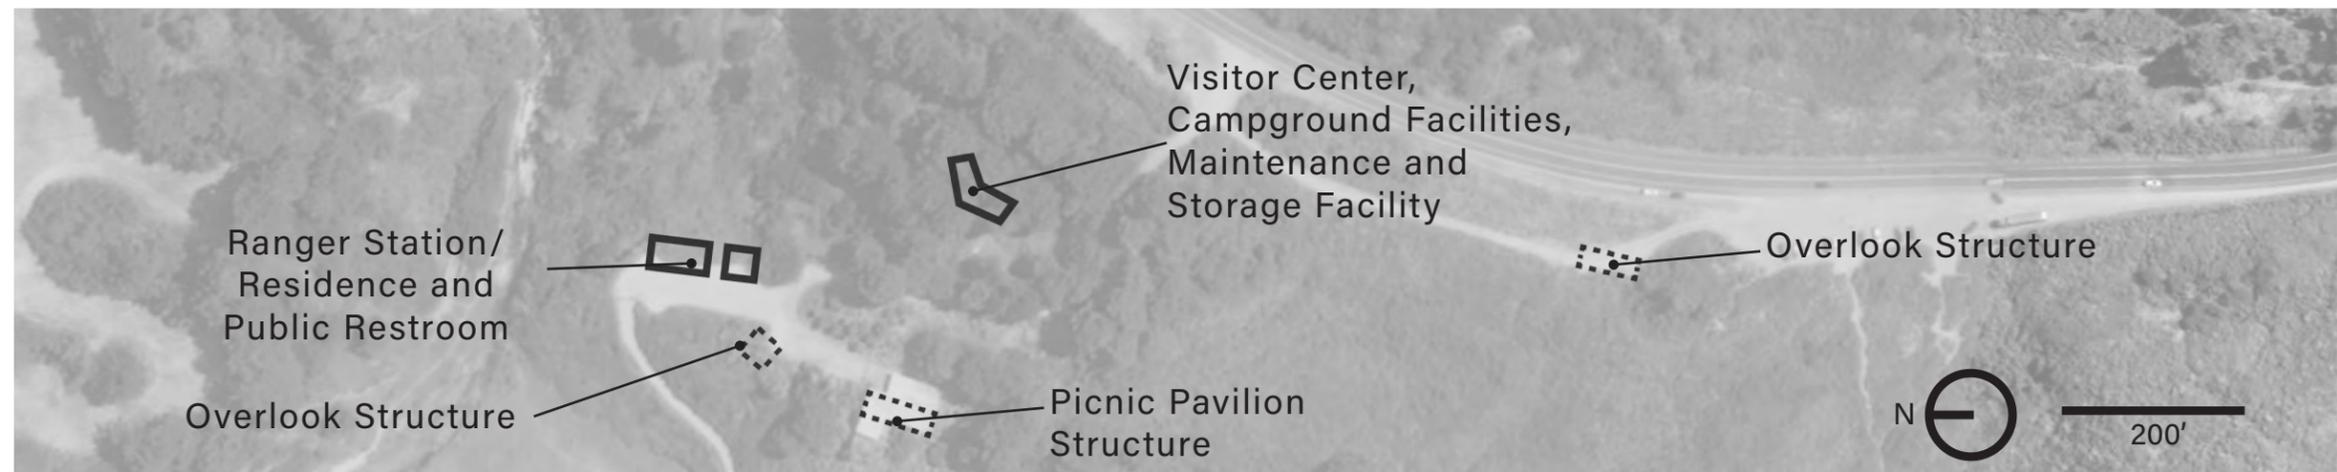
Alternative 3:

- Ranger Station and Residence: 1,000-1,500 sqft
- Public Restroom: 400-500 sqft
- Upgraded Maintenance/Storage: 2,000 sqft
- Visitor Center: 1,200-3,000 sqft
- Campground Facilities: 1,000 sqft

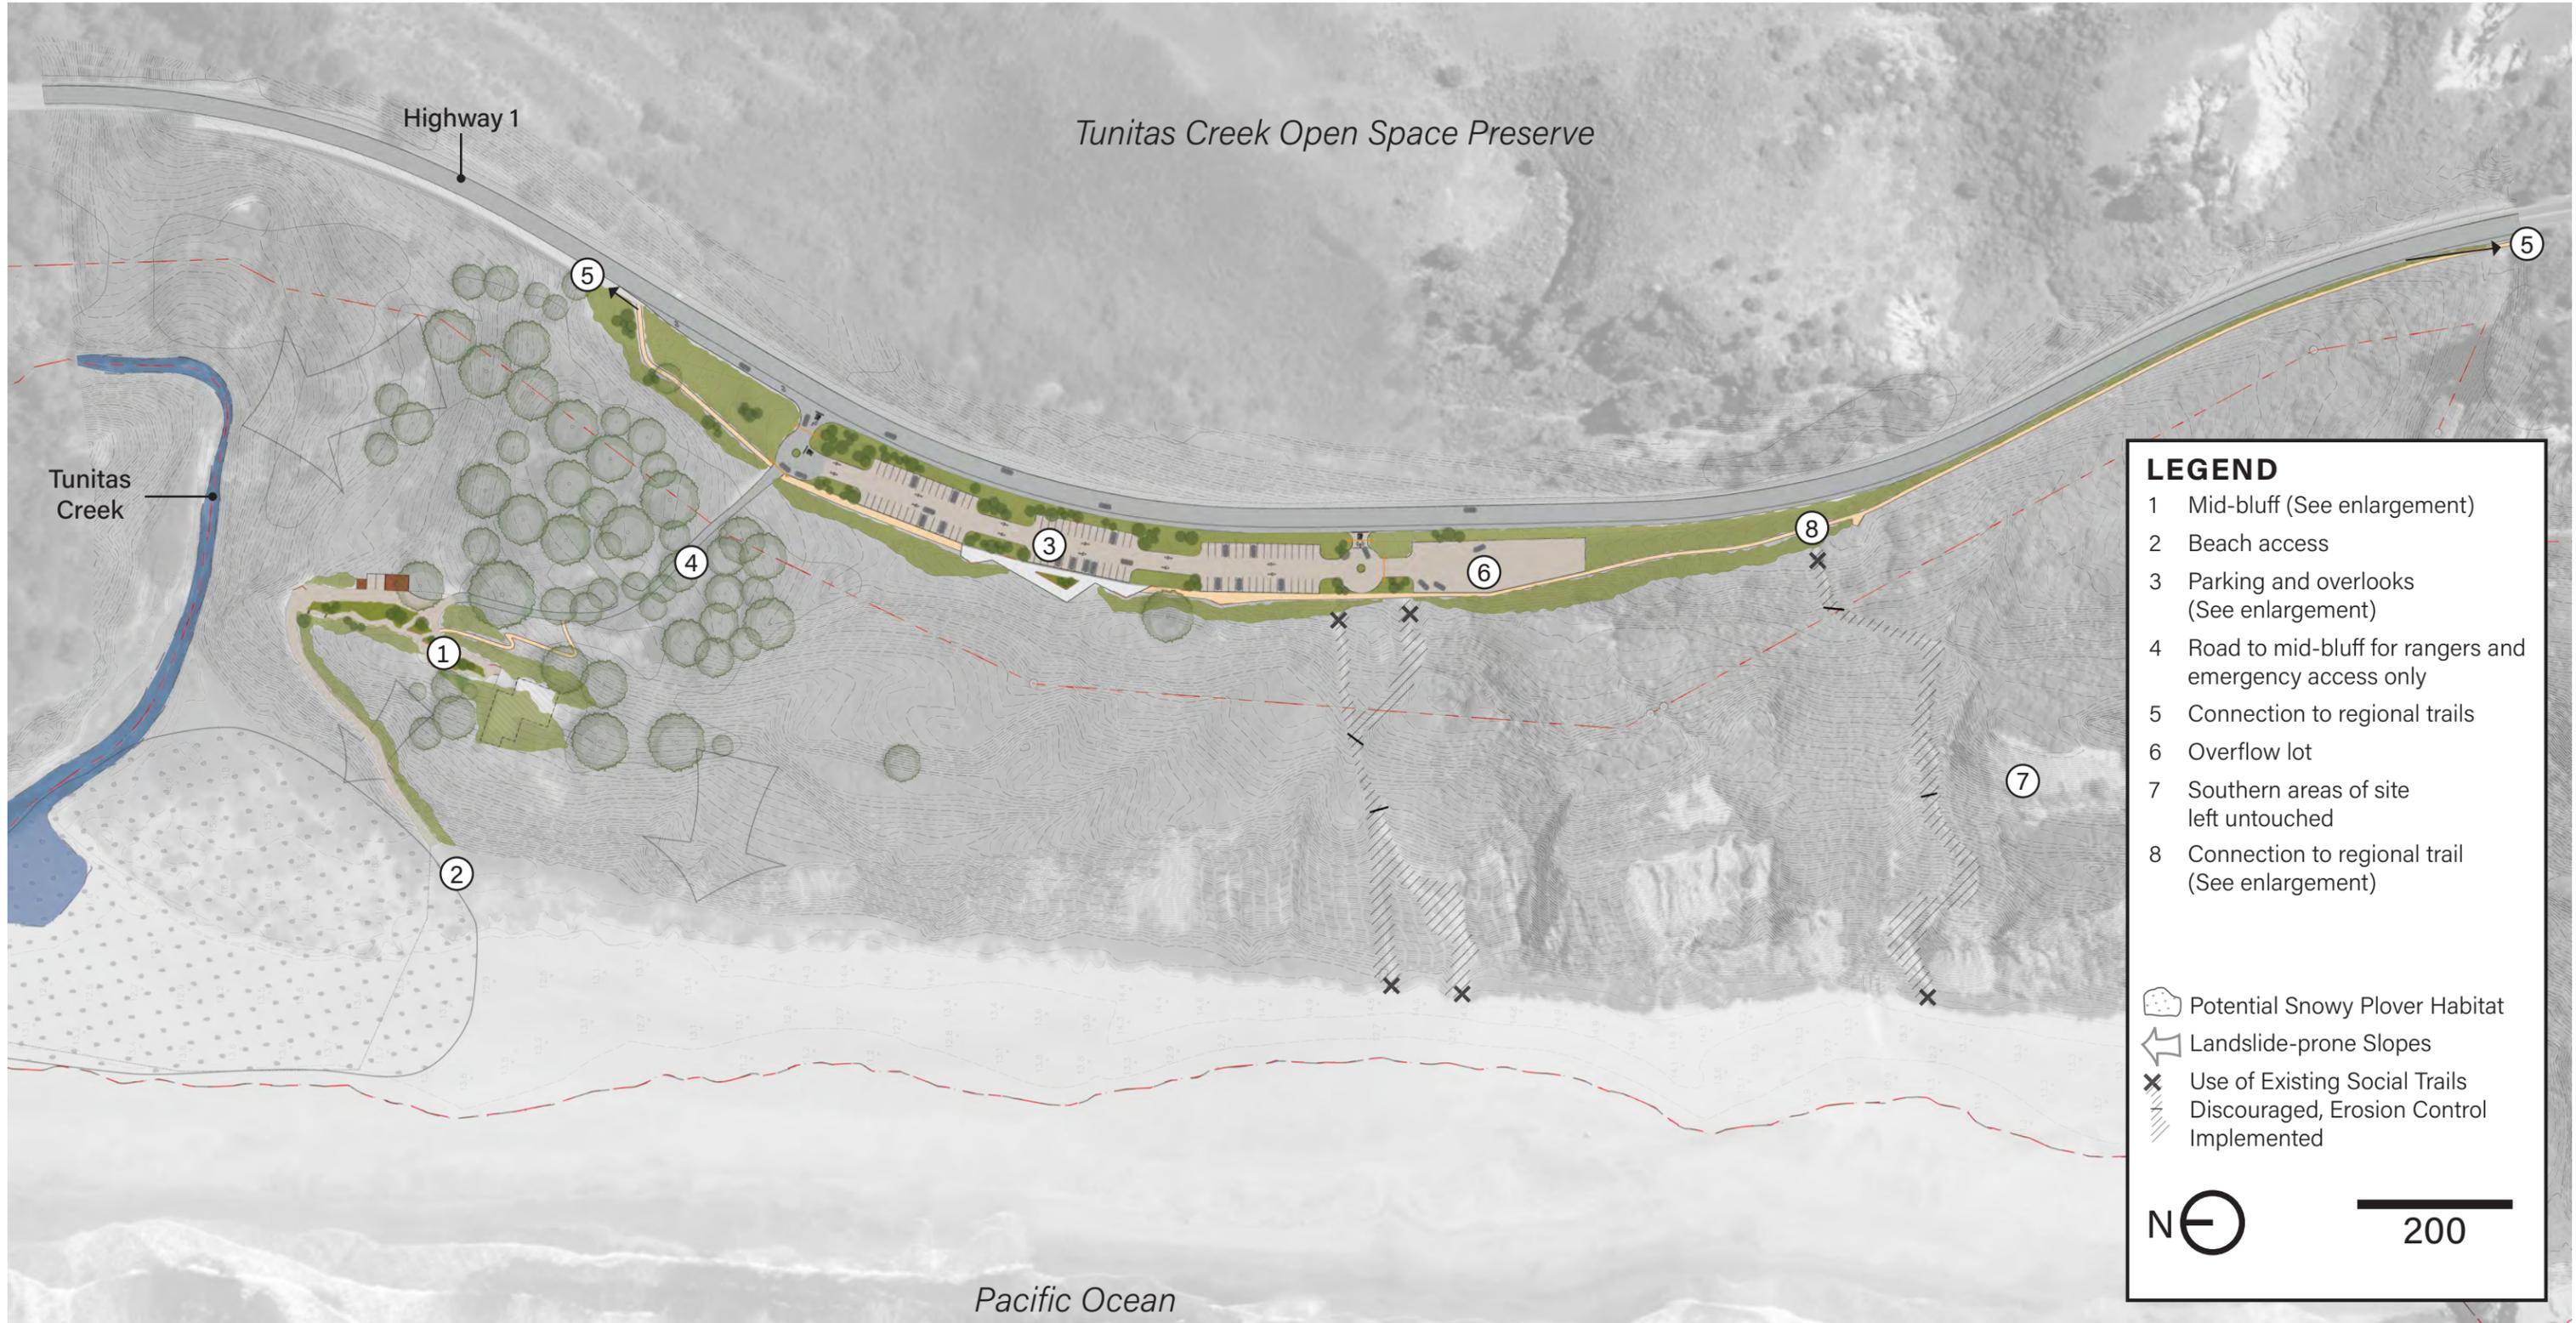
ALTERNATIVE 1: FULL SITE

- 1 Mid-bluff (See enlargement)
- 2 Beach access
- 3 Parking and overlooks (See enlargement)
- 4 Road to mid-bluff for rangers and emergency access only
- 5 Connection to regional trails
- 6 Overflow lot
- 7 Southern areas of site left untouched
- 8 Connection to regional trail (See enlargement)

Potential Snowy Plover Habitat
 Landslide-prone Slopes
 Use of Existing Social Trails Discouraged, Erosion Control Implemented

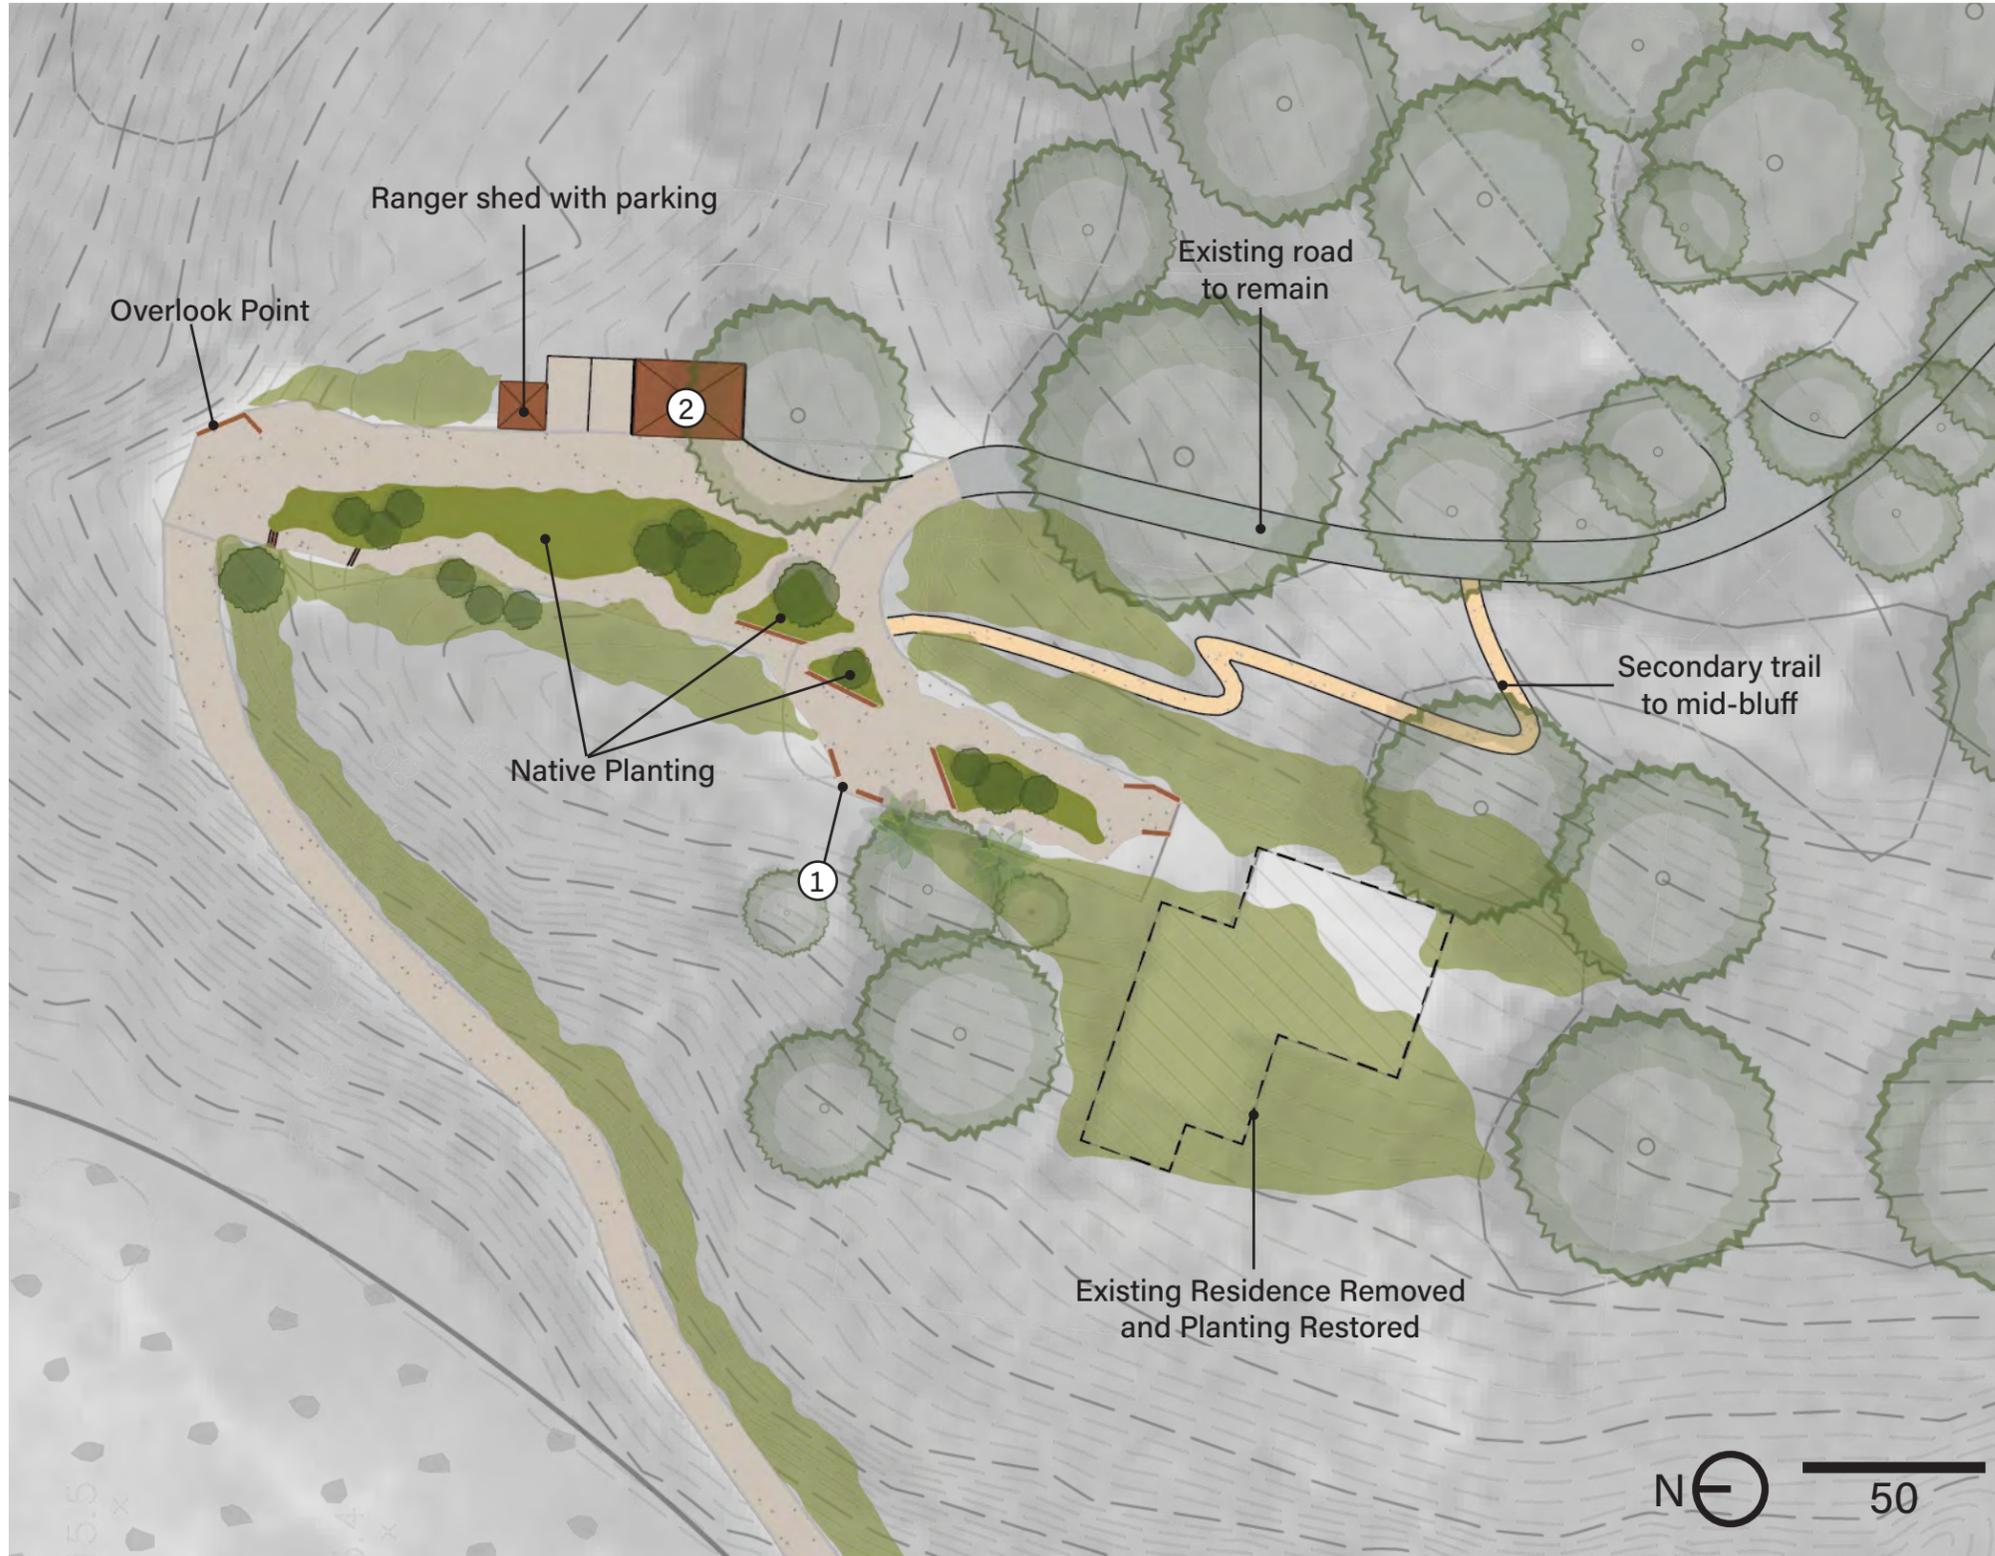
ALTERNATIVE 1: MID-BLUFF

① Overlook

② Restroom Facility

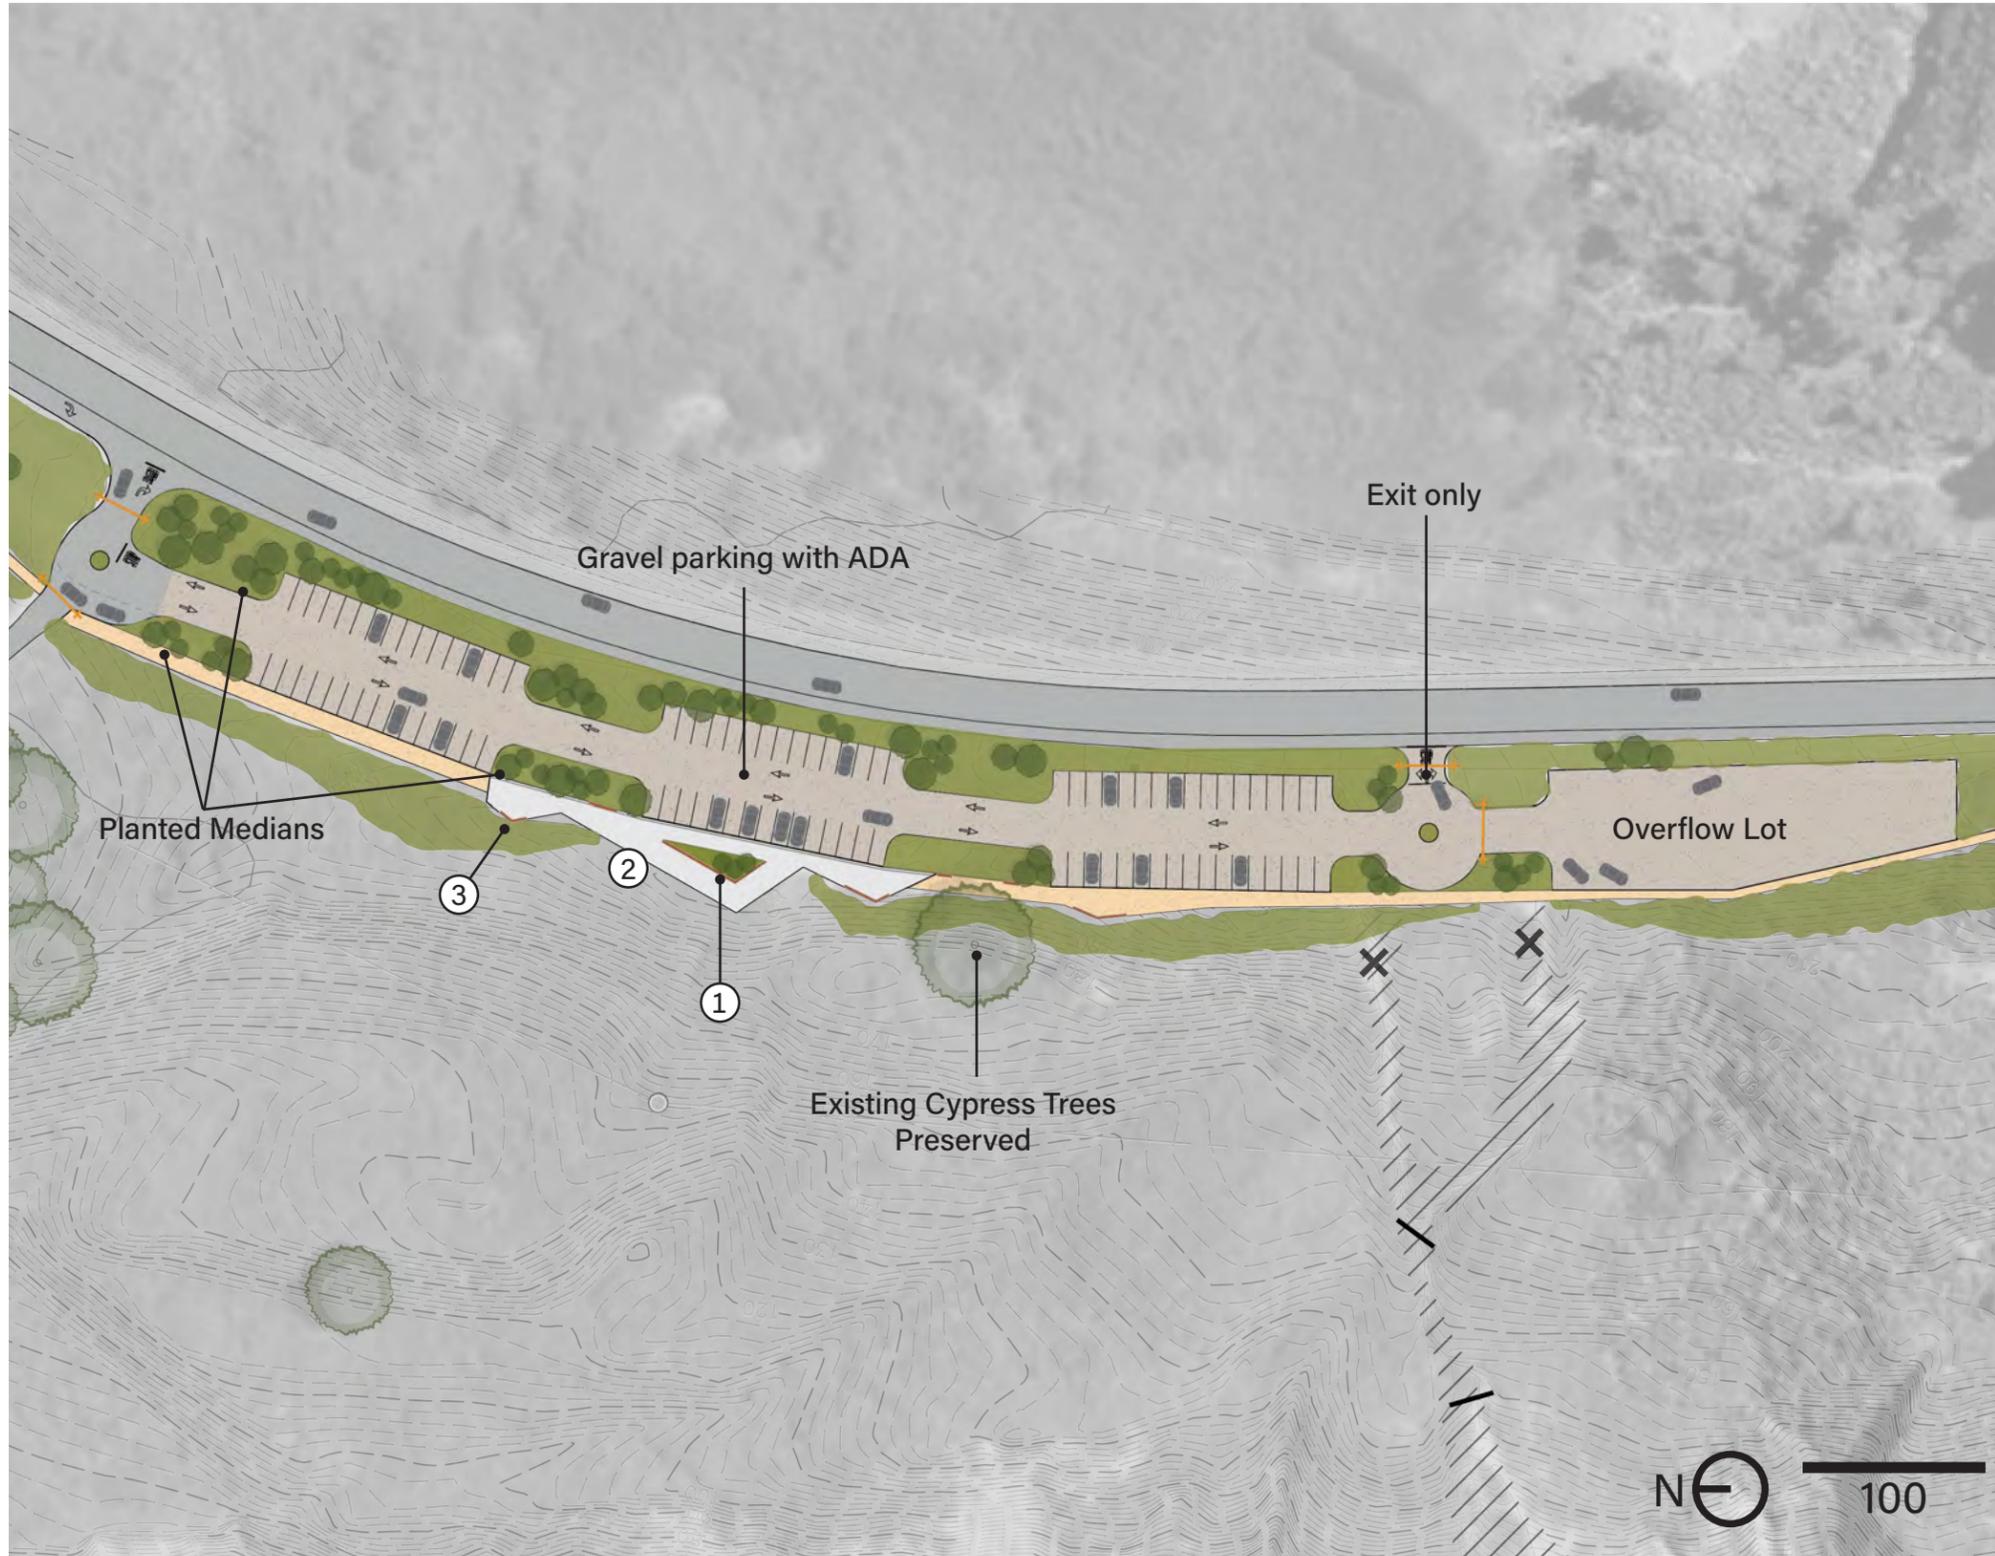
ALTERNATIVE 1: PARKING AND OVERLOOK

① Seat Wall

② Overlook Edge

③ Bench as Retaining Structure, Donor Recognition
