TUNITAS CREEK BEACH IMPROVEMENT PROJECT

DESIGN ALTERNATIVES

July 2020

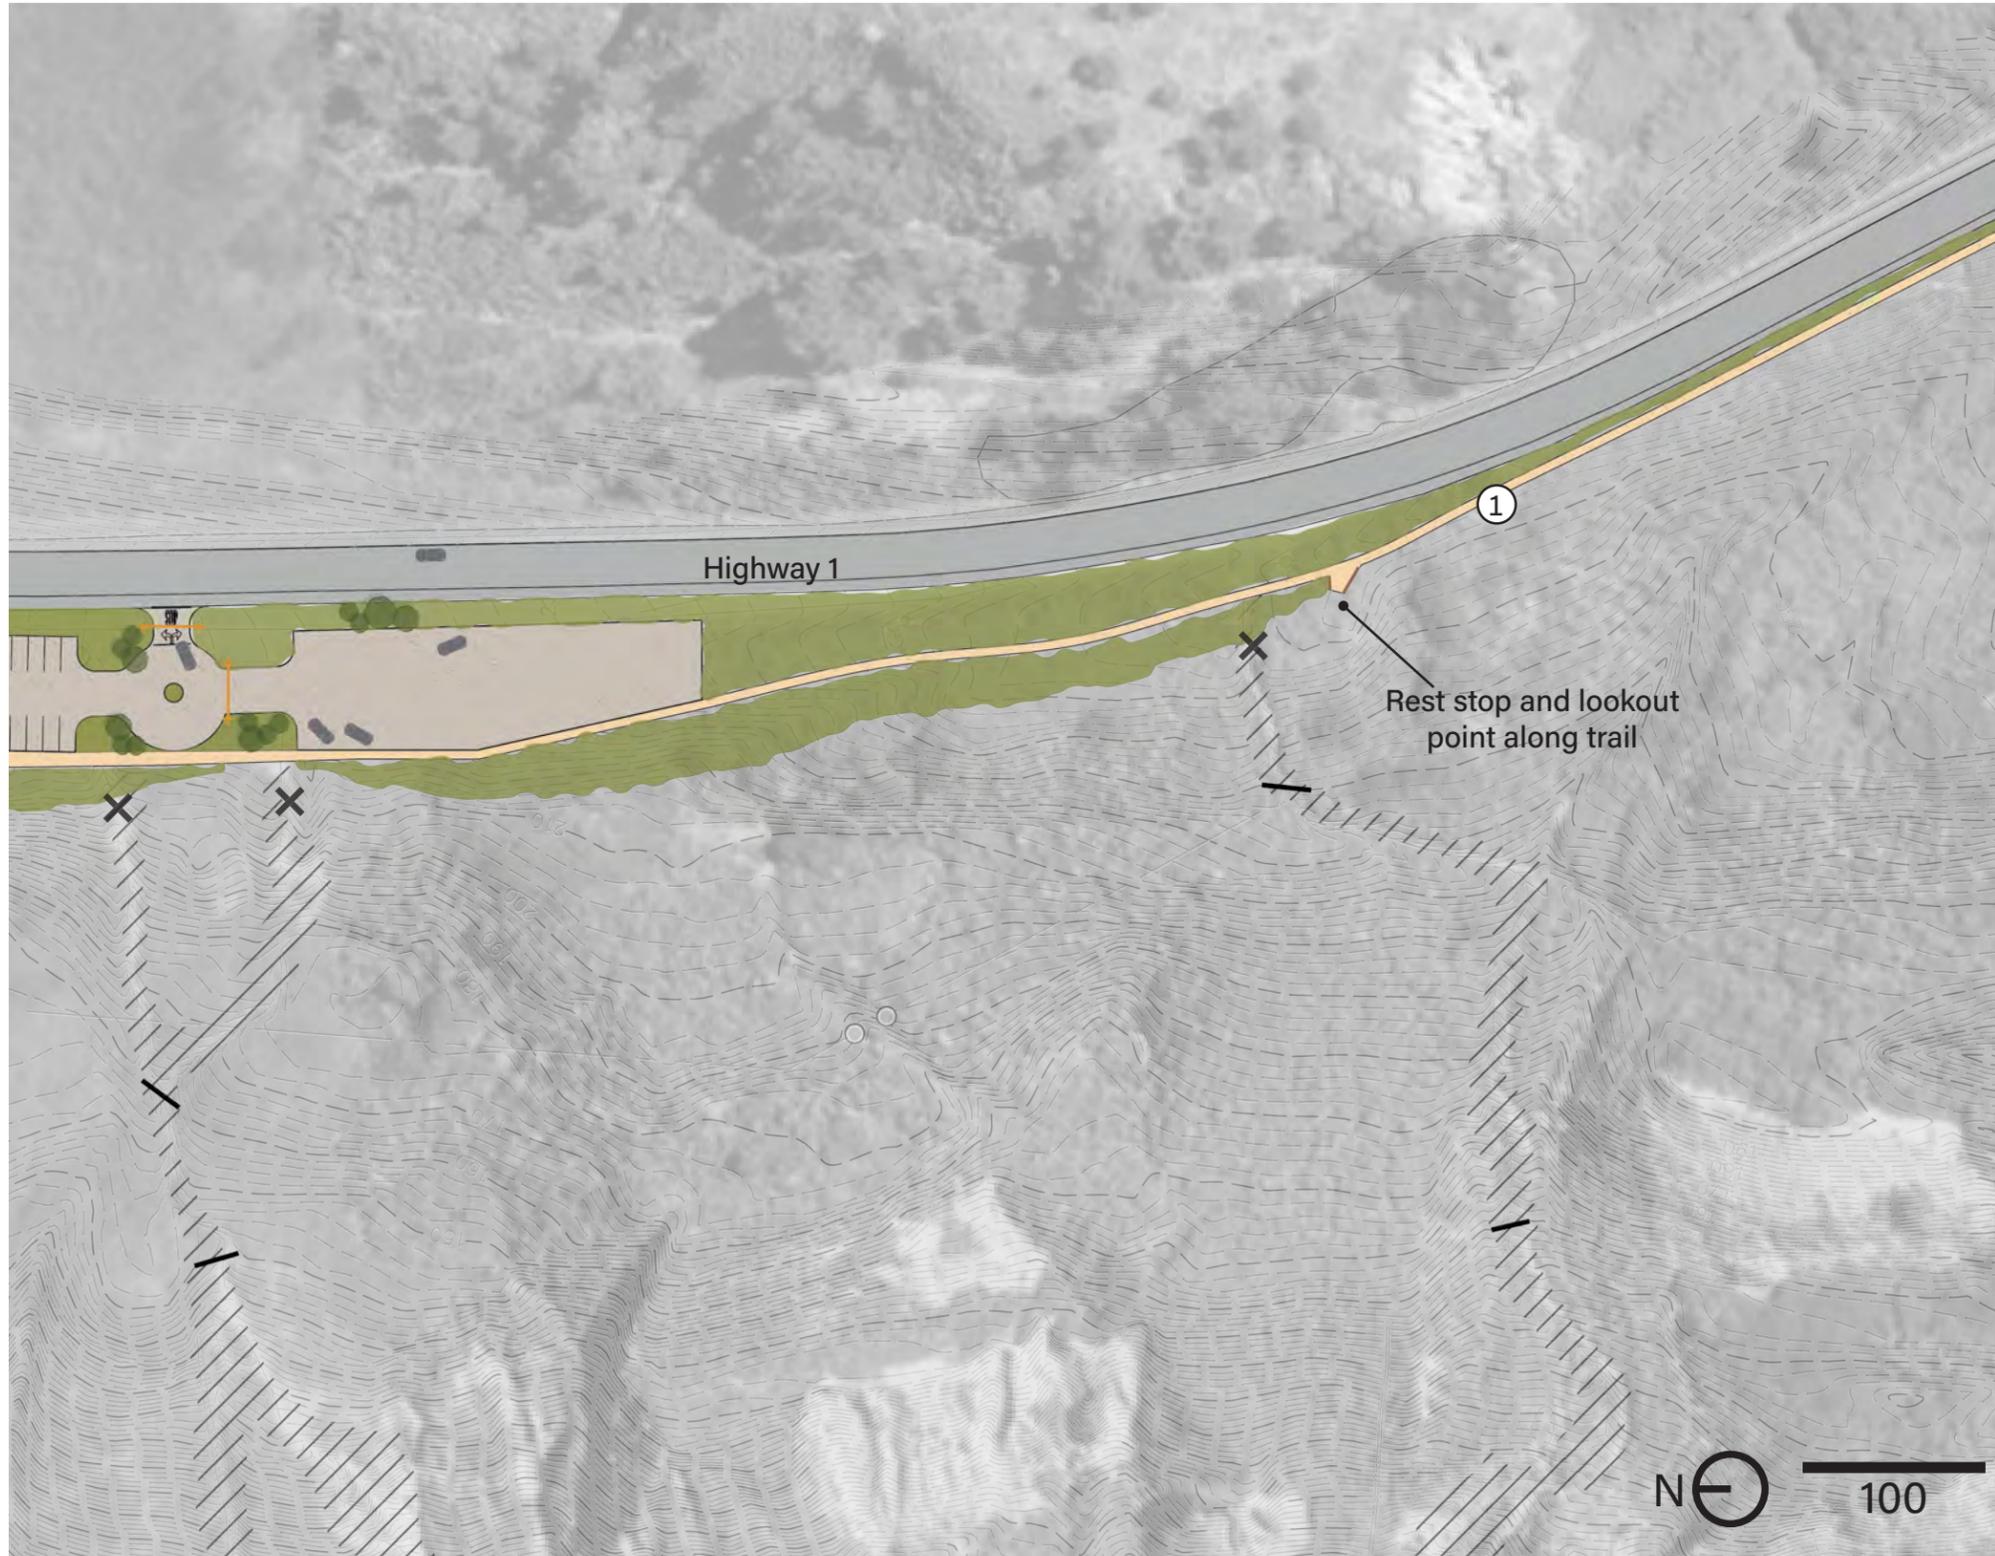
ALTERNATIVE 1: REGIONAL TRAIL CONNECTION

① Trail to connect to future regional trail

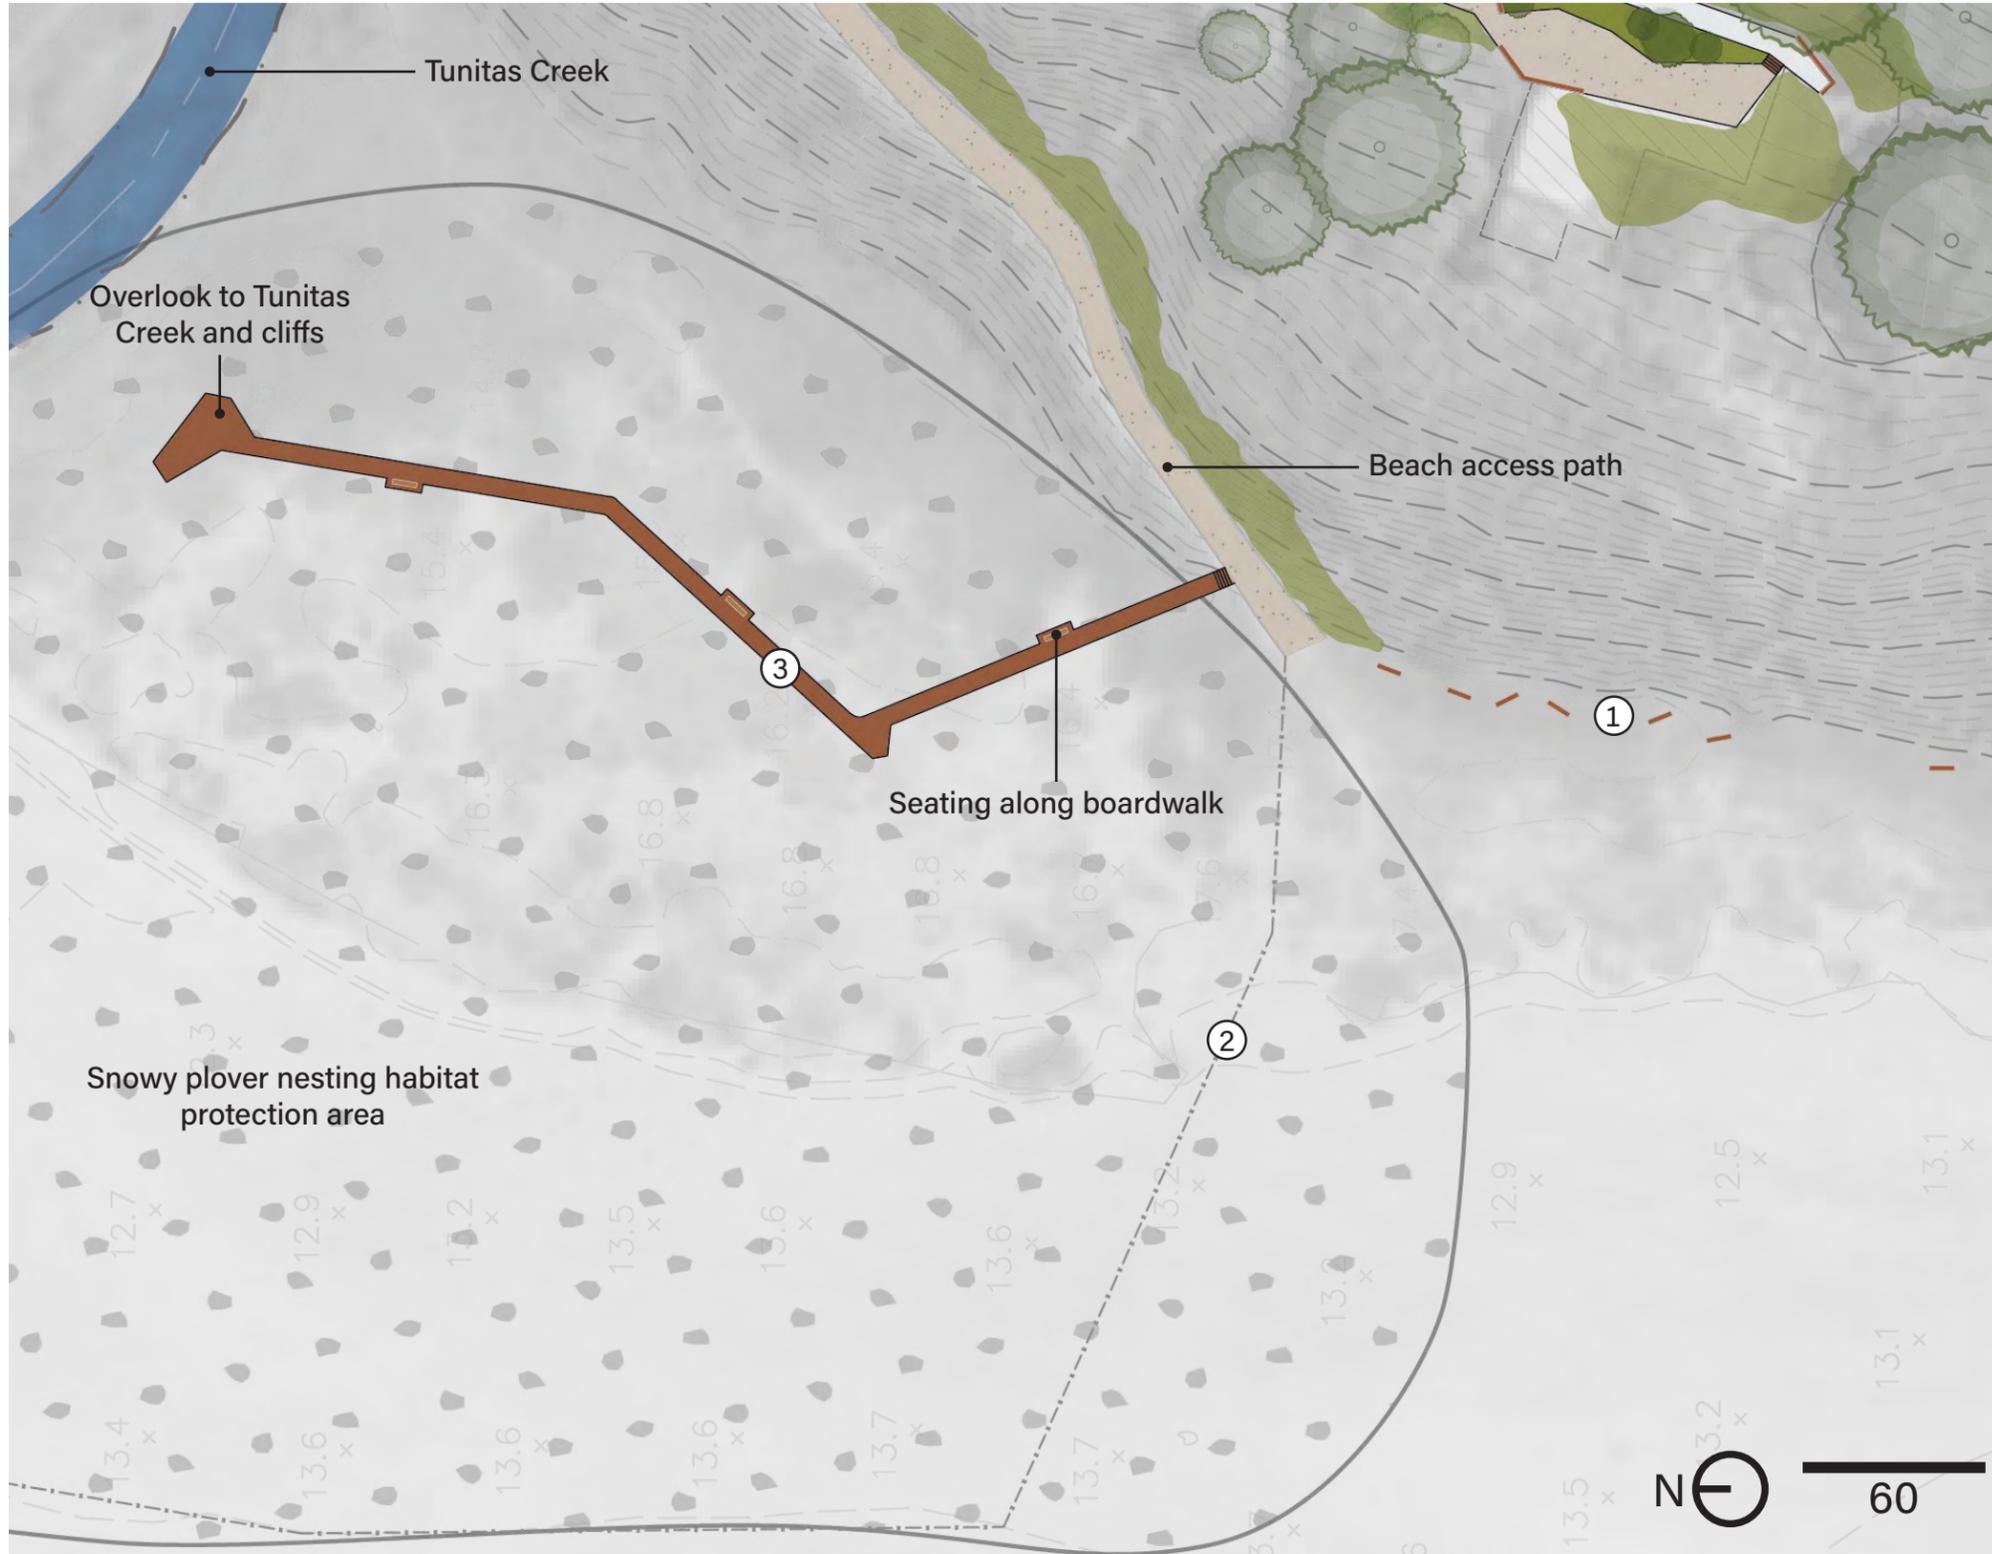
ALTERNATIVE 2: BEACH

① Log Seating on Beach

② Habitat Protection Fencing

③ Boardwalk Through Habitat Protection Area

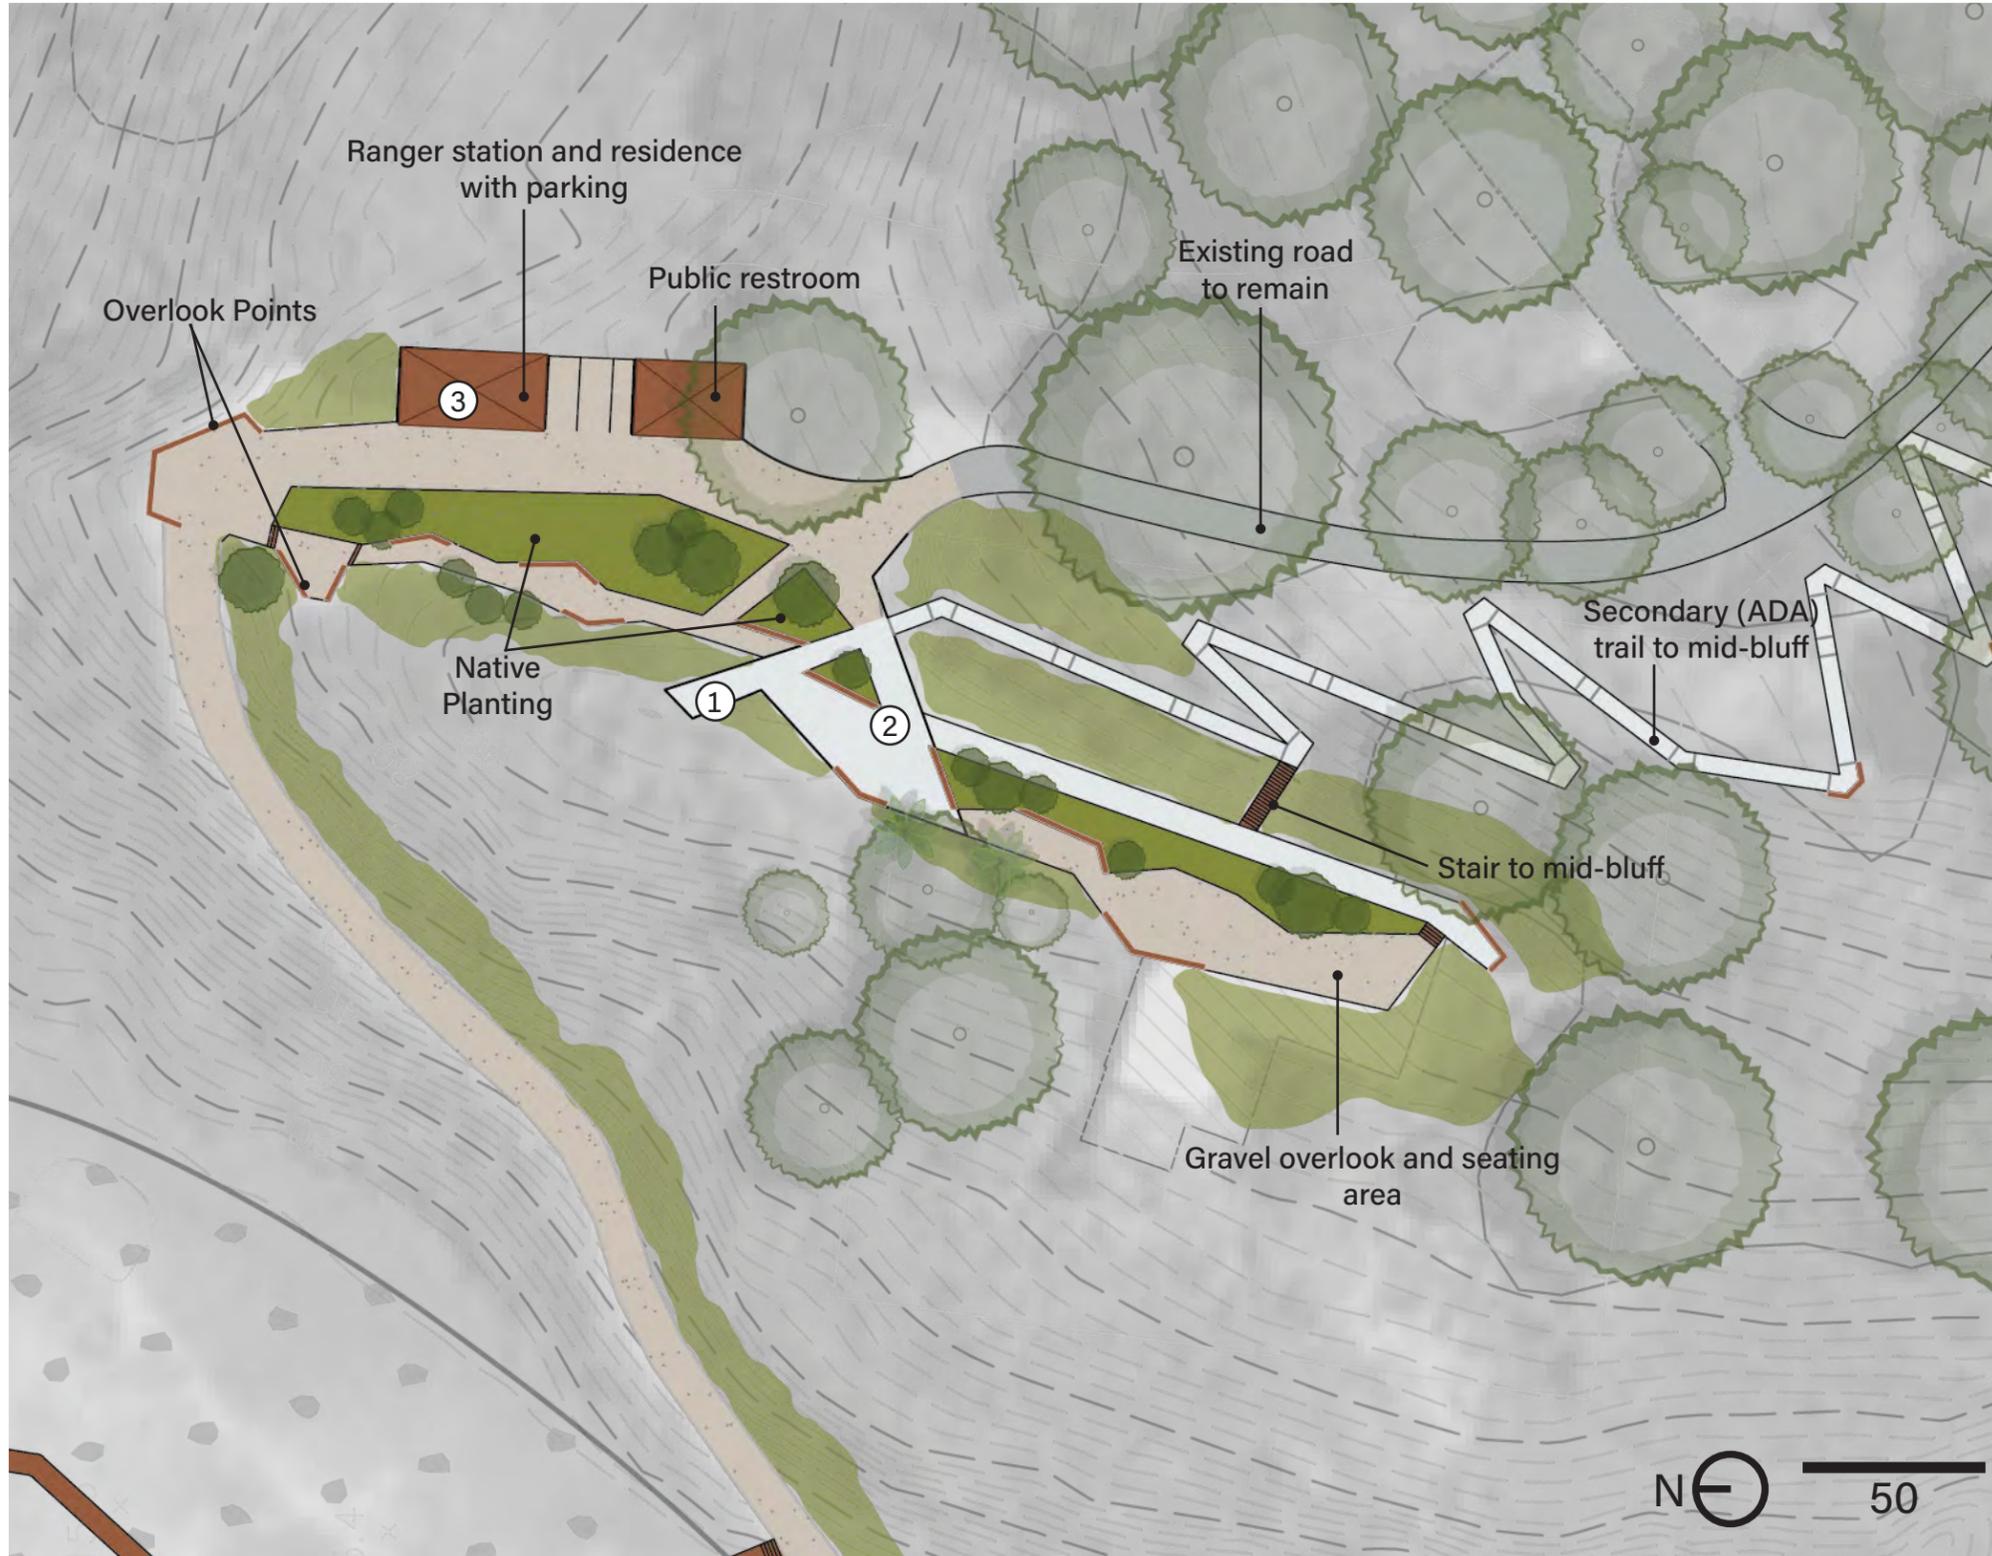
ALTERNATIVE 2: MID-BLUFF

① Overlook Sliced Through Berm

② Seating

③ Ranger Station

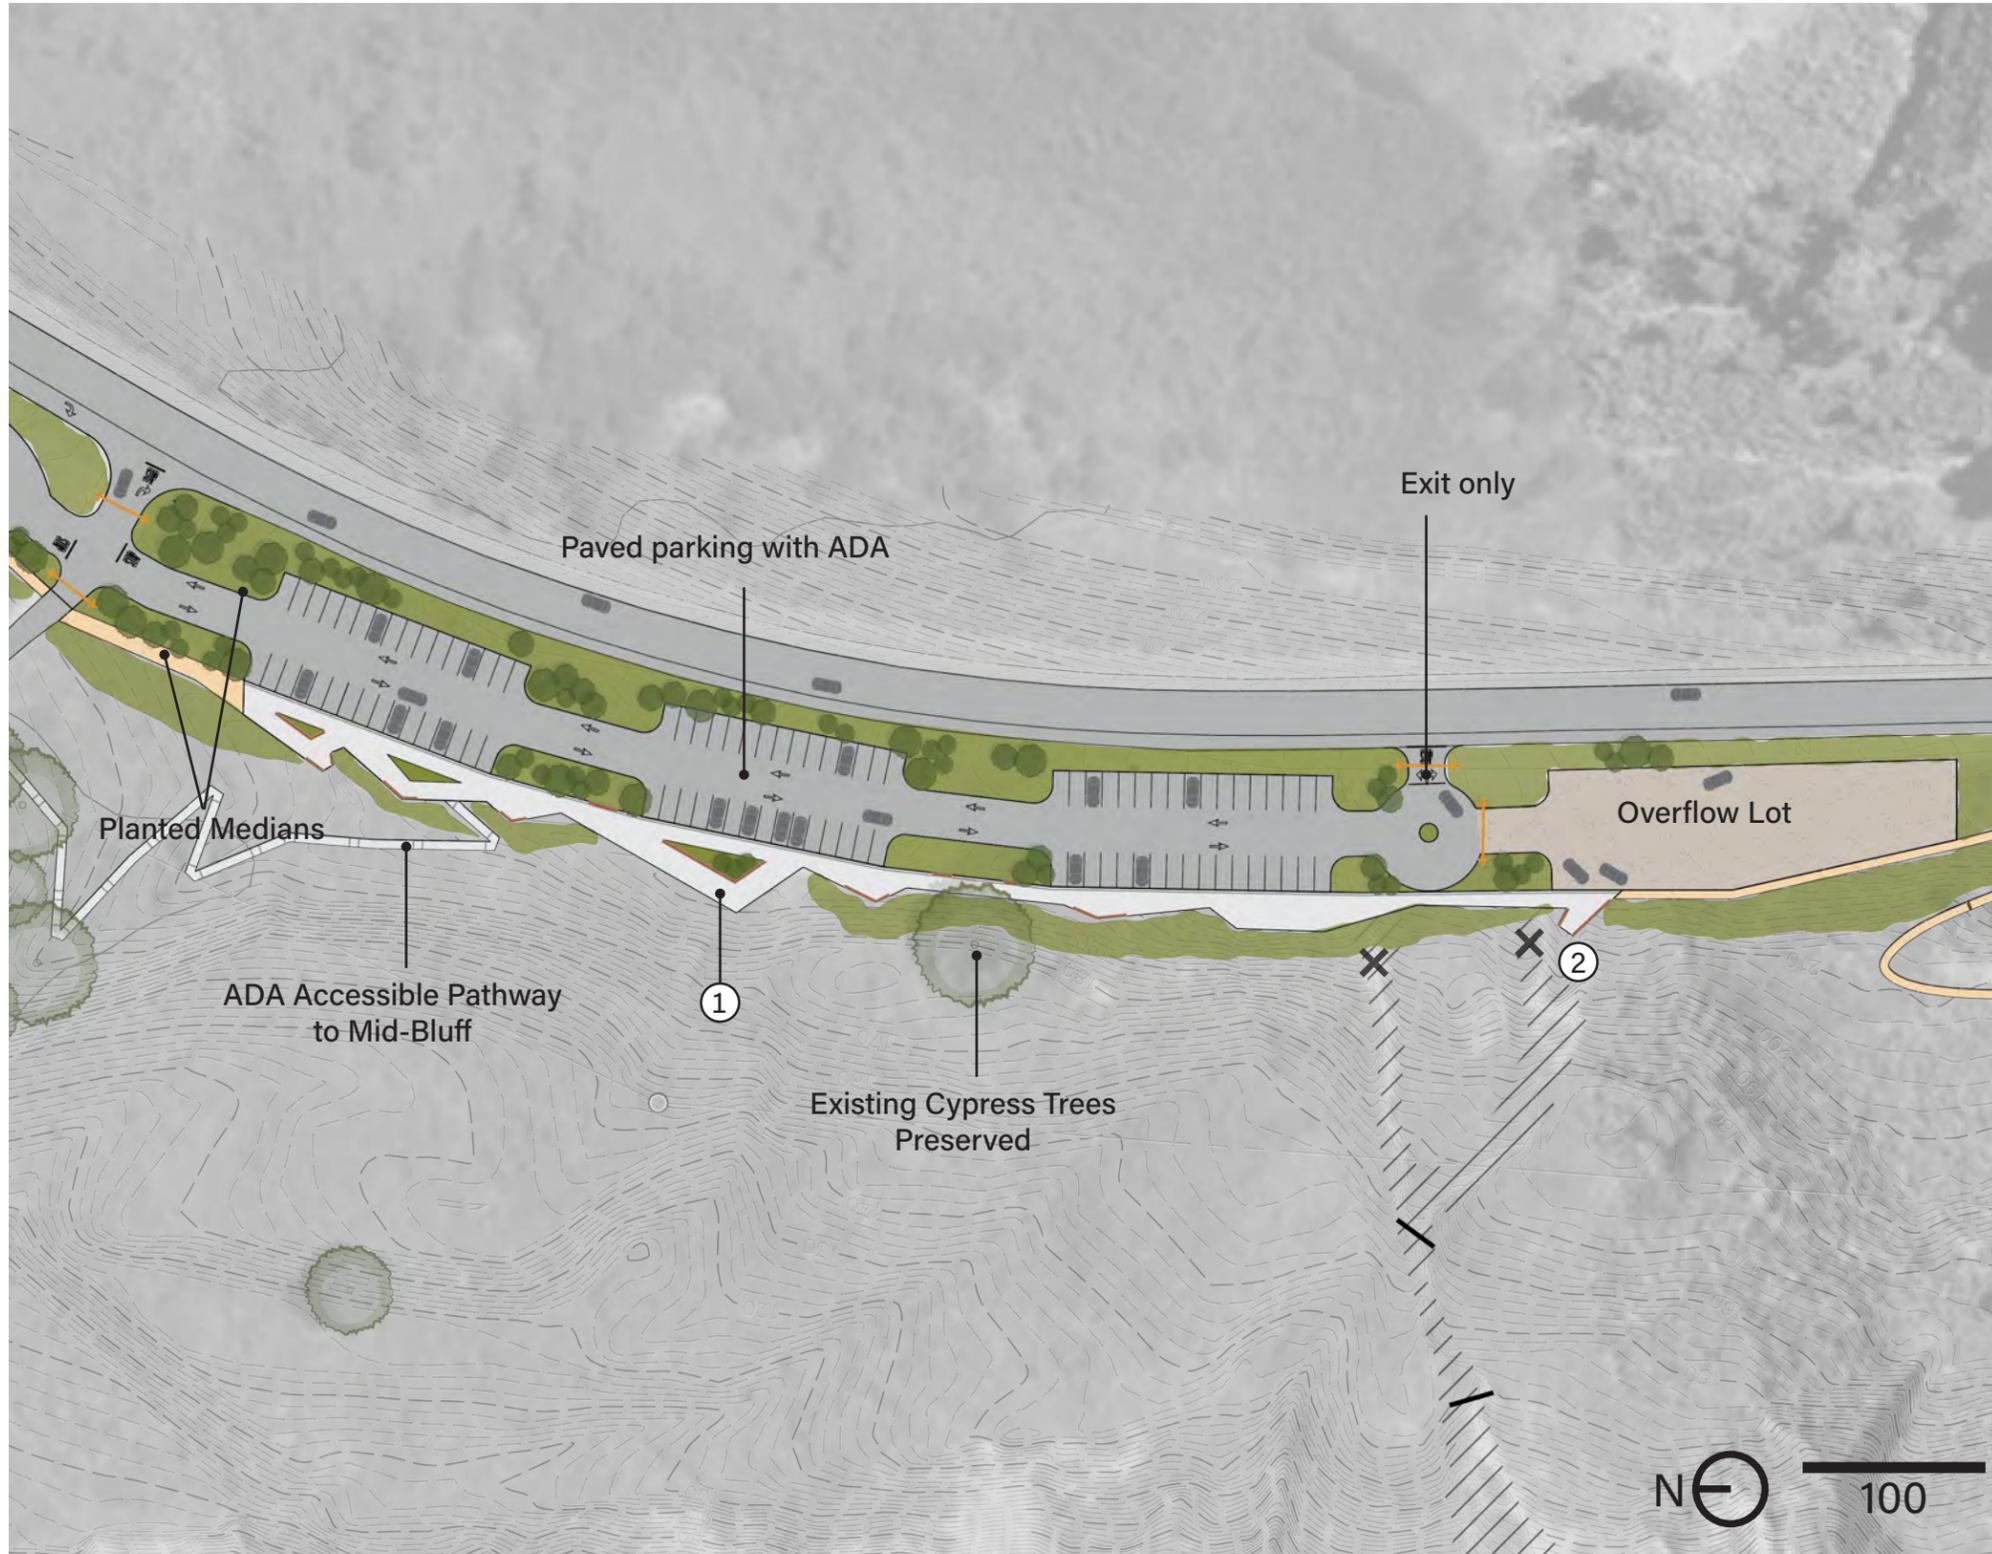
ALTERNATIVE 2: PARKING AND OVERLOOK

① Primary Overlook

② Secondary Overlook Nook at Top of Bluff

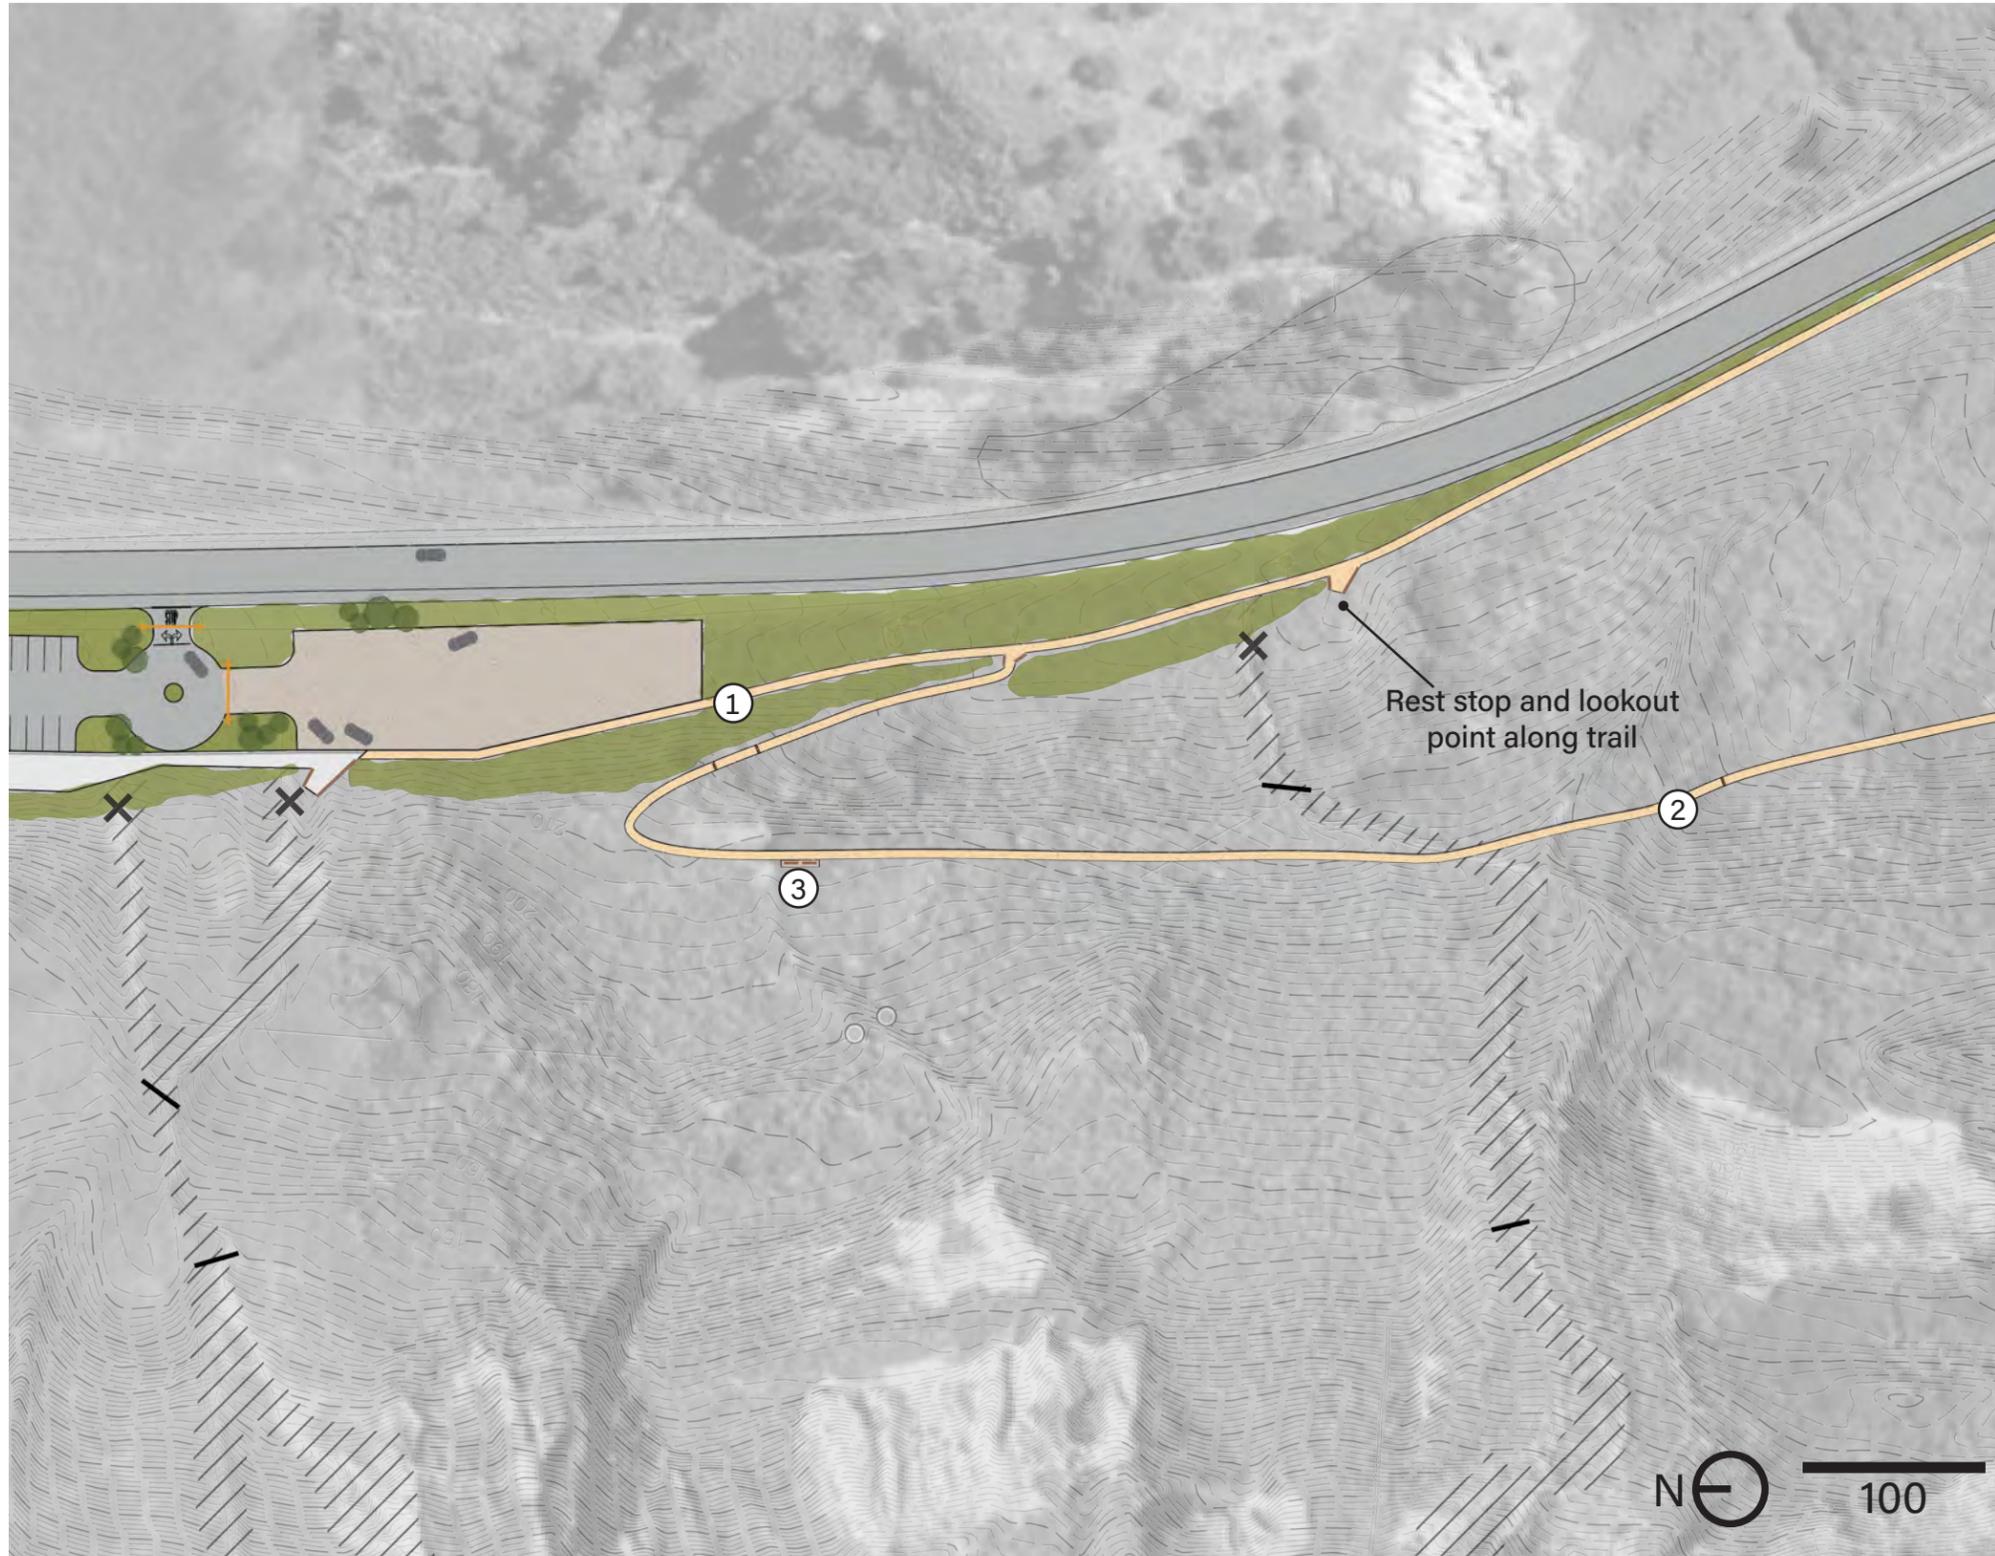
ALTERNATIVE 2: LOOP TRAIL

① Loop and Regional Trail-Head

② Loop Trail

③ Overlook Nook along Loop Trail

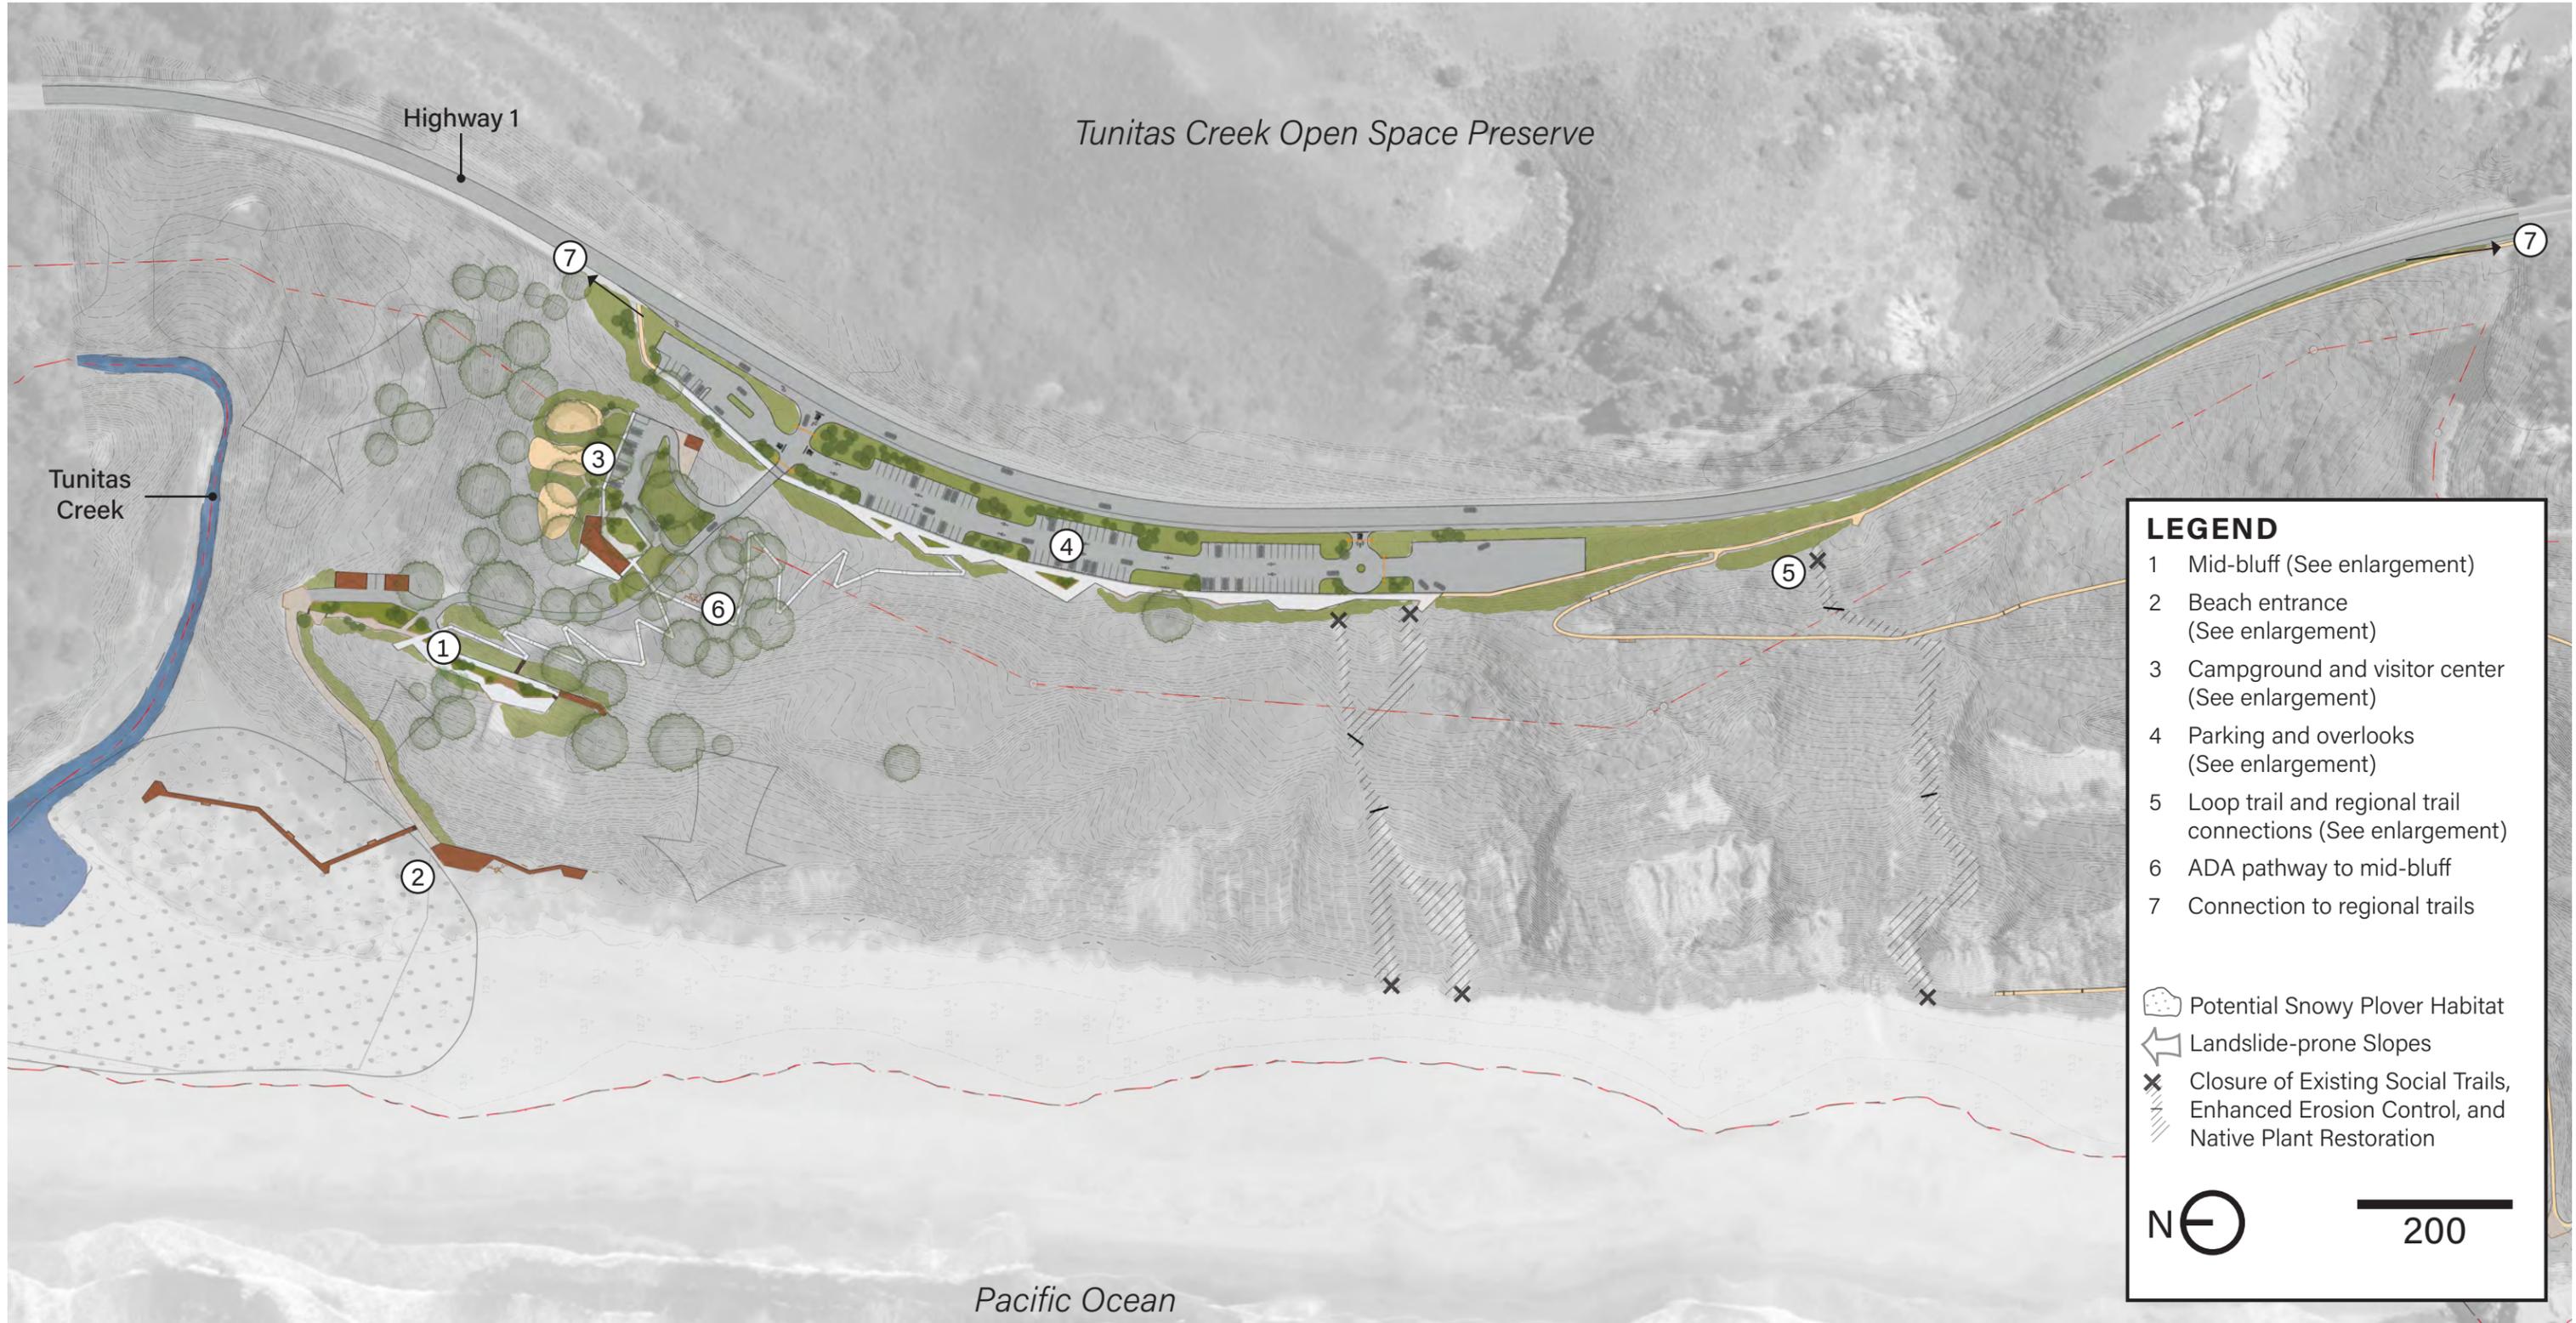
ALTERNATIVE 3: FULL SITE

- 1 Mid-bluff (See enlargement)
- 2 Beach entrance (See enlargement)
- 3 Campground and visitor center (See enlargement)
- 4 Parking and overlooks (See enlargement)
- 5 Loop trail and regional trail connections (See enlargement)
- 6 ADA pathway to mid-bluff
- 7 Connection to regional trails

- Potential Snowy Plover Habitat
- Landslide-prone Slopes
- Closure of Existing Social Trails, Enhanced Erosion Control, and Native Plant Restoration

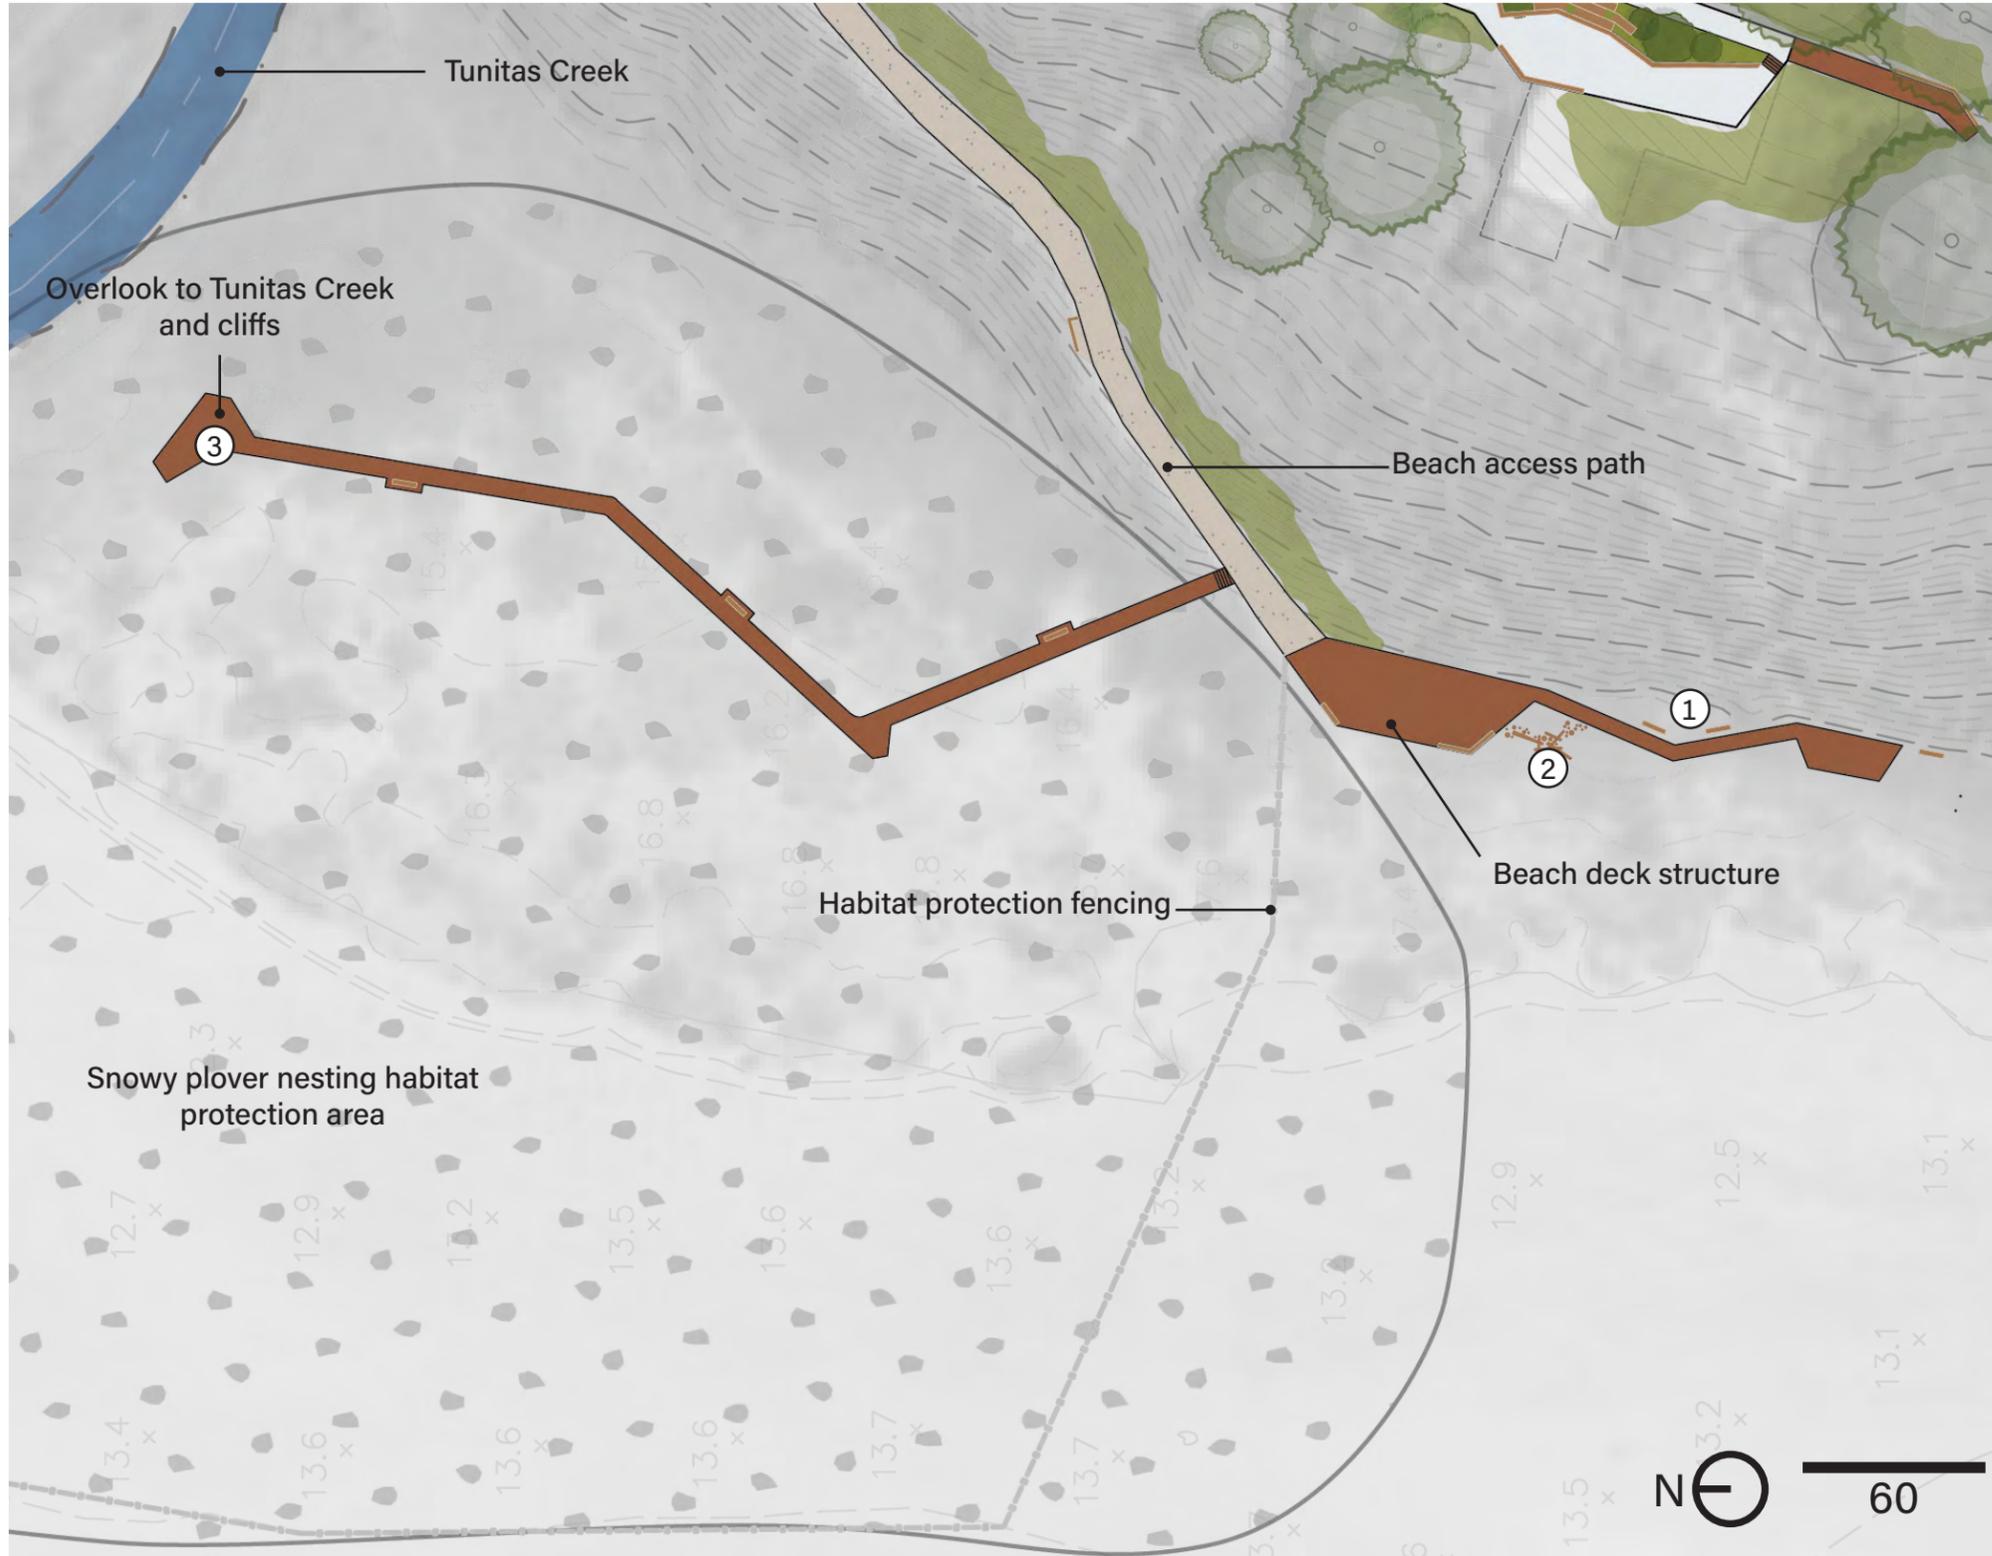
ALTERNATIVE 3: BEACH

① Log Seating on Beach

② Driftwood Play Feature

② Overlook on Boardwalk
