TUNITAS CREEK BEACH IMPROVEMENT PROJECT

DESIGN ALTERNATIVES

July 2020

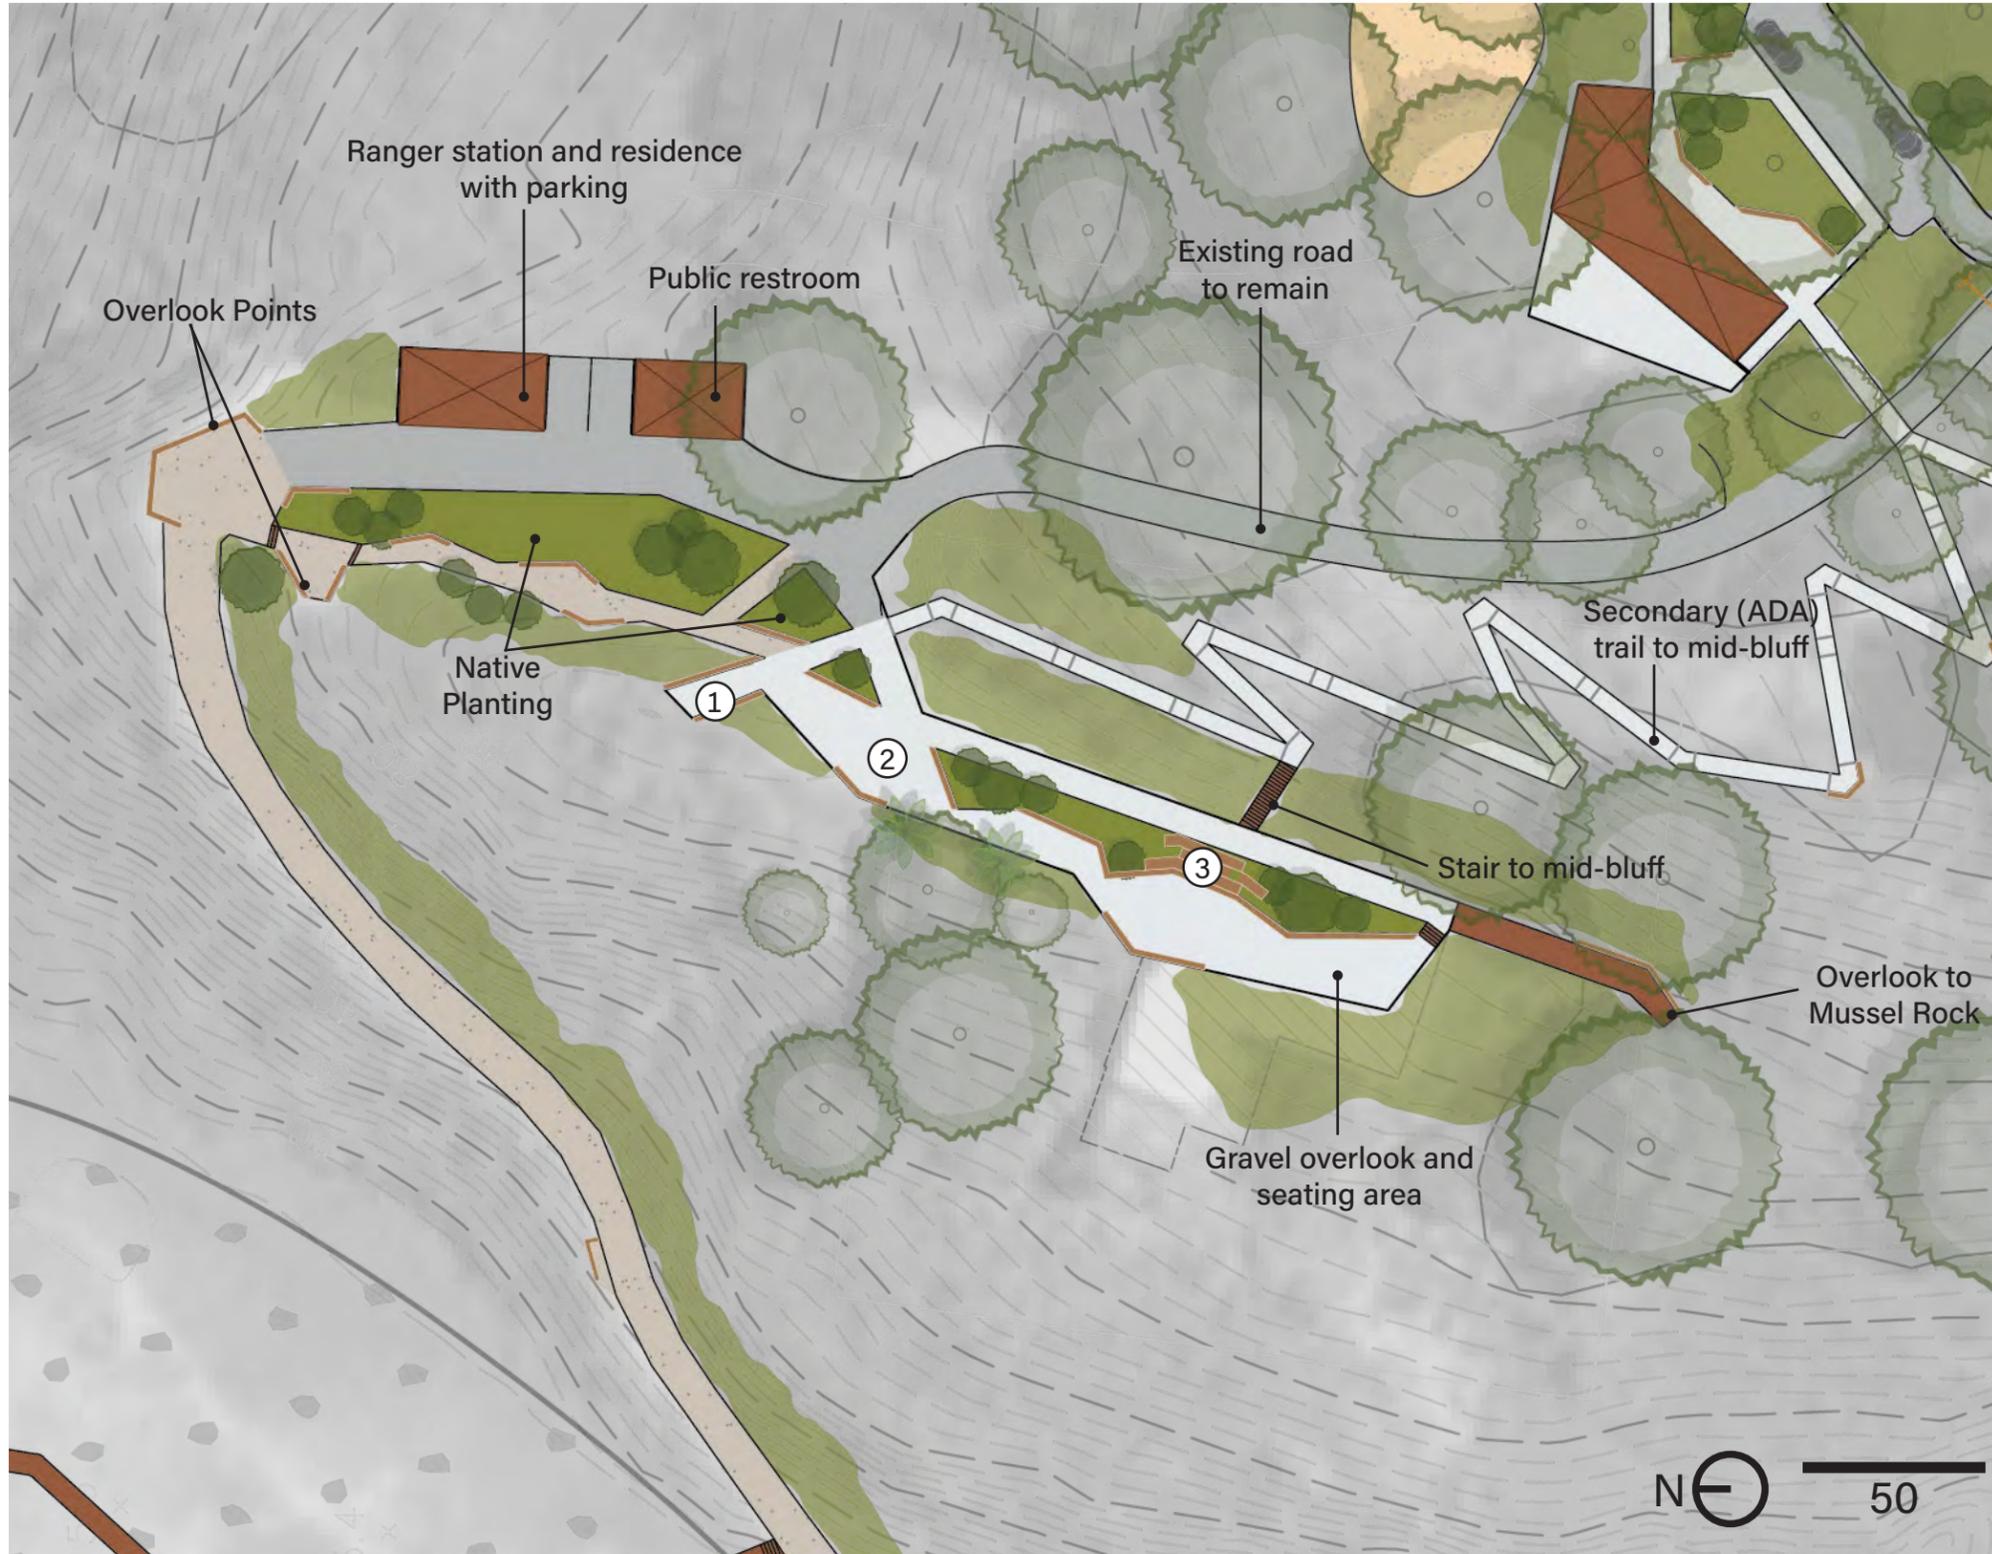
ALTERNATIVE 3: MID-BLUFF

① Slanted Overlook Point

② Seating

③ Feature seatwall overlook

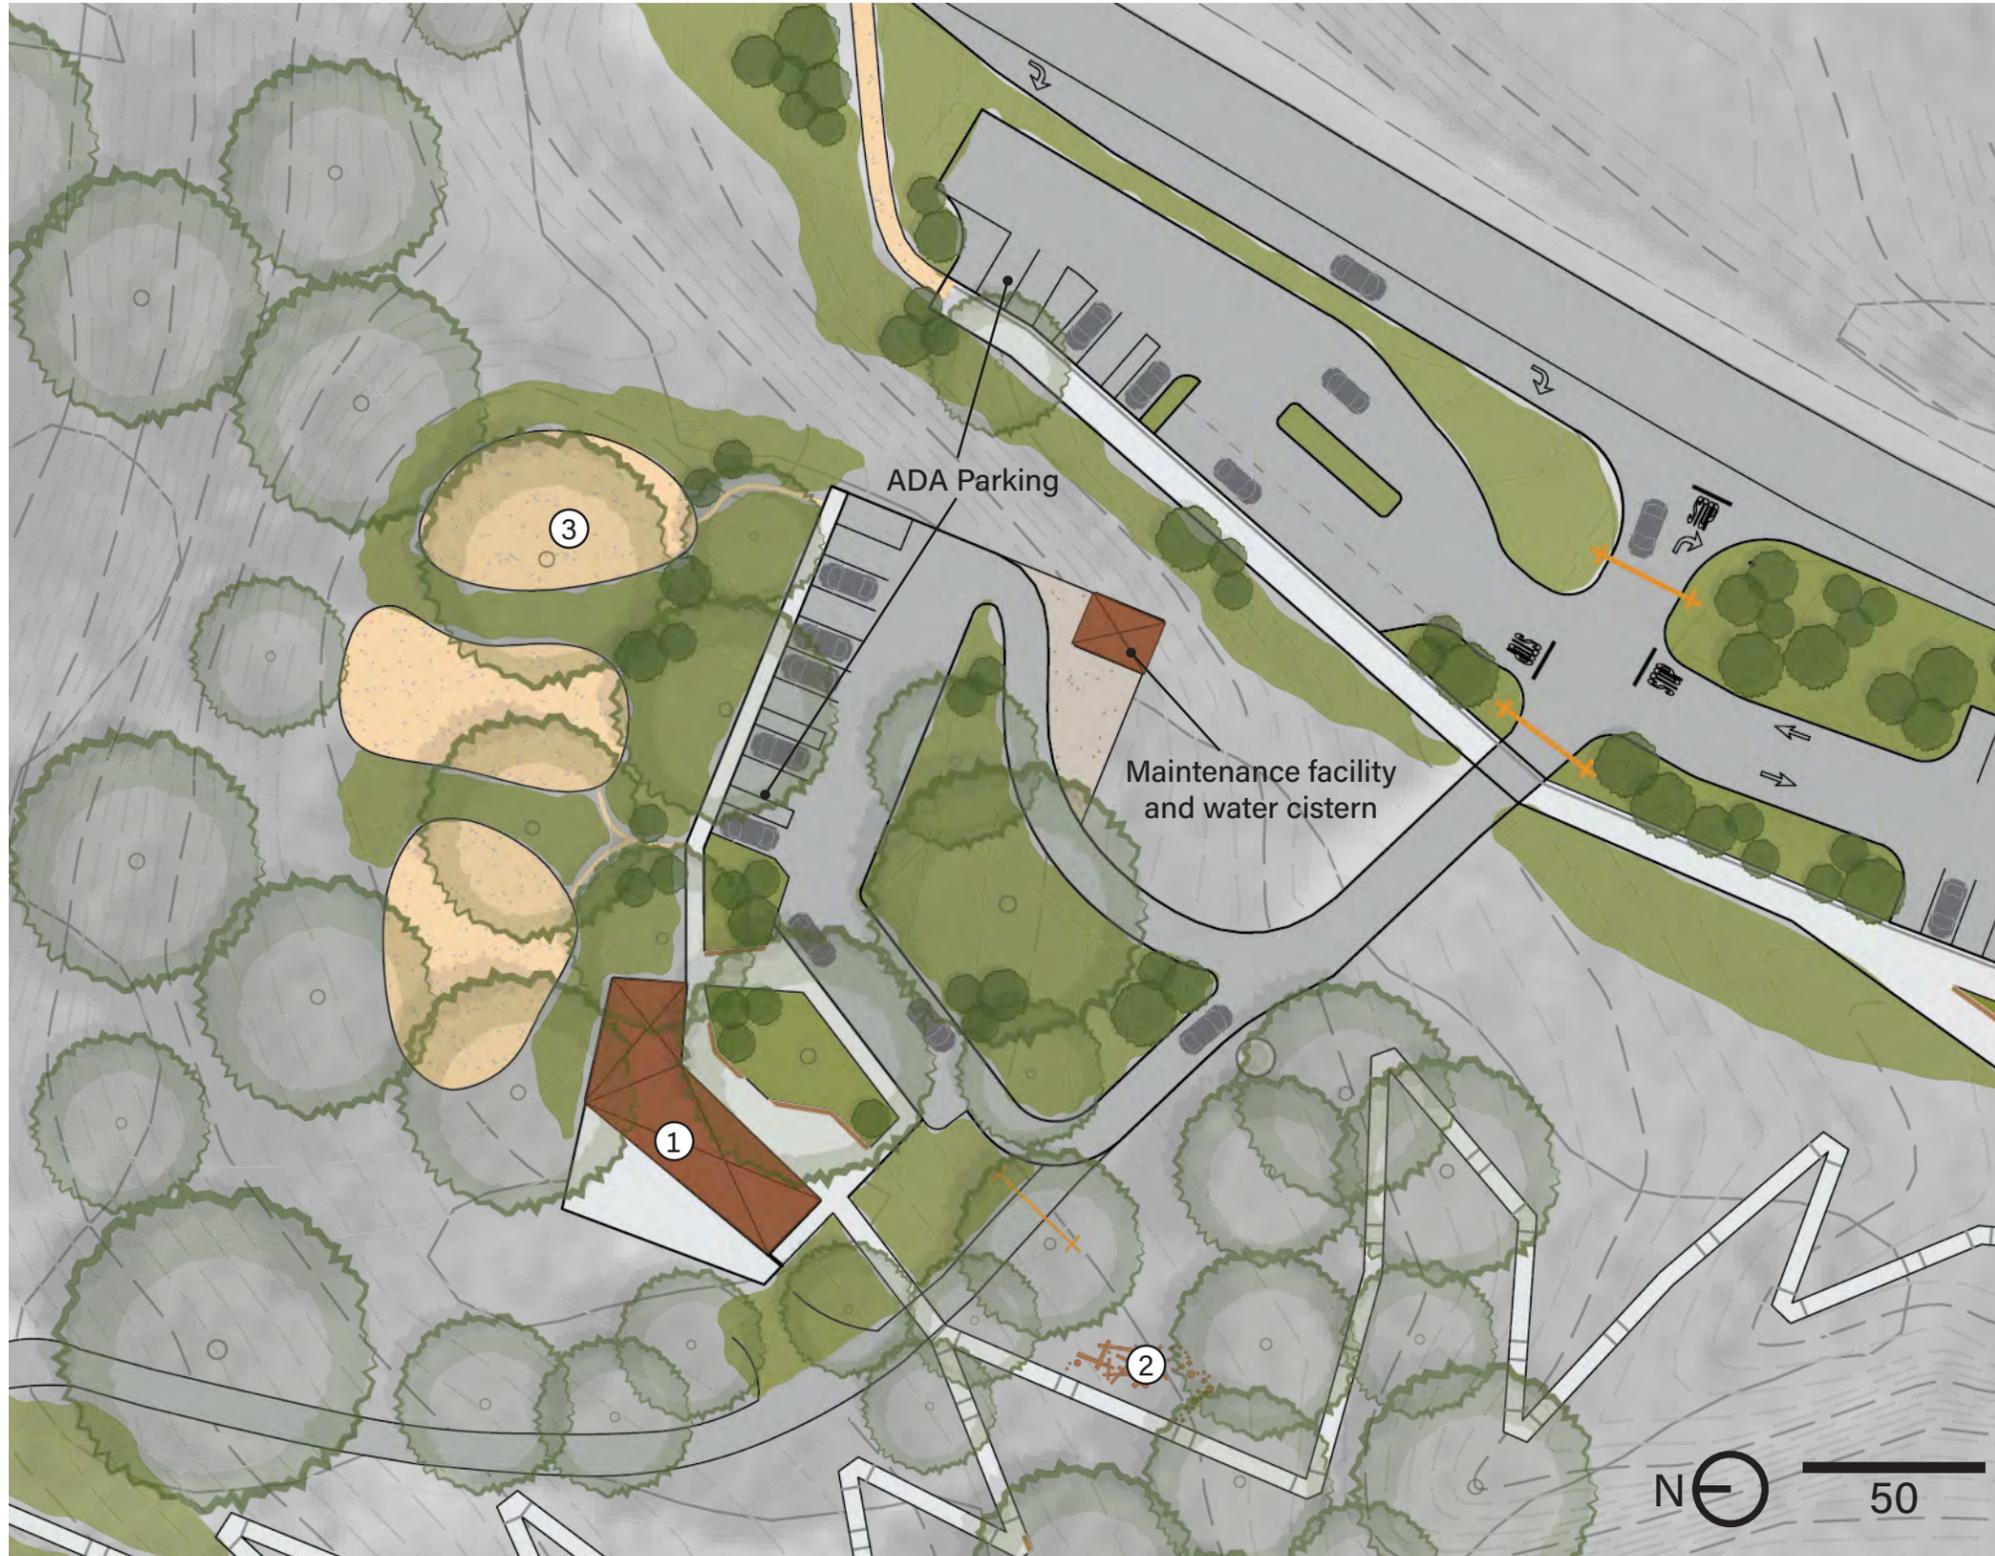
ALTERNATIVE 3: CAMPGROUND AND PARKING

① Visitor Center with Restrooms and Picnic Patio

② Natural Play Features

③ Group Camping Pods

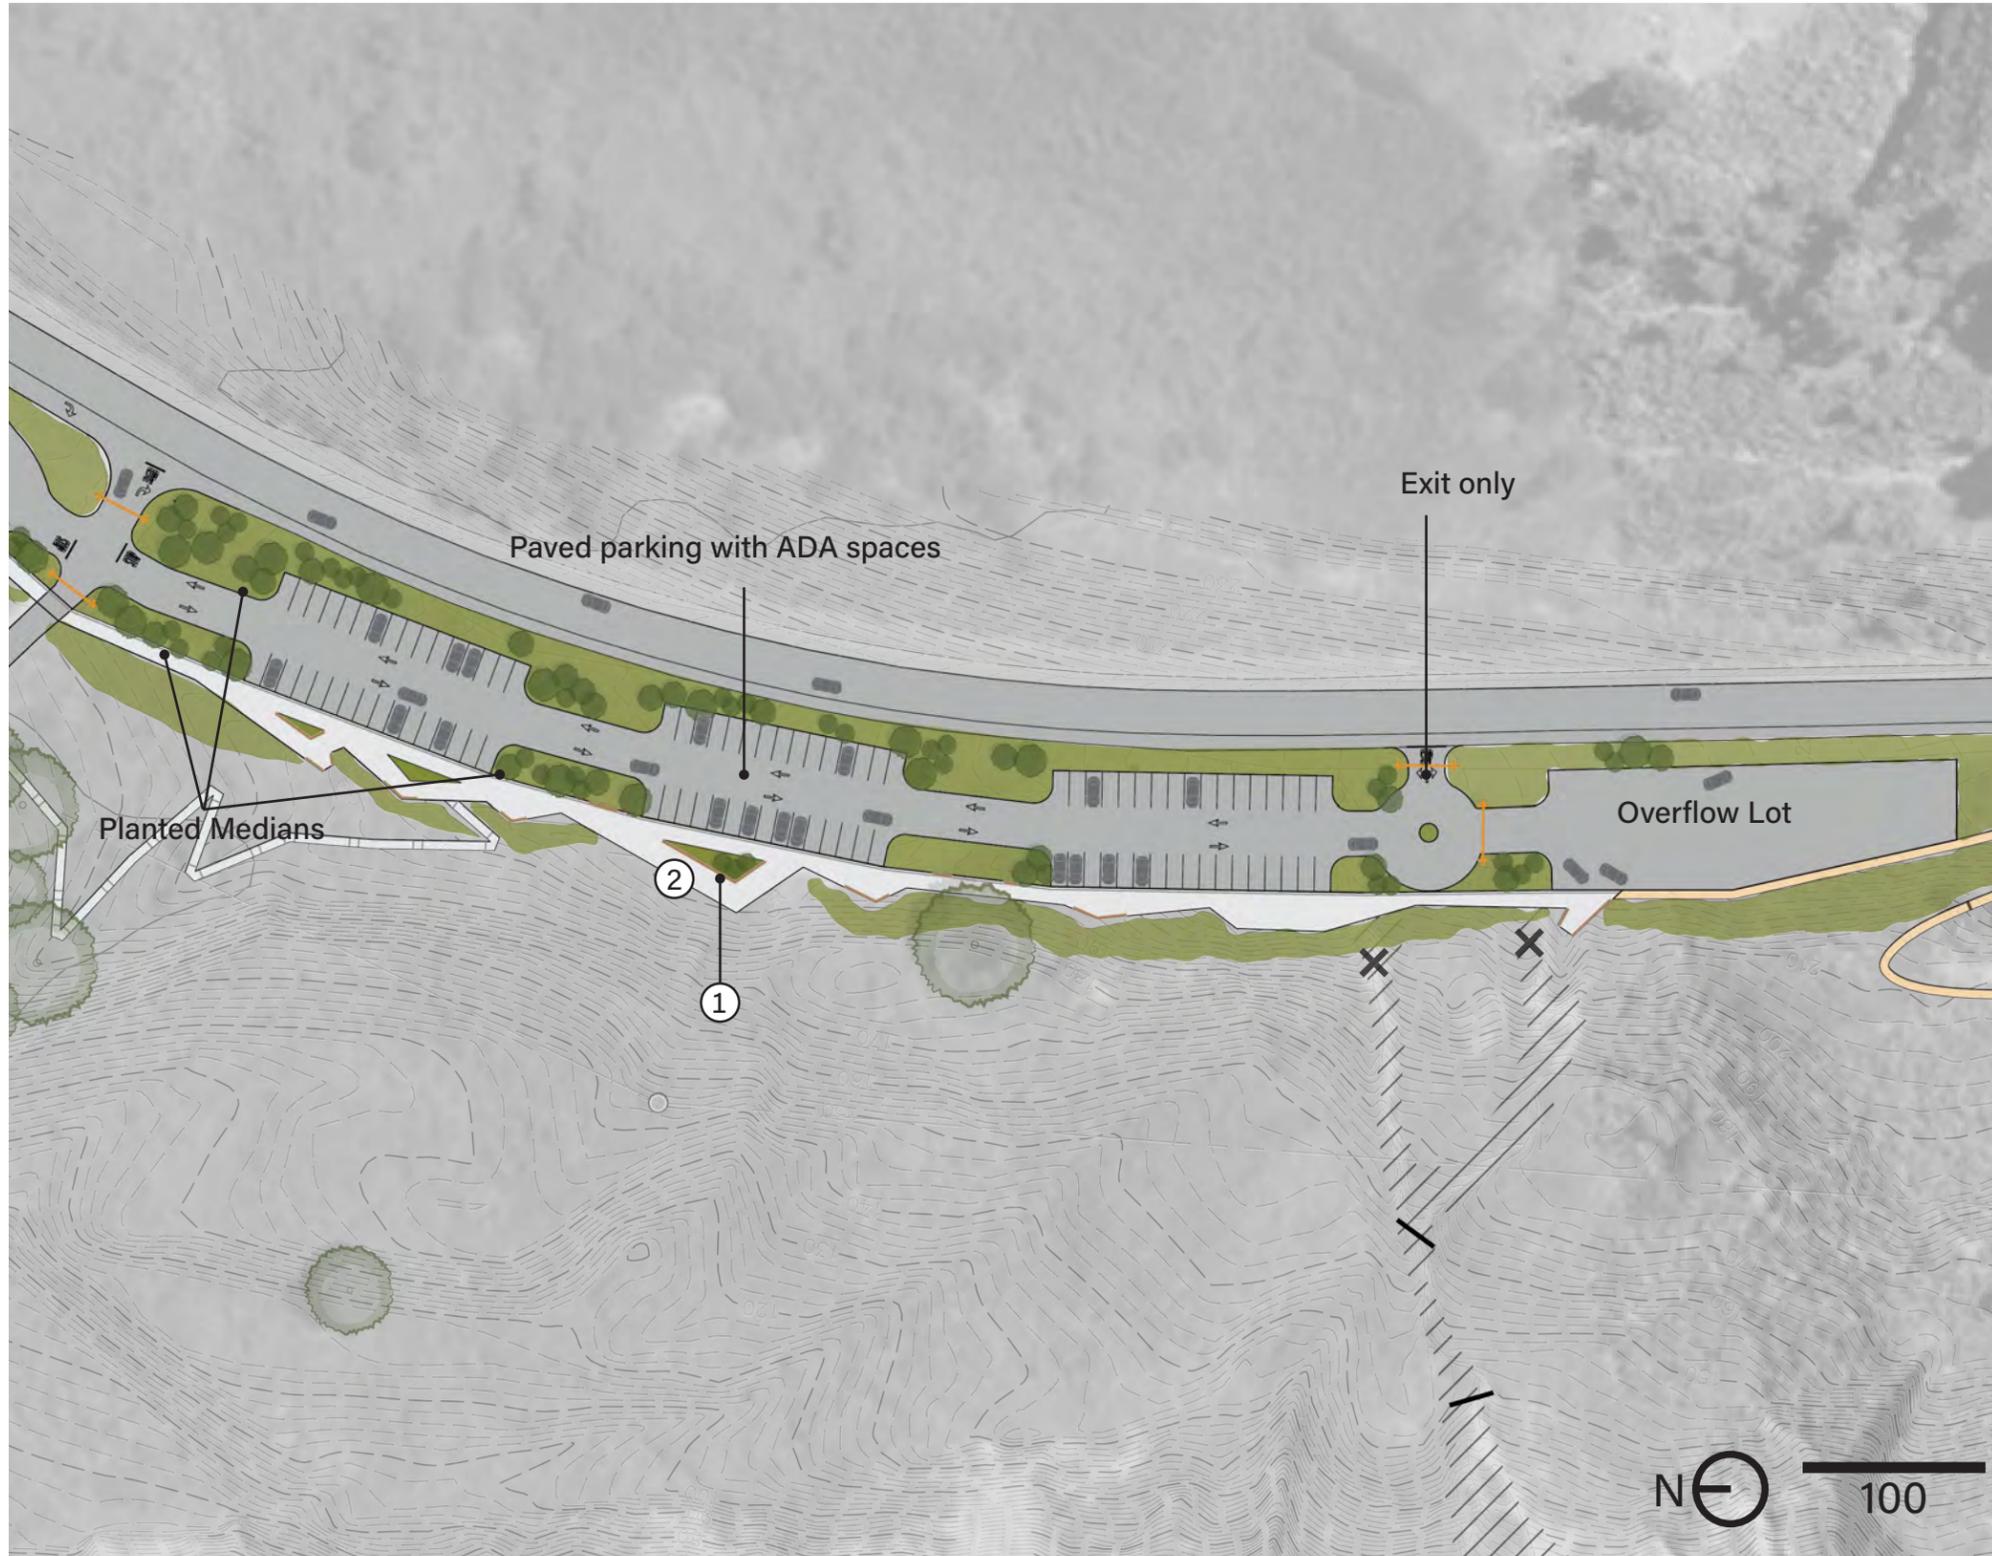
ALTERNATIVE 3: OVERLOOK

① Seat Walls Along Overlook

② Cantilevered Overlook

② Overlook Overhead Structure

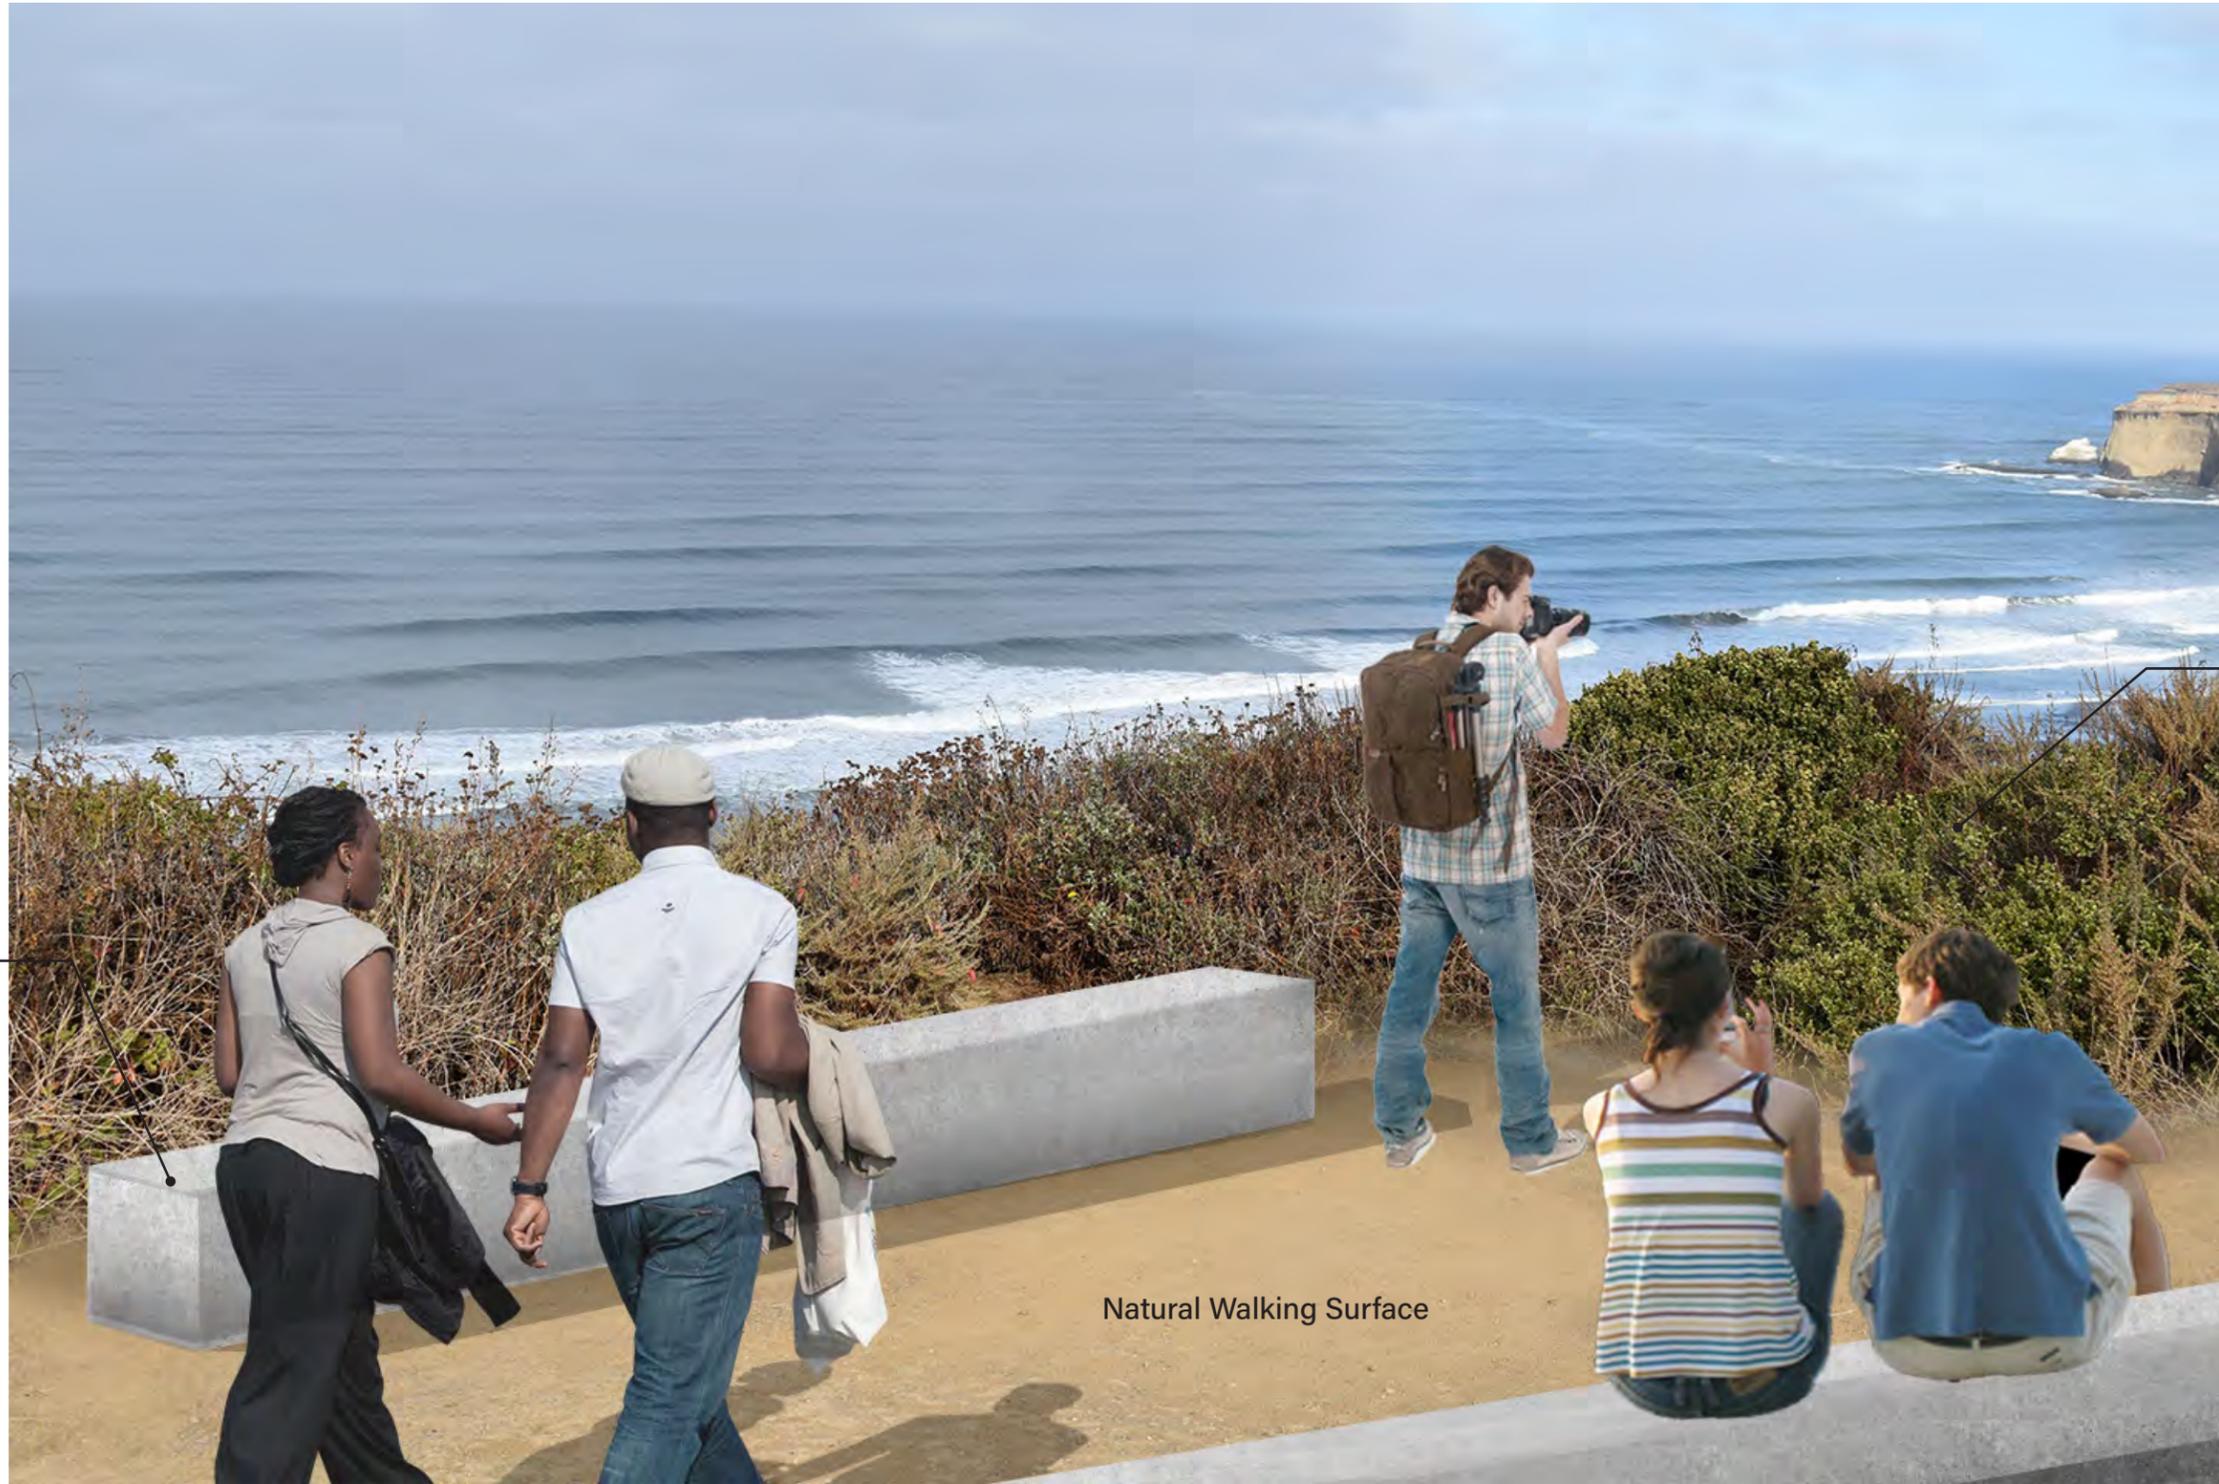
PERSPECTIVE VIEW: ALTERNATIVE 1

Simple Seating Elements

Existing Vegetation

Natural Walking Surface

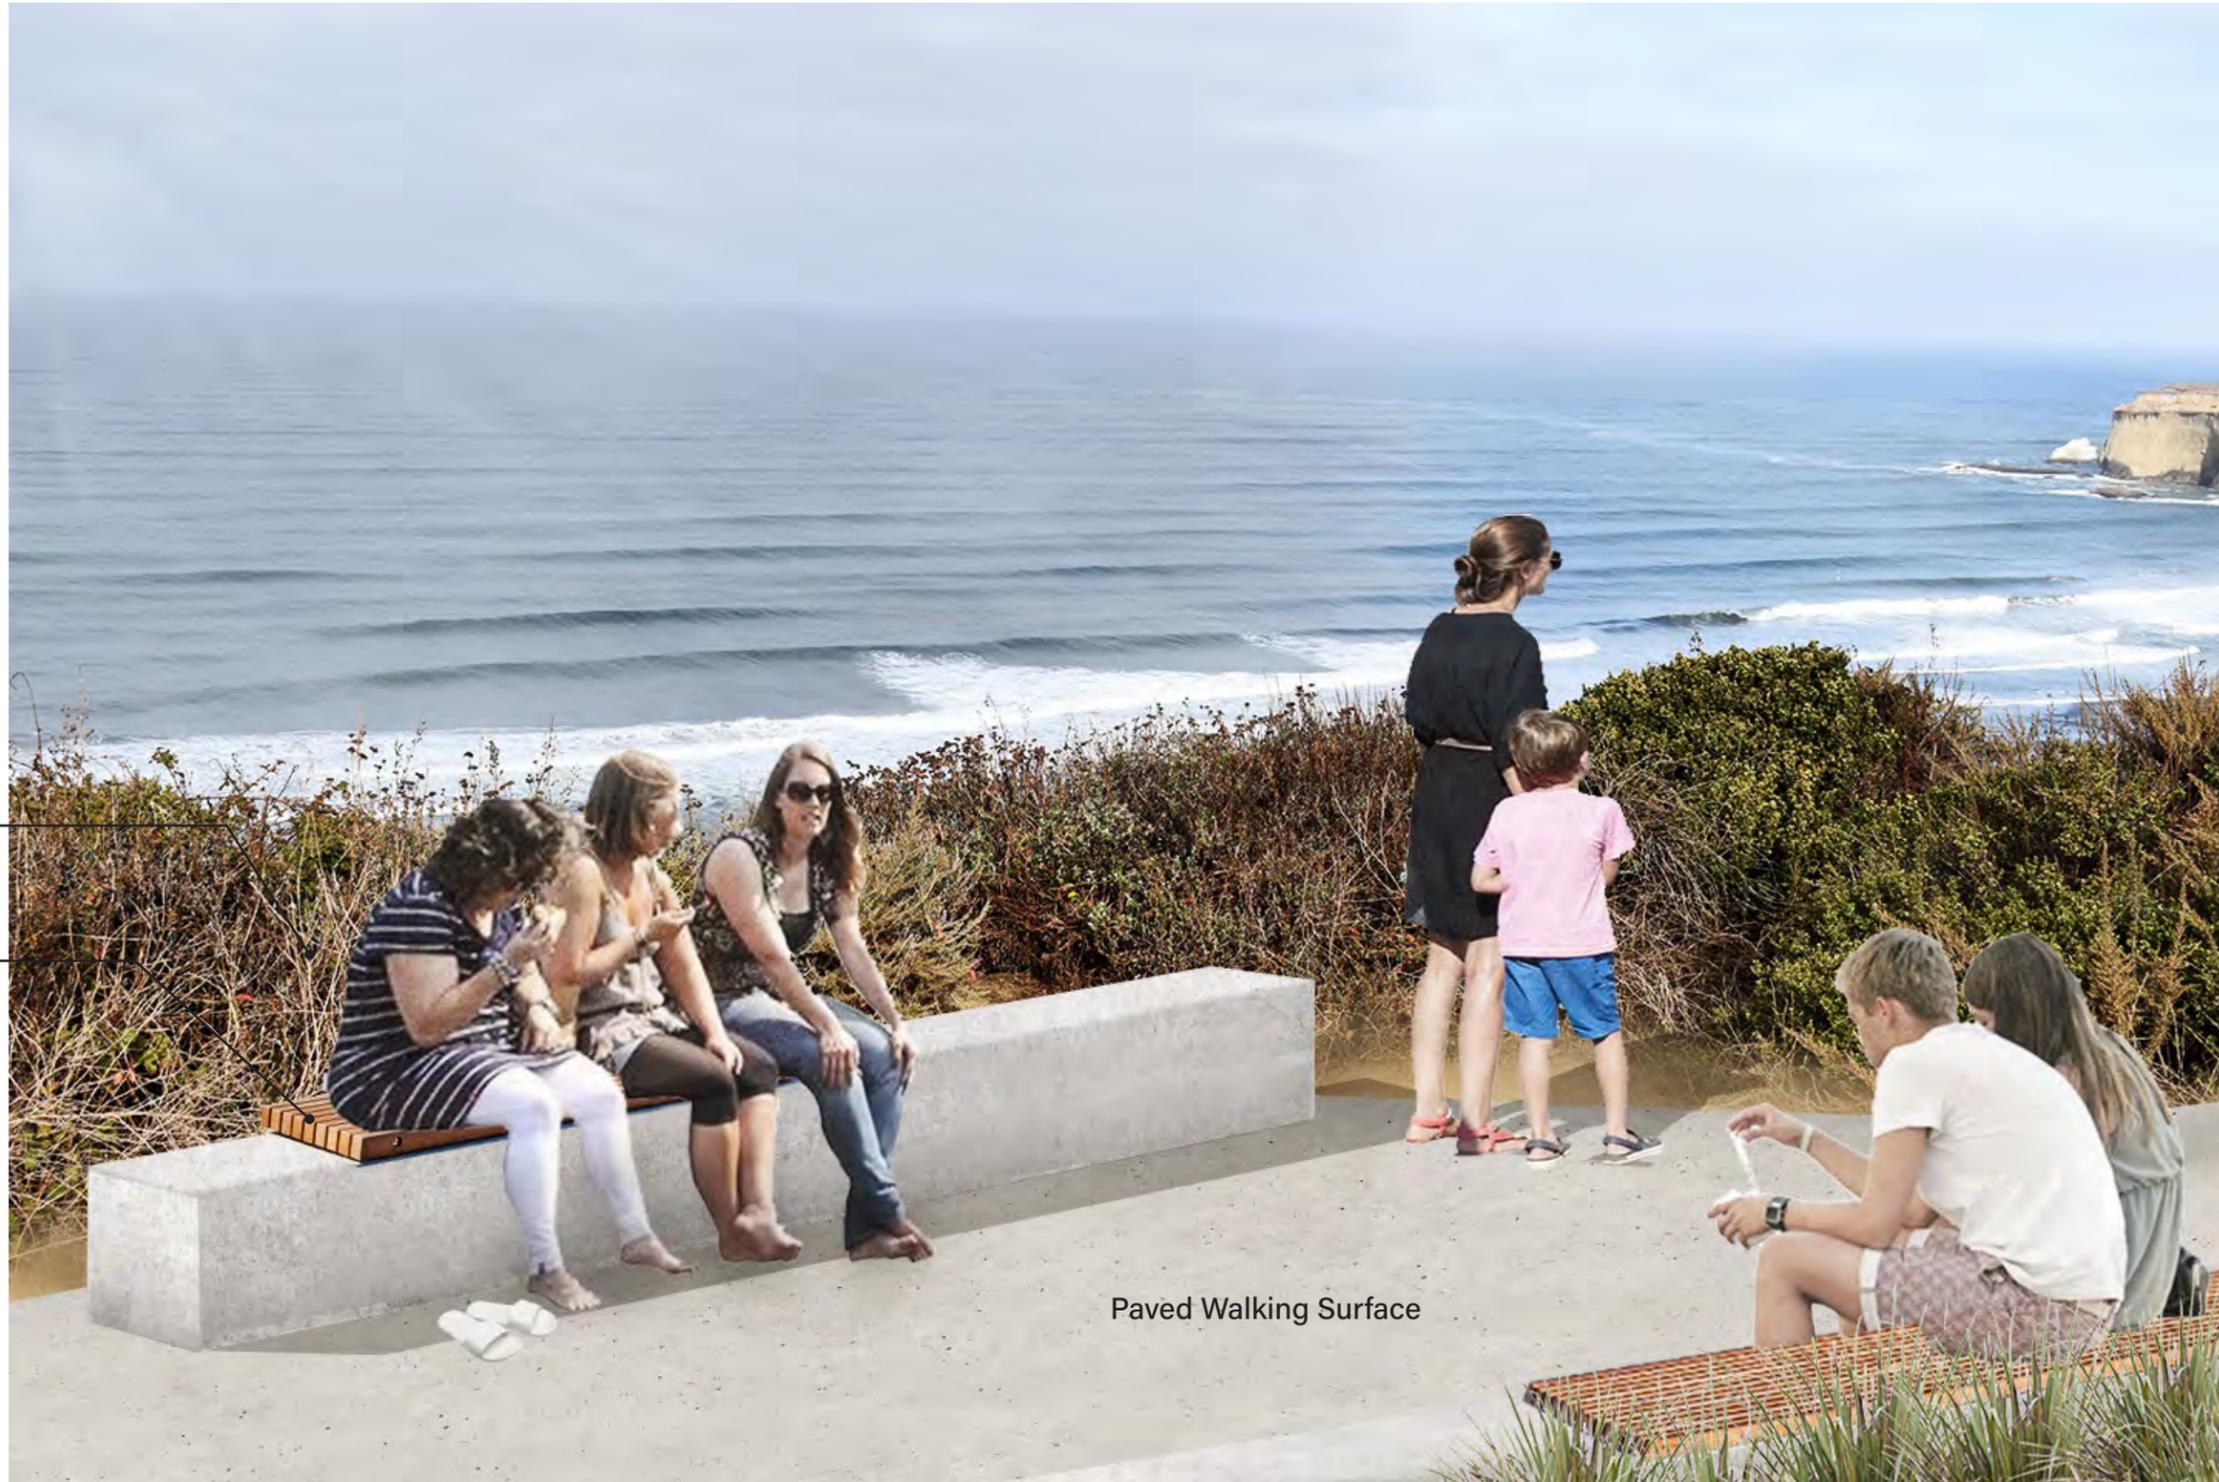
PERSPECTIVE VIEW: ALTERNATIVE 2

Invasive Planting Removed

Enhanced Seating Elements

Paved Walking Surface

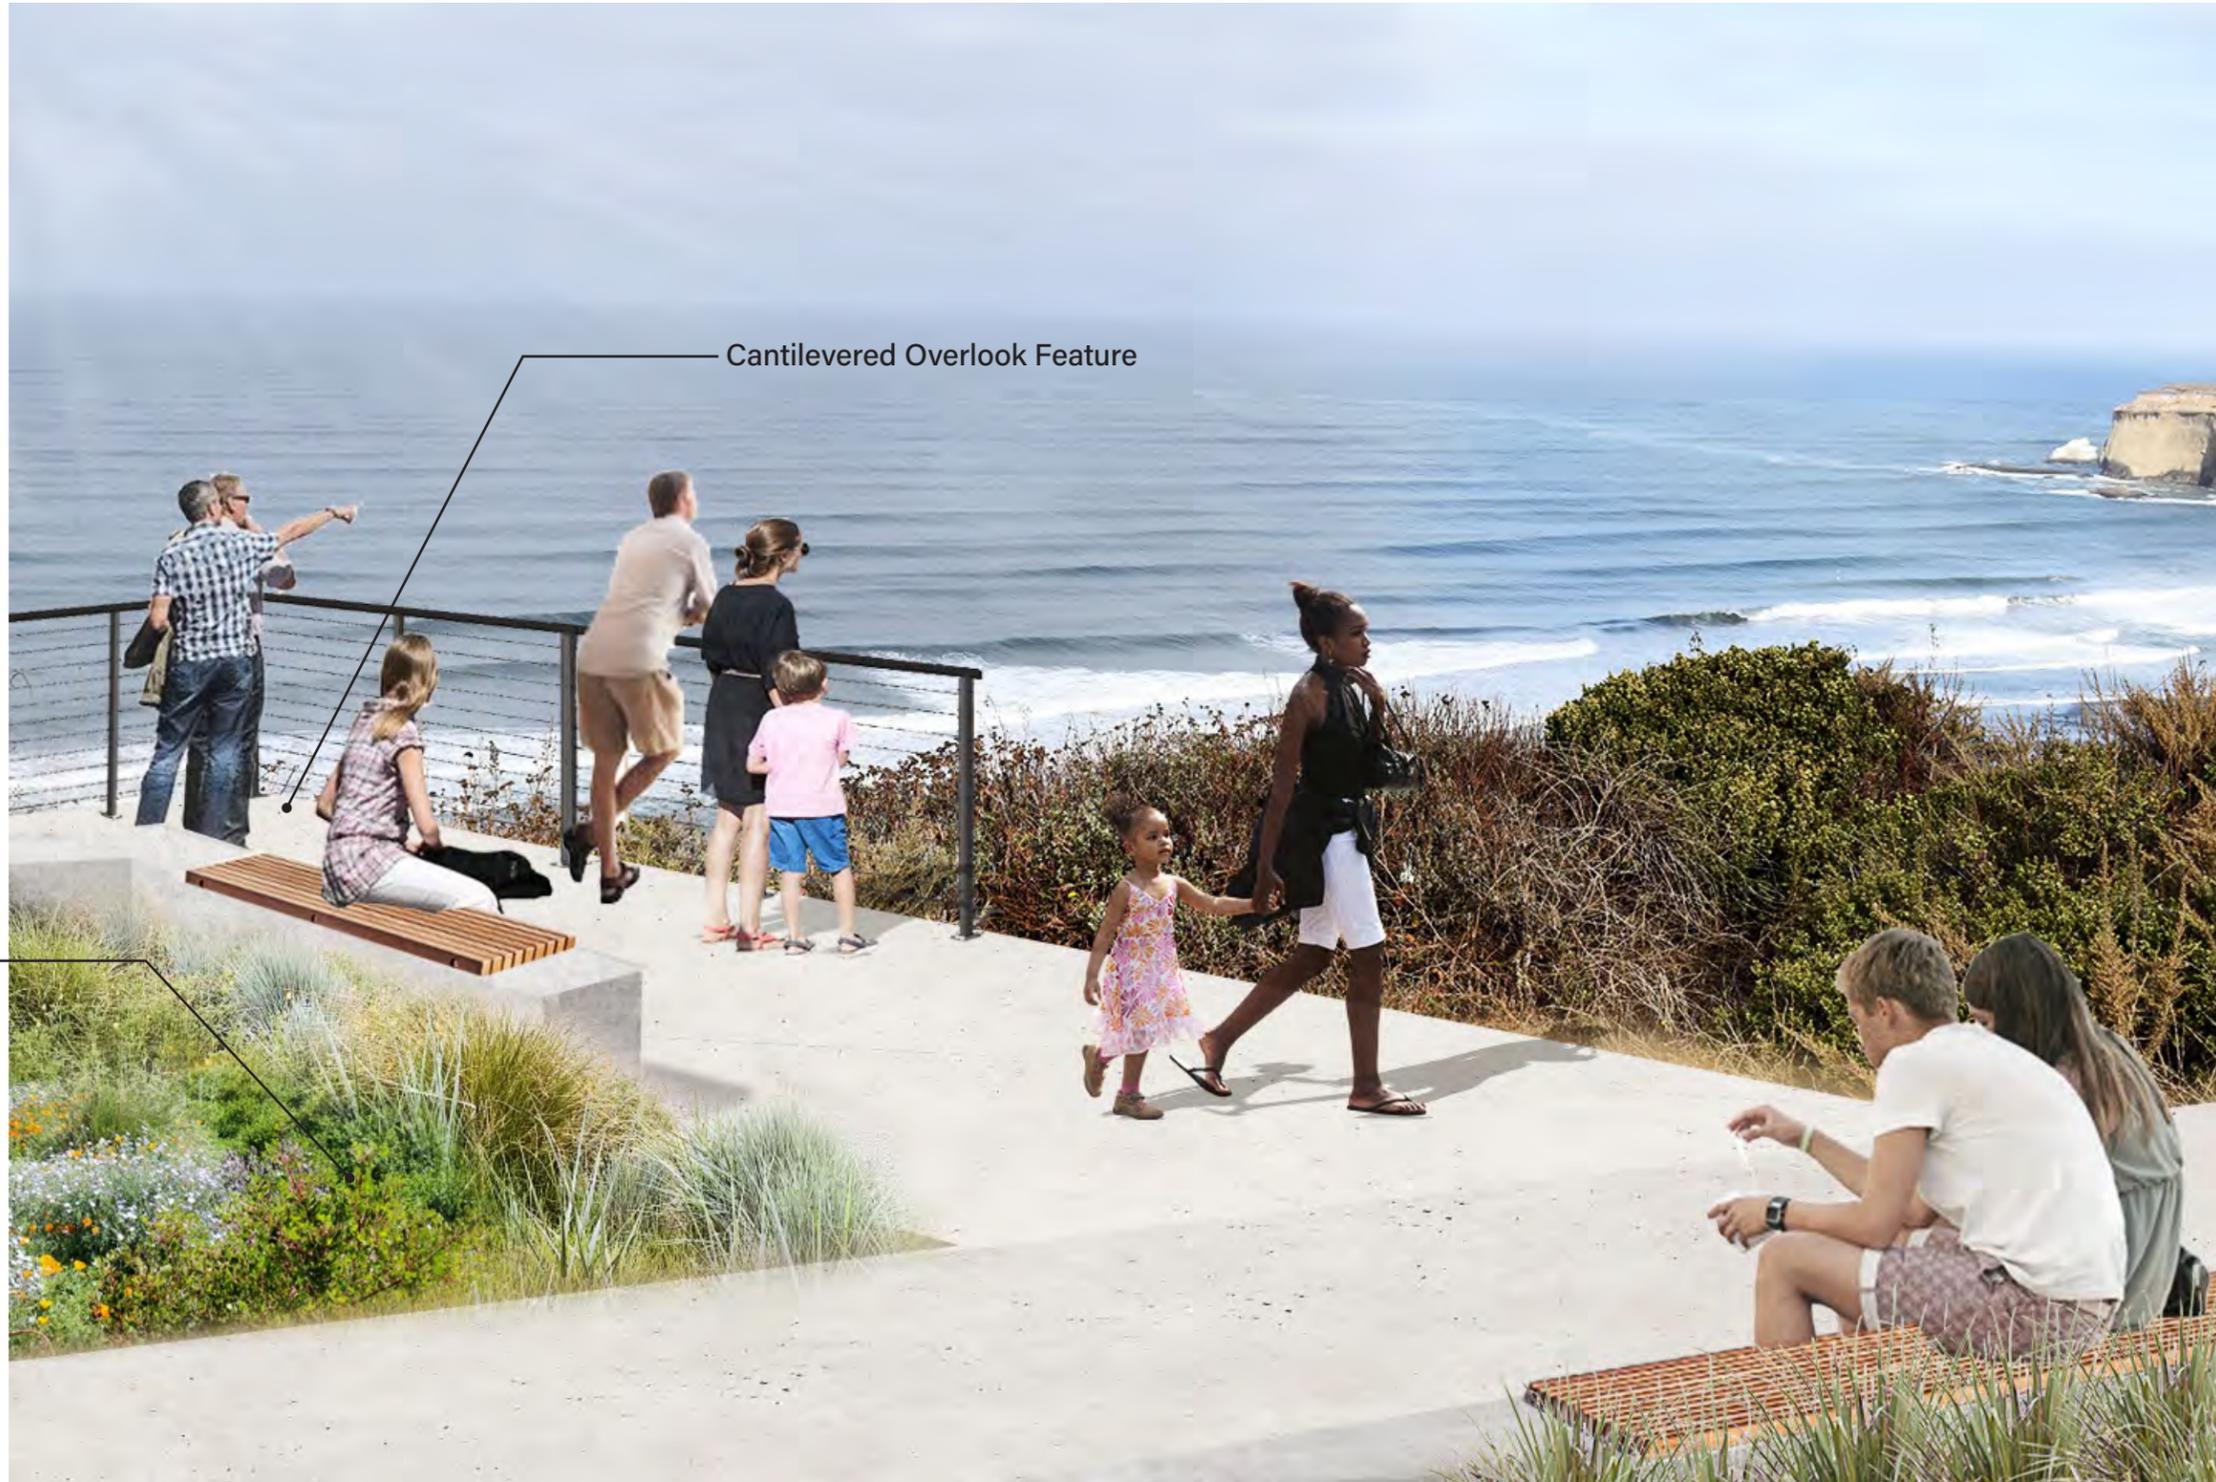
PERSPECTIVE VIEW: ALTERNATIVE 3

Additional Native Planting

Cantilevered Overlook Feature

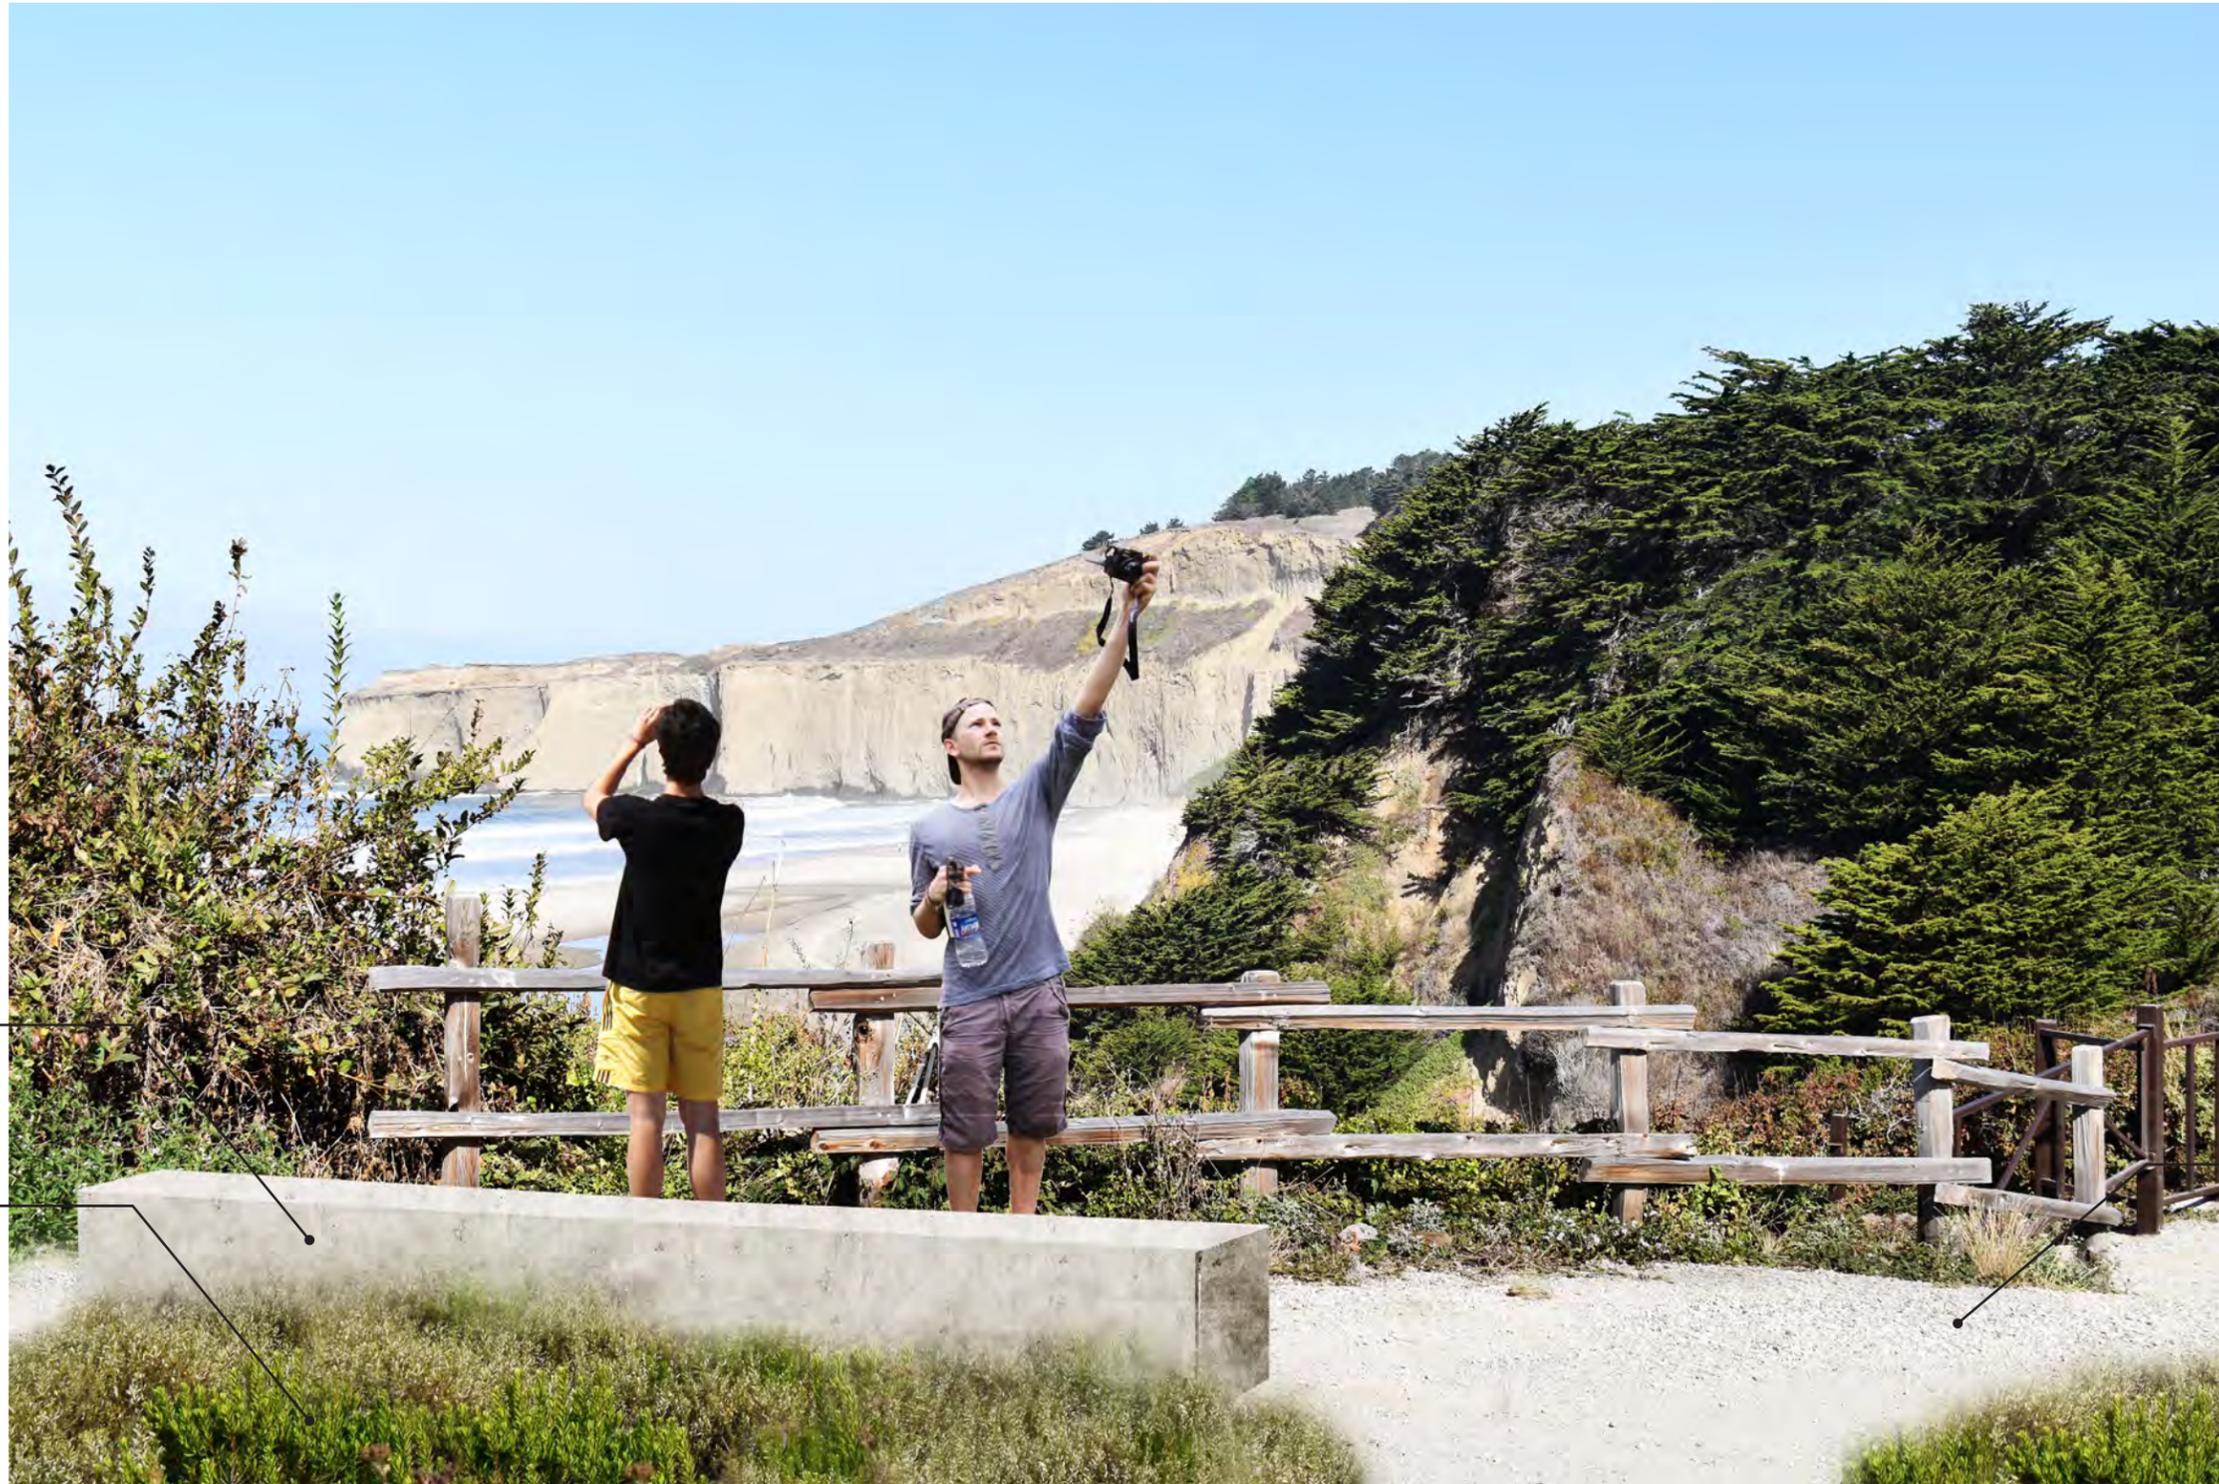
PERSPECTIVE VIEW: ALTERNATIVE 1

Simple Seating Elements

Existing Vegetation

Existing Gravel Walking Surface
