TUNITAS CREEK BEACH IMPROVEMENT PROJECT

DESIGN ALTERNATIVES

July 2020

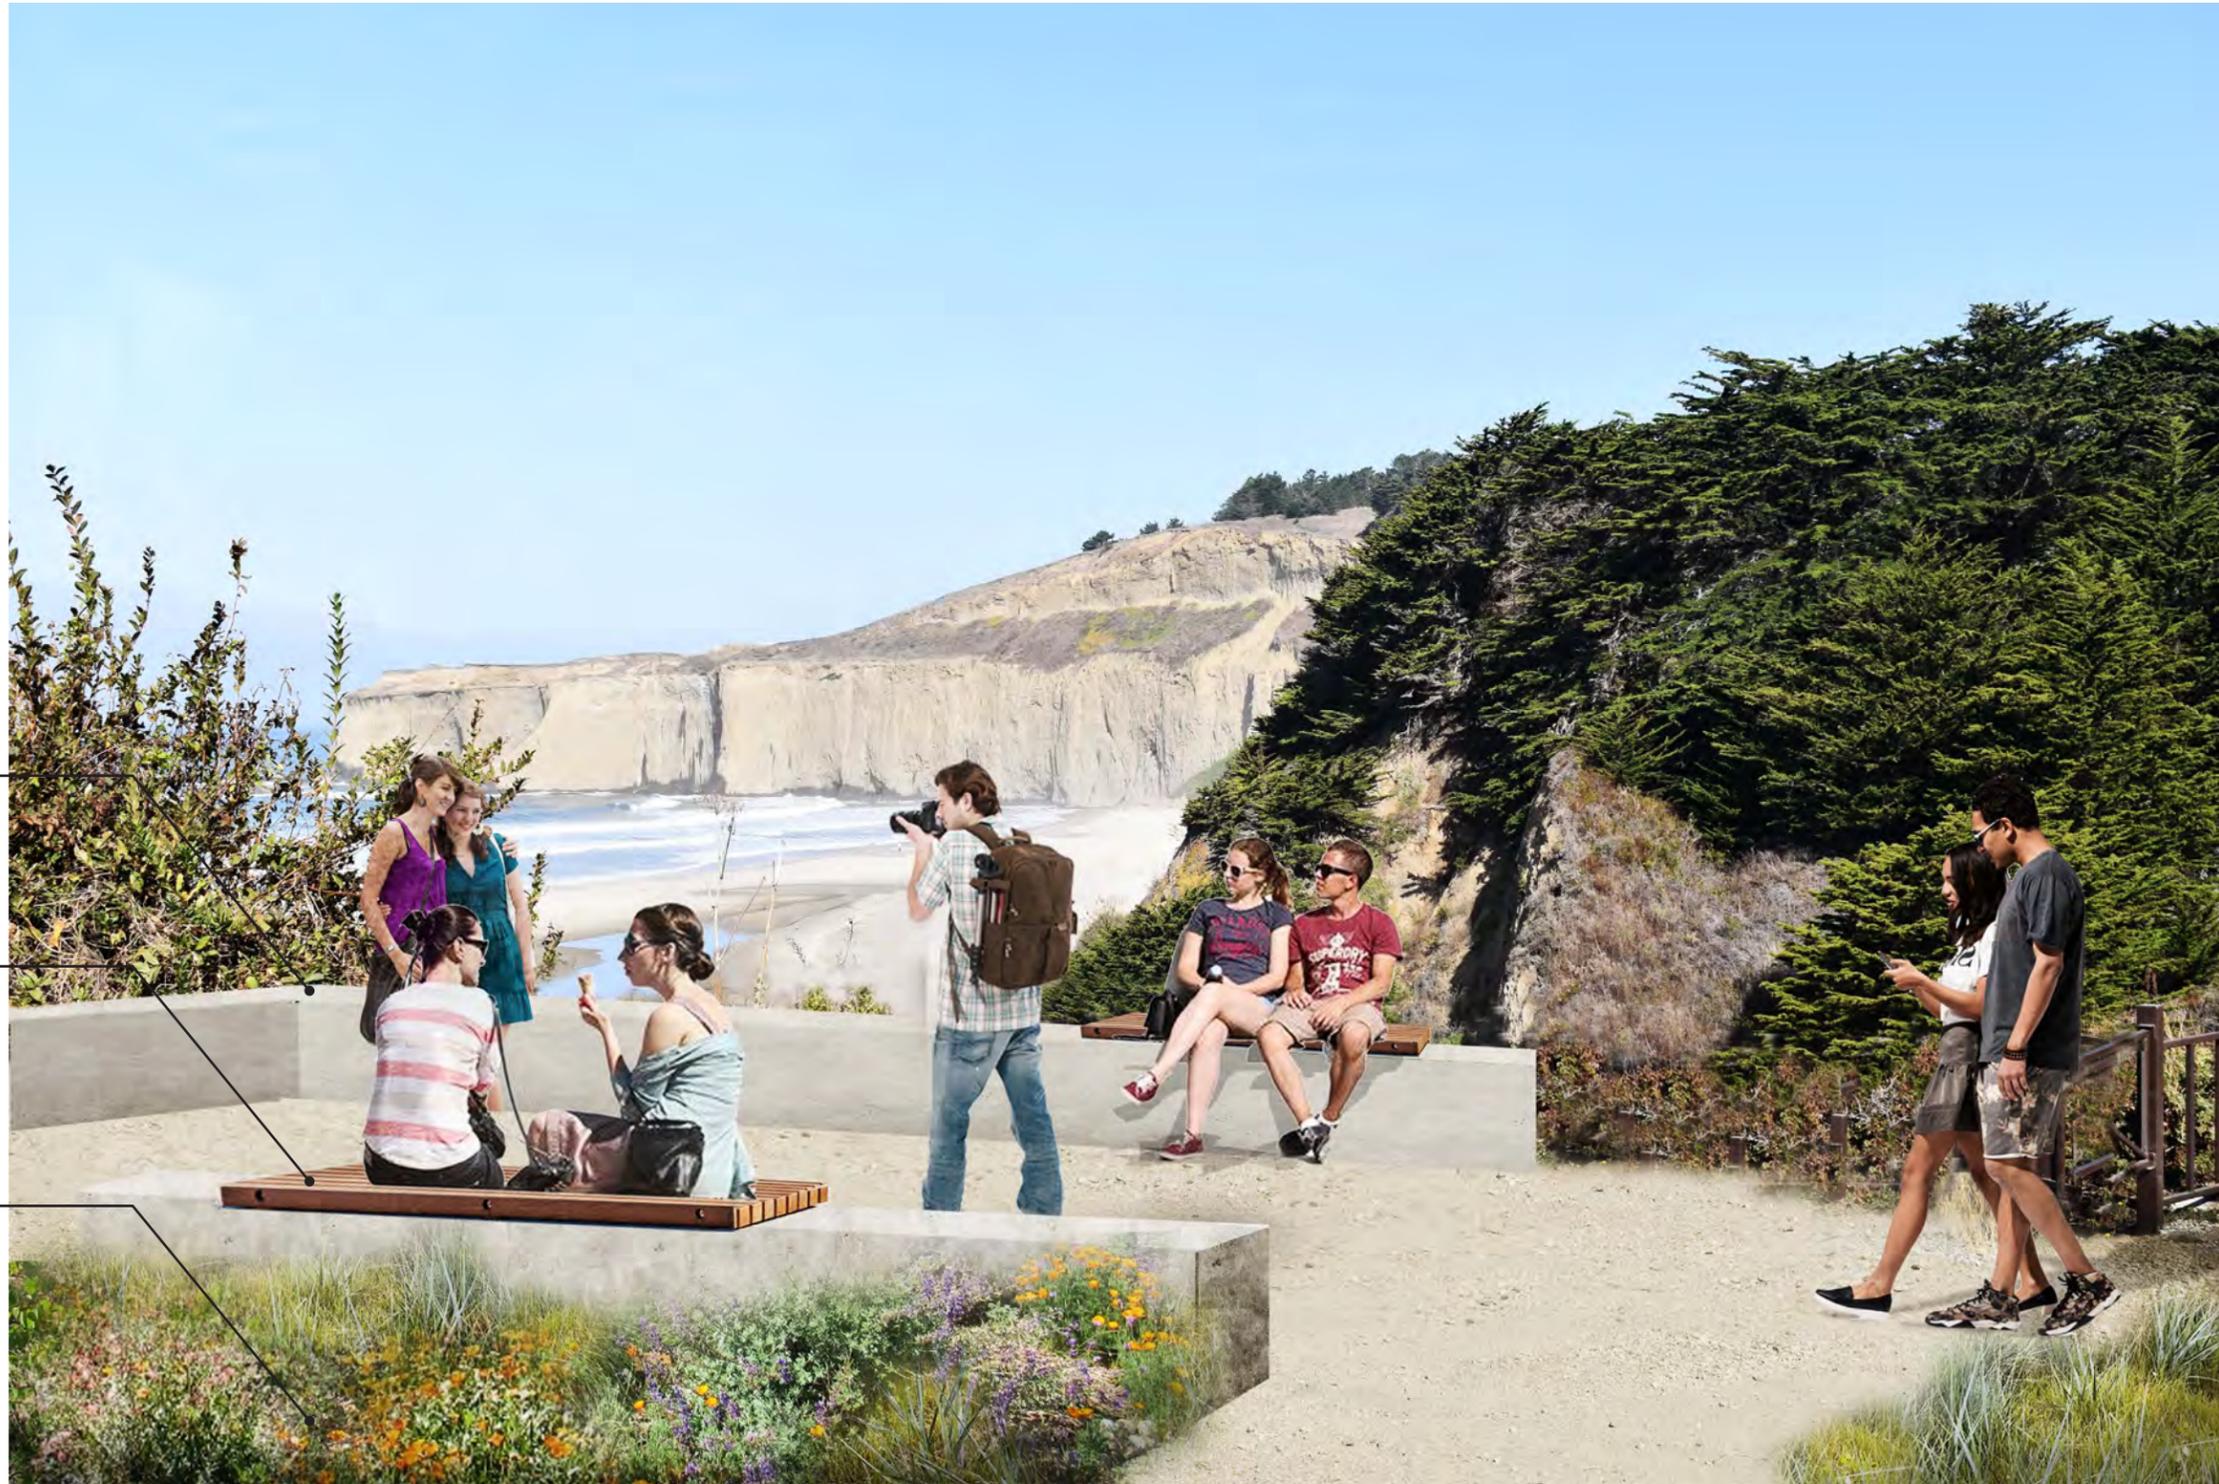
PERSPECTIVE VIEW: ALTERNATIVE 2

Seat Wall

Enhanced Seating Elements

Additional Native Planting,
Invasive Species Removed

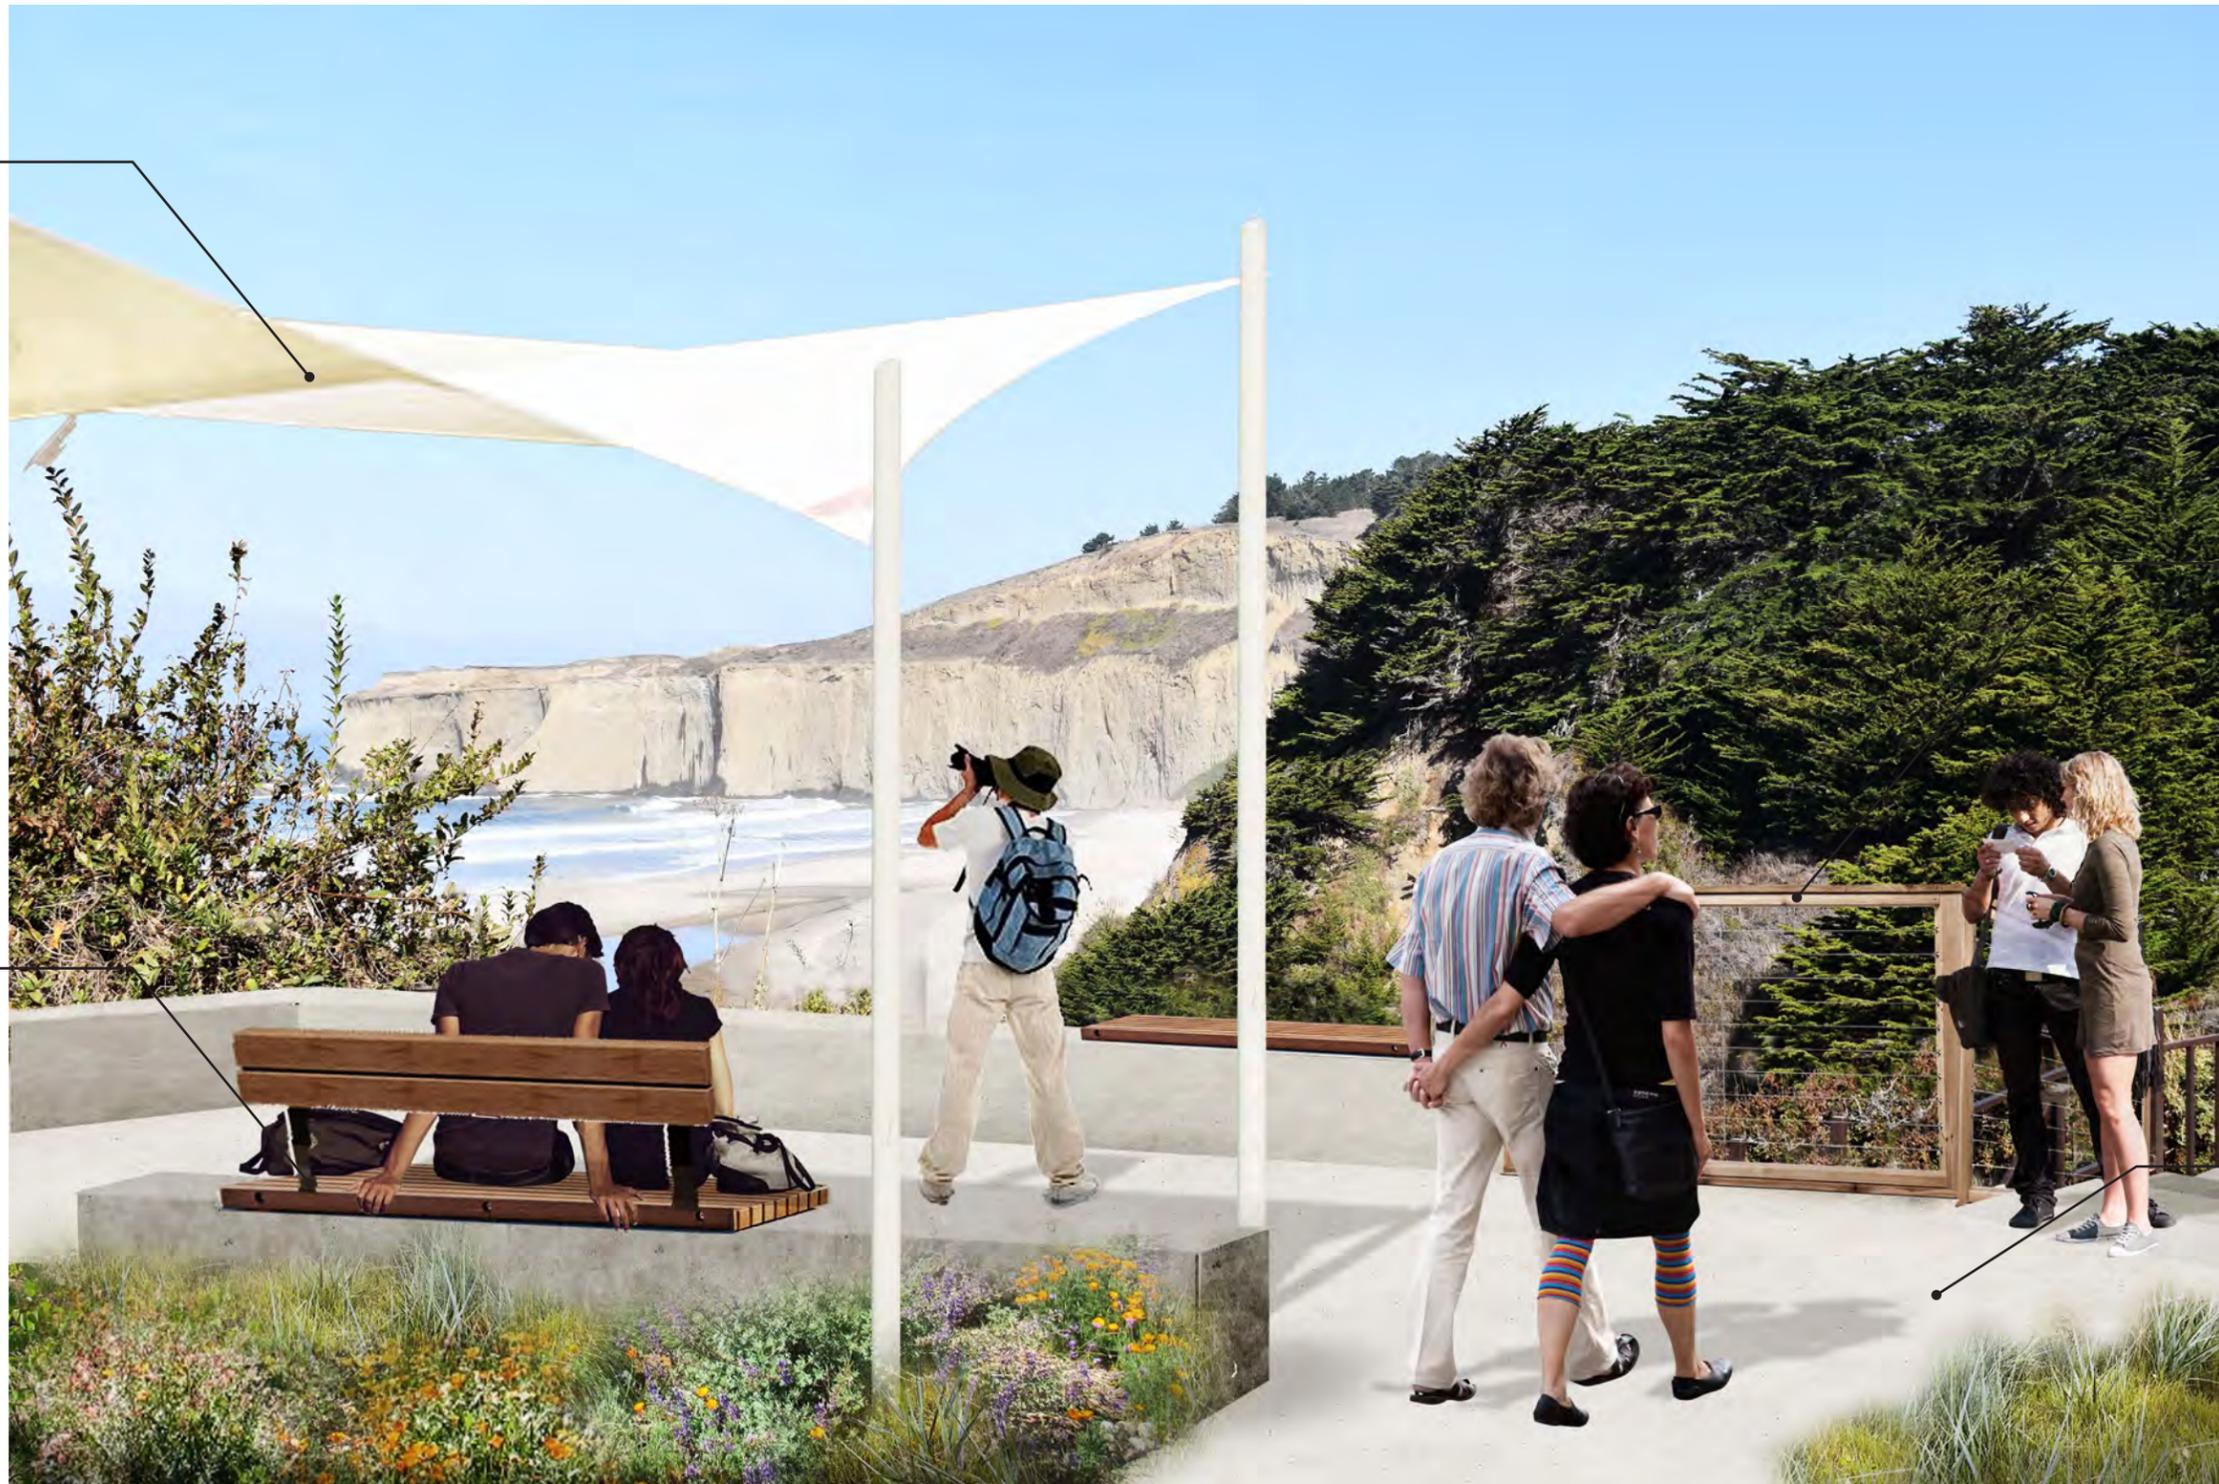
PERSPECTIVE VIEW: ALTERNATIVE 3

Shade Structure

Improved Fencing

Paved Walking Surface

Enhanced Seating Elements

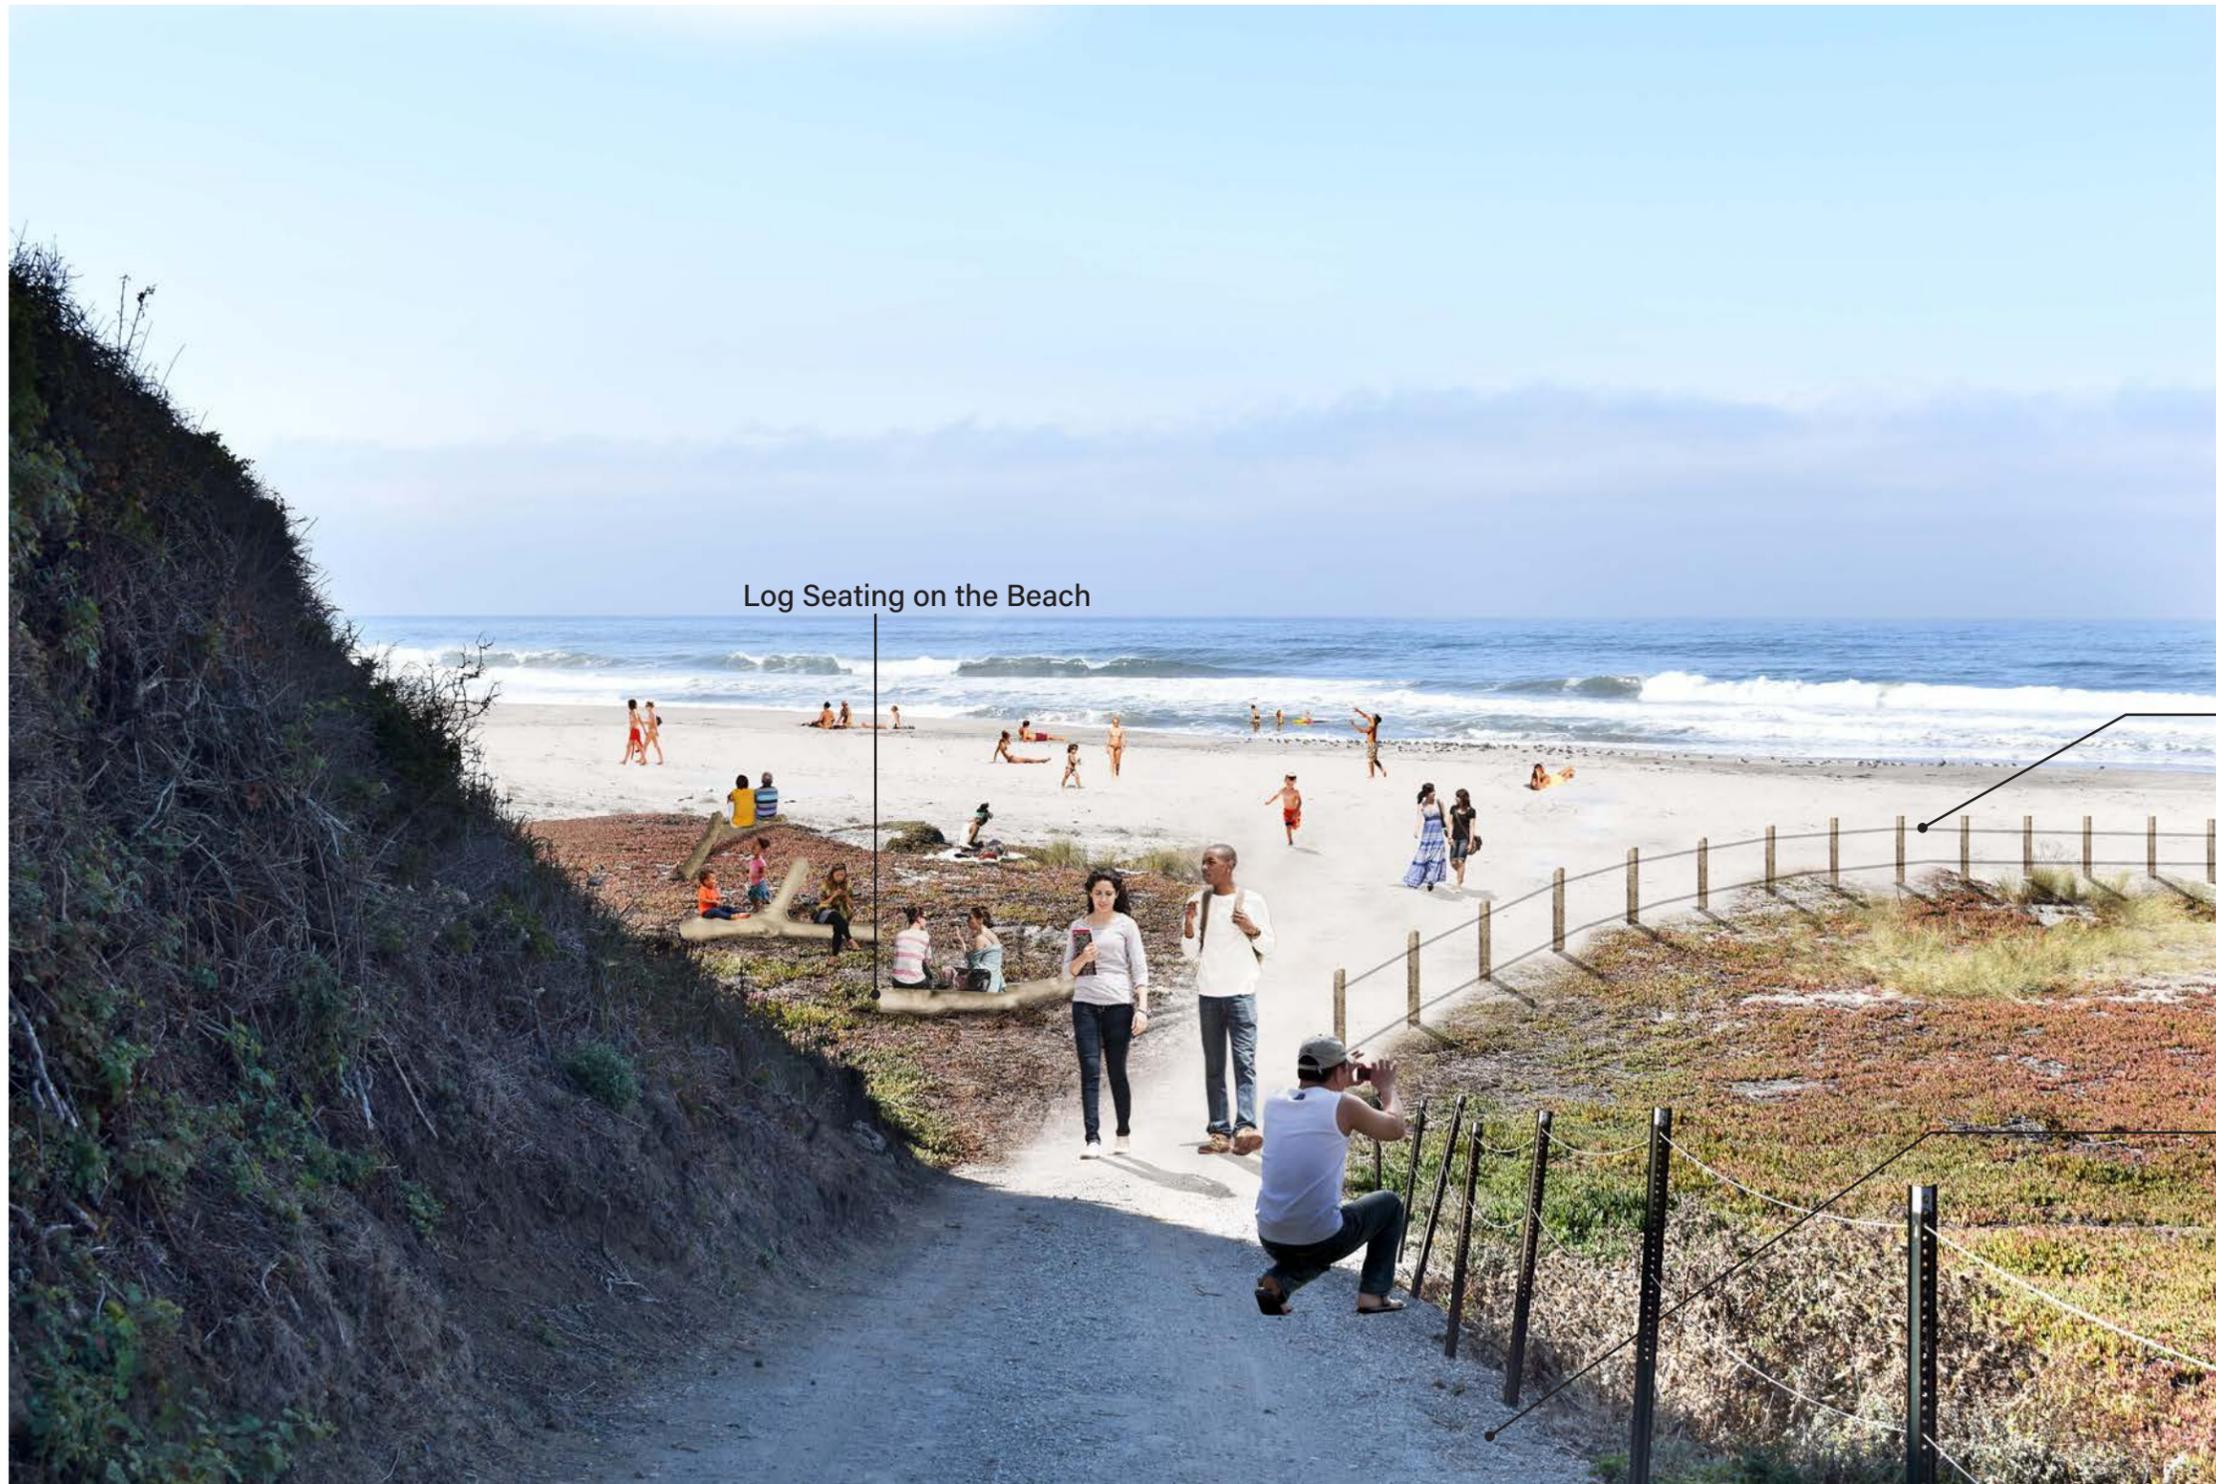
PERSPECTIVE VIEW: ALTERNATIVE 1

Log Seating on the Beach

Snowy Plover Habitat Protection Fencing

Existing Access Trail

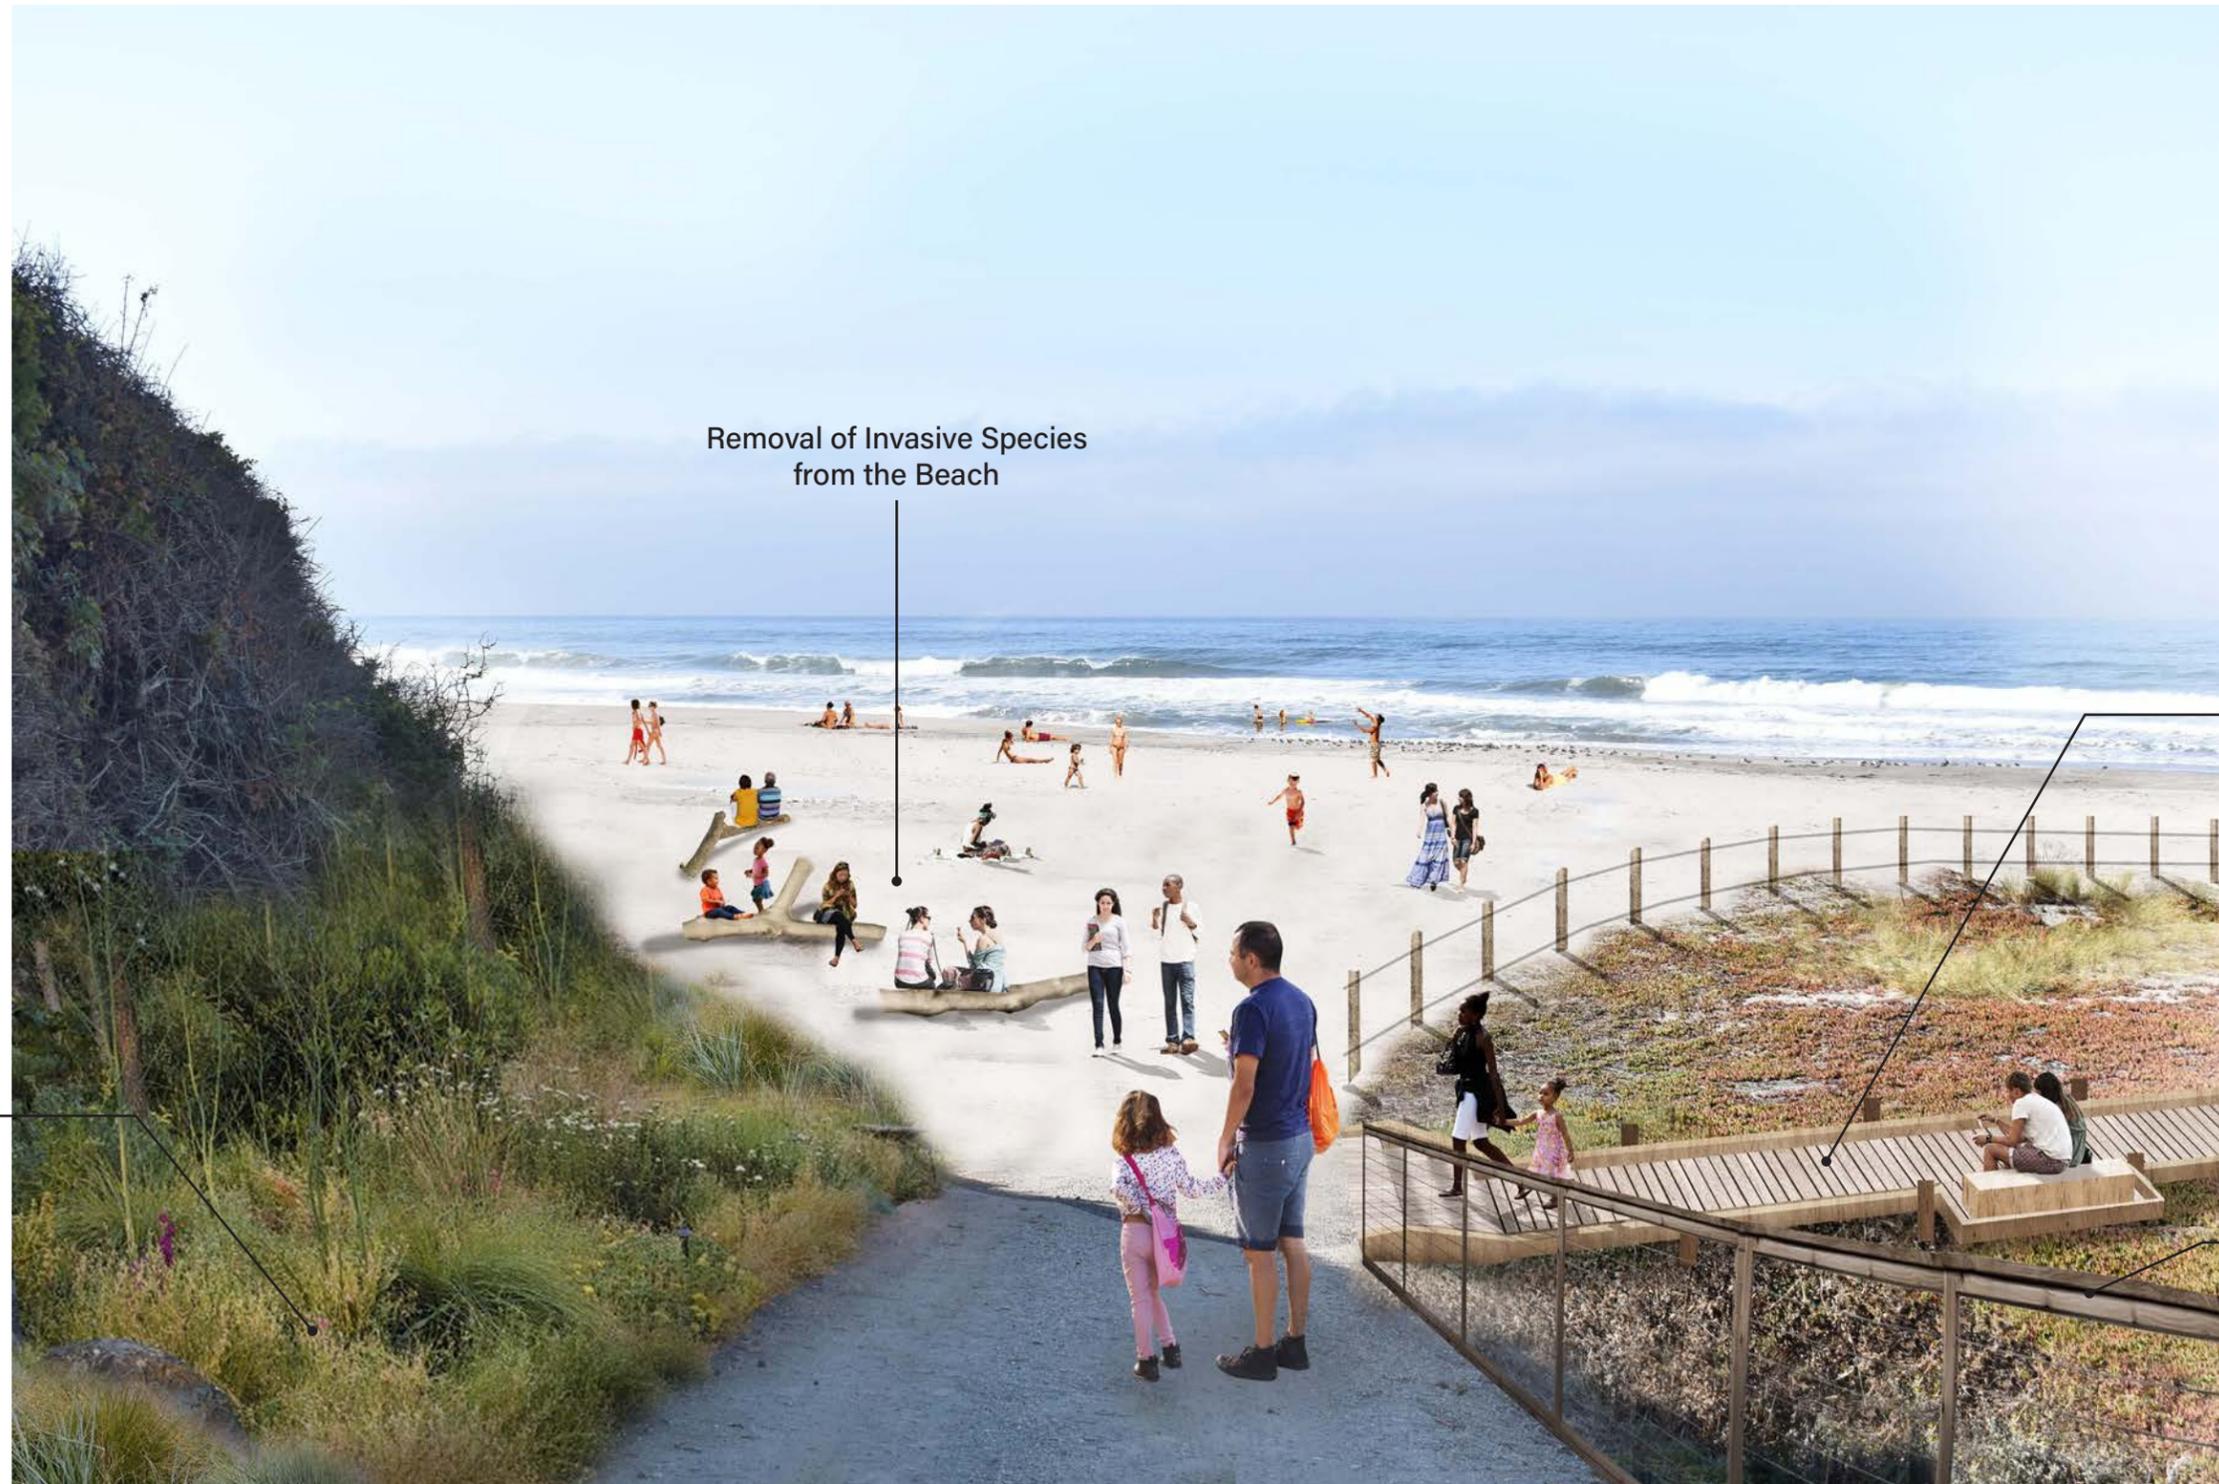
PERSPECTIVE VIEW: ALTERNATIVE 2

Removal of Invasive Species from the Beach

Beach Boardwalk Through Snowy Plover Habitat Protection Area

Improved Access Trail

Slope Stabilization Planting

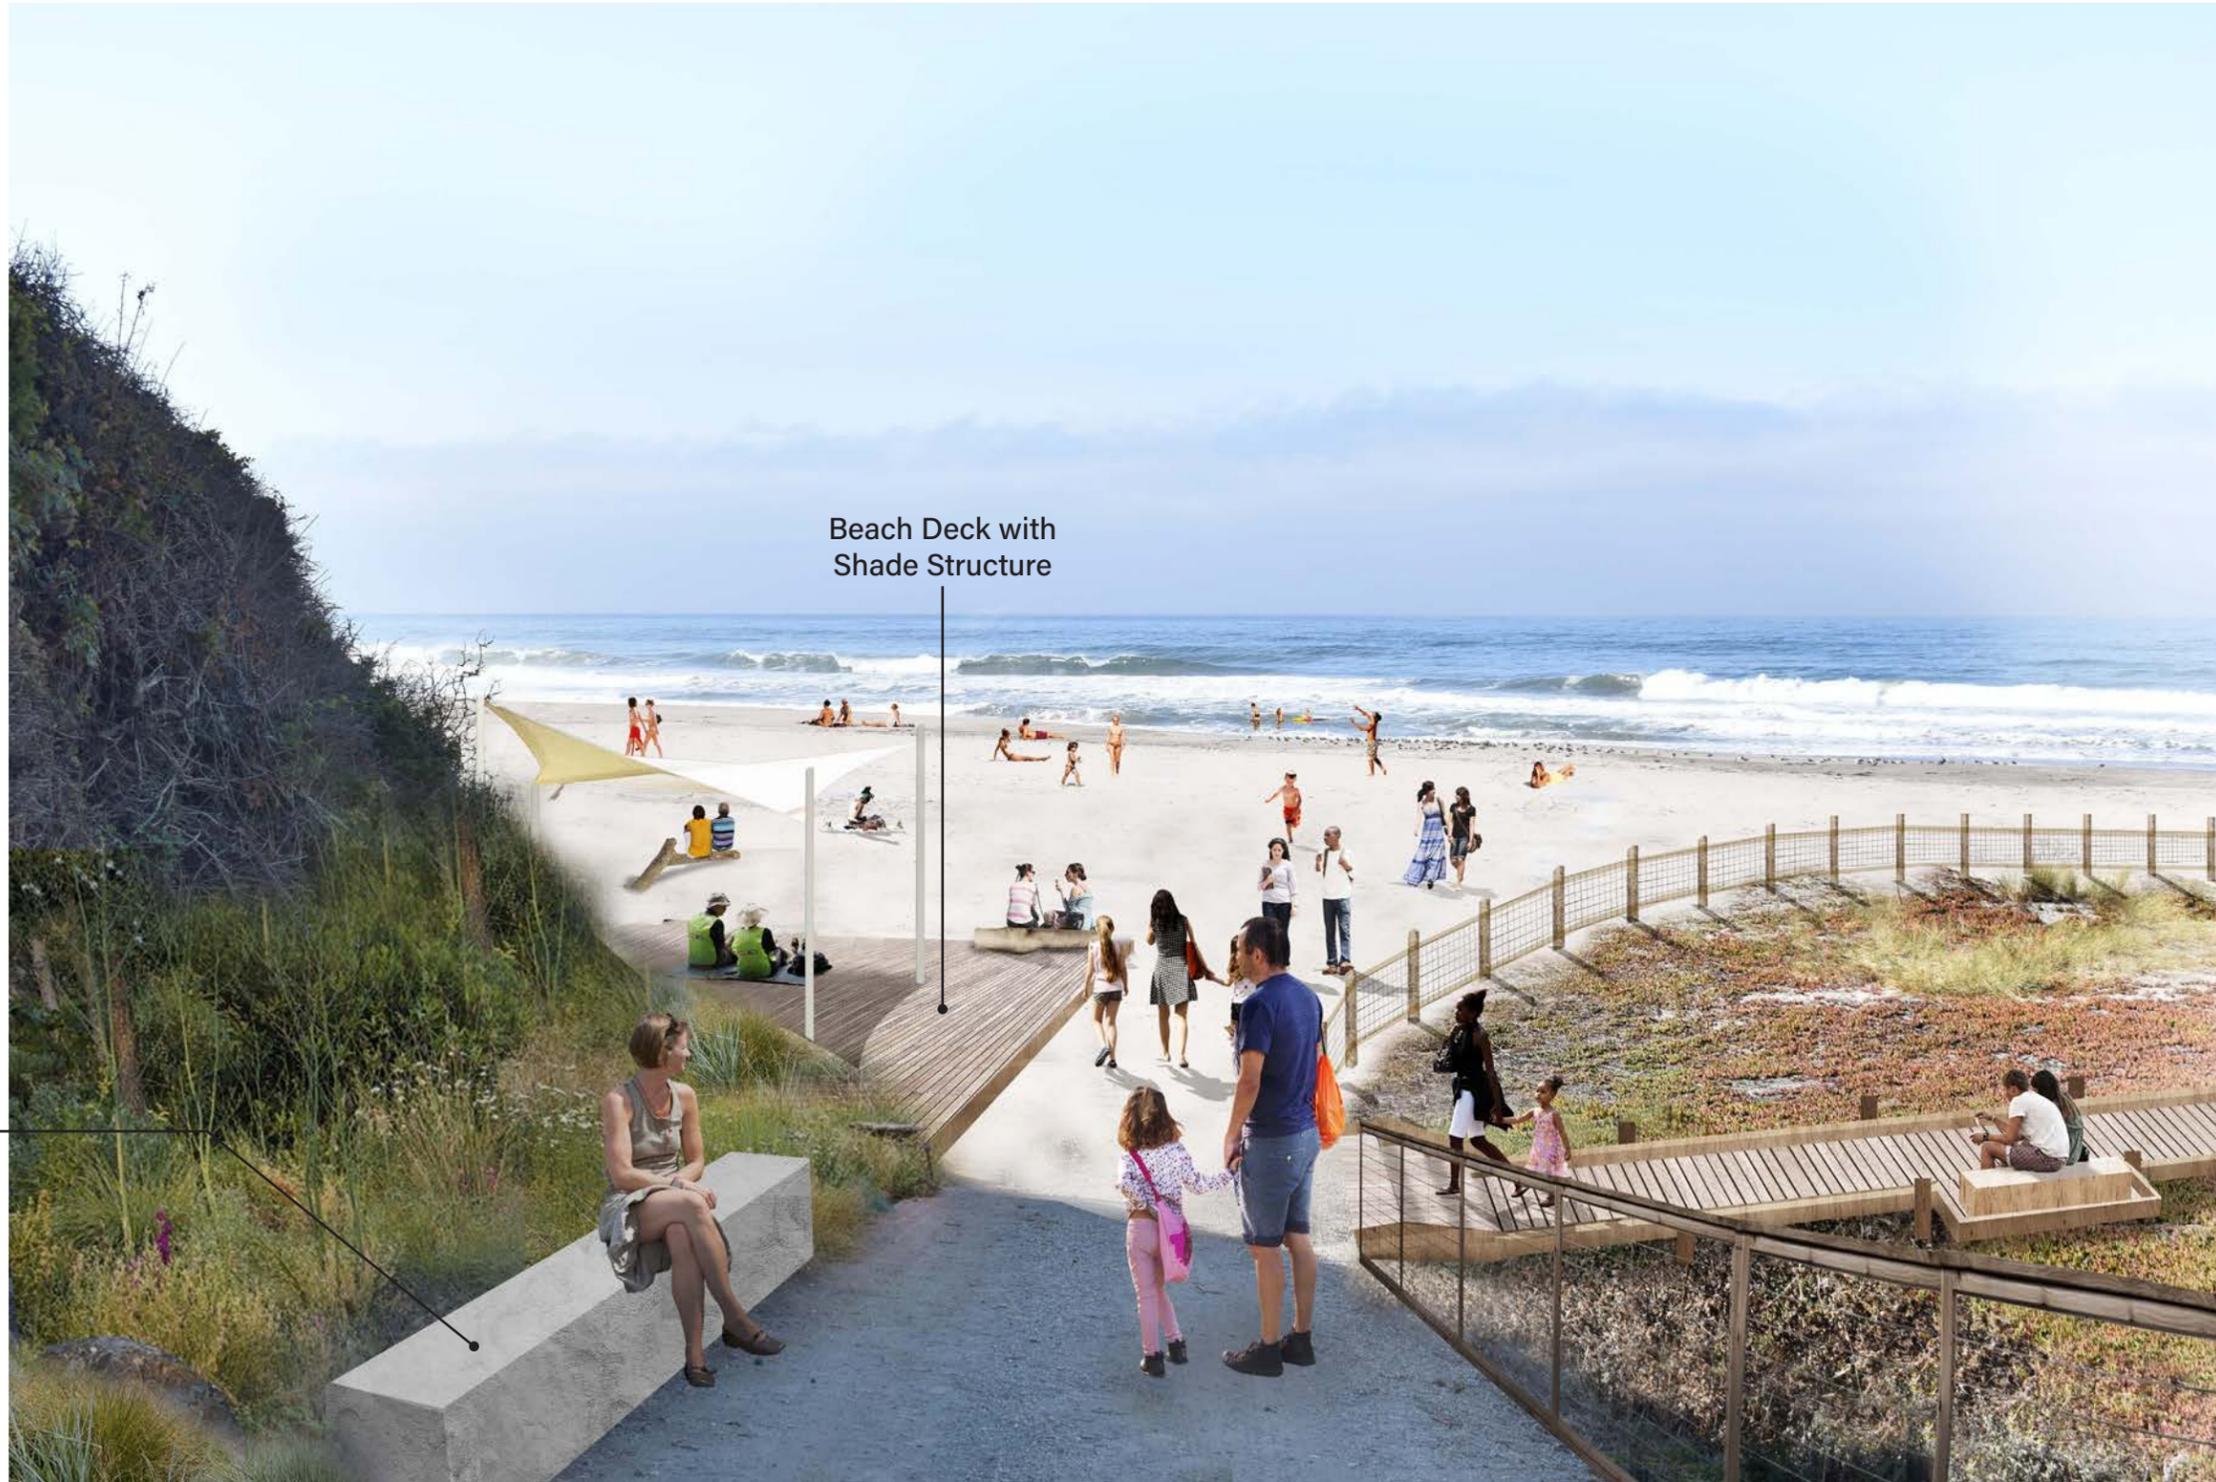
PERSPECTIVE VIEW: ALTERNATIVE 3

Beach Deck with
Shade Structure

Seating Along Beach
Access Trail
